# BOARD OF WATER SUPPLY

Subject: Honolulu Board of Water Supply (BWS) Comments on the Red Hill Bulk Fuel Storage Facility (RHBFSF), Scope of Work for Destructive Testing Supplement – Destructive Testing Plan, Supplement to Administrative Order on Consent (AOC) and Statement of Work (SOW) Section 5.3.2, dated June 1, 2018 and Our Inspection on June 25, 2018 of Coupons Removed from Tank 14.

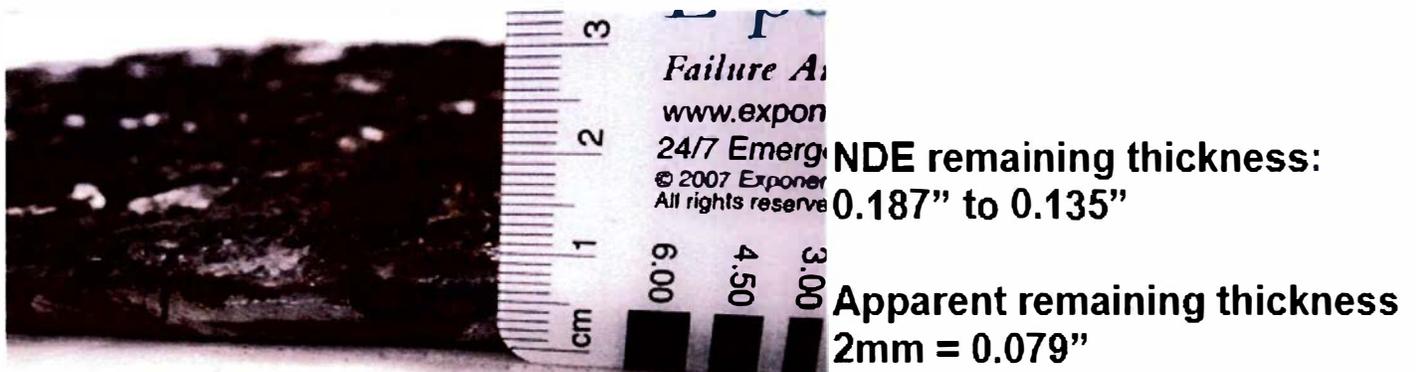
1. Presence of substantial backside corrosion — There were areas of substantial corrosion on the backside (non-fuel wetted side) of the ¼-inch thick steel plate lining the tank (Figure 1, for example).

Furthermore, our visual observations of some coupons suggest that the actual defect depth was greater than measured by either NDE technique. For example, Coupon #7 measurements indicated a remaining wall of either 0.157-inches or 0.135-inches whereas the cut edge of this coupon appears to show a minimum

remaining wall of 0.079-inches (see Figure 1). These are our observations, and we look forward to reviewing the results of the independent testing laboratory for confirmation.

Figure 1: Coupon No. 7 viewed from the cut edge shows the corrosion and staining on the backside against the concrete. Remaining wall appears to be about 2 mm or 0.079-inches.

3. Grind each of the four edges of the coupons flat and perpendicular to the plate faces in order to accurately document the minimum remaining wall thickness on each edge.

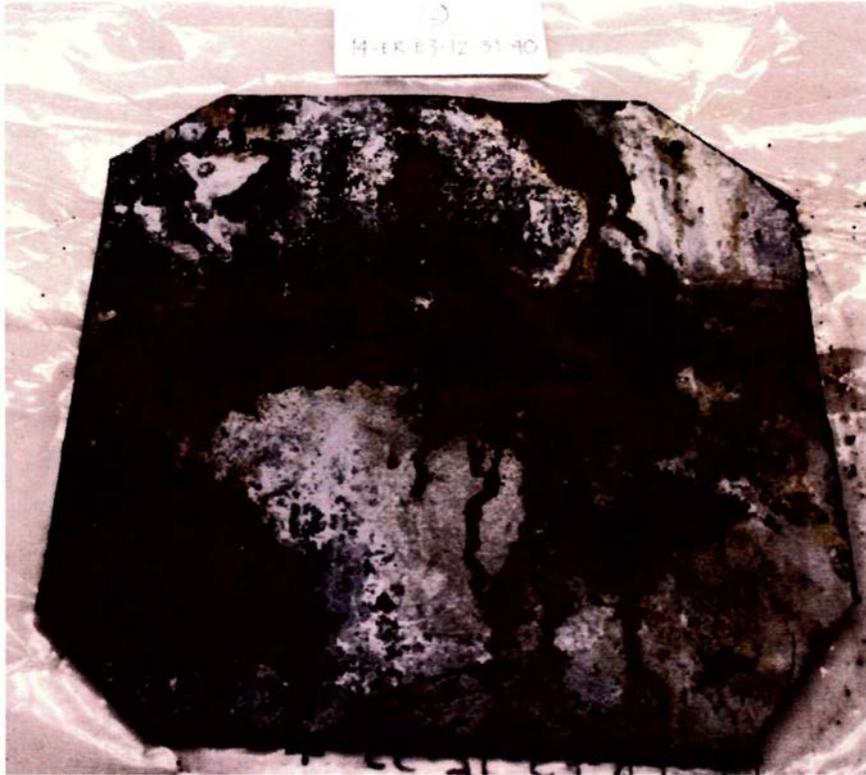
2. Staining on Backside of Steel — Deposits on the backside of some coupons suggest hydrocarbon-staining and should be tested for presence of released product (Figure 2, for example).
3. Non-Destructive Evaluation (NDE) Technique Underestimates Remaining Wall Thickness — Corrosion pit depths measured on the cut specimen edges suggest that NDE techniques were not able to locate and measure the thinnest wall of the coupon. For instance, the scale shown in Figure 1 indicates the wall along the edge of Coupon No. 2 has thinned to about 0.079-inches (reduced from 0.25-inches thick when new). However, the two NDE techniques (screening and Prove-up) predicted the thinnest area of this coupon to be 0.187-inches and 0.135-inches, respectively, underestimating the measured thickness by 51%.

Figure 2: Backside of Coupon No. 2 - The dark horizontal stain is likely corrosion product and/or hydrocarbon stains. Drip seen running down backside.

1. Collect samples of corrosion product and stains for scanning electron microscopy (SEM/EDS) and Fourier Transform Infrared (FTIR) spectroscopy prior to any cutting or grinding.
