**Technical Report for the Review of the
Joint Base Pearl Harbor-Hickam (JBPHH)
Interagency Team's Technical Memorandum on the
Lines of Evidence Evaluation of TPH Detections
Observed During Long-Term Monitoring**

Prepared for the Honolulu Board of Water Supply (BWS)

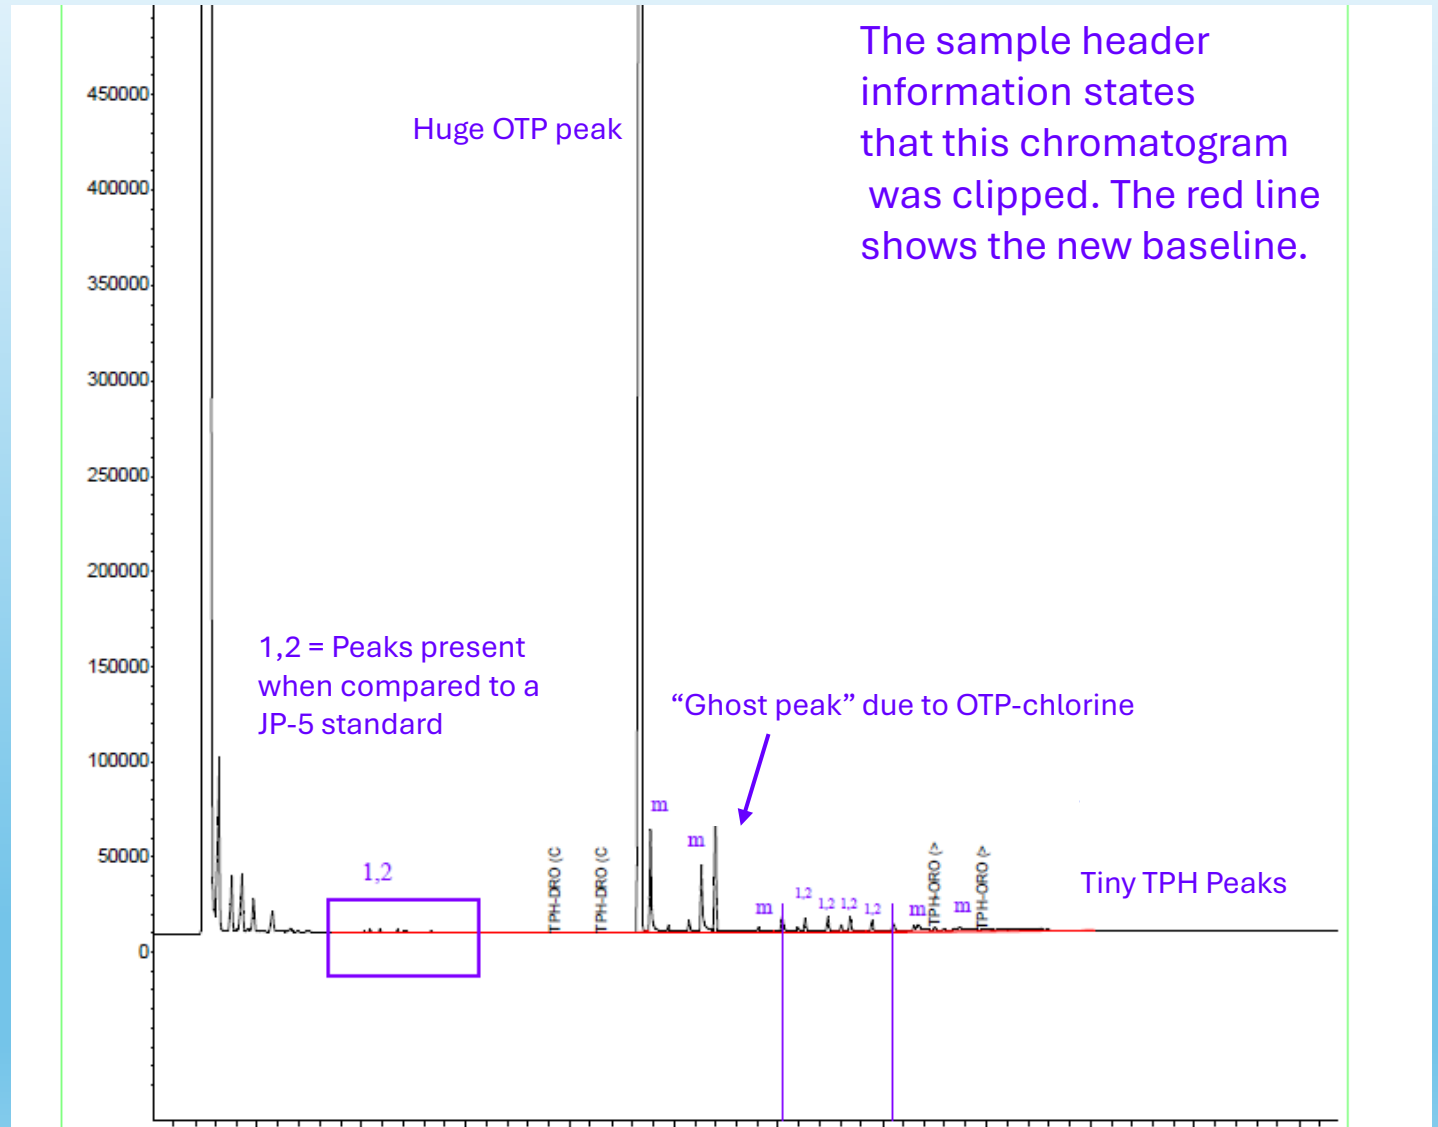
A picture is
worth a
thousand
words

- A. Method 8015, used to analyze the samples, was not adjusted for low-level analysis by using dedicated glassware and instrumentation and lower concentration standards.
- B. In many instances, there was too much interference to see low-level peaks.
- C. Chromatographic data (pictures of peaks) were cut off at the bottom (“clipped”) because laboratory analysts judged that the peaks were noise, effectively making all peaks on the chromatogram smaller and/or cutting them out entirely.
- D. The contamination in the method blanks shows that there is contamination in the blanks, but it does not prove that JP-5 is not present in the samples.
