MID ATLANTIC ENVIRONMENTAL	
EMERGENCY REPAIRS FOR RED HILL TANKS	
Tank #7 RECOMMENDED REPAIR DRAWINGS	
Repair No.: 016	File: 7R016
Upper Dome	Quadrant: D
Course: A	Plate: 21
Drawn by: Tom Kitchen	Date: 5/4/98

**Dames & Moore**  
Emergency Repairs For Red Hill Tanks at the Fleet Industrial & Supply Center  
Contract No. N62742-96-C-1356

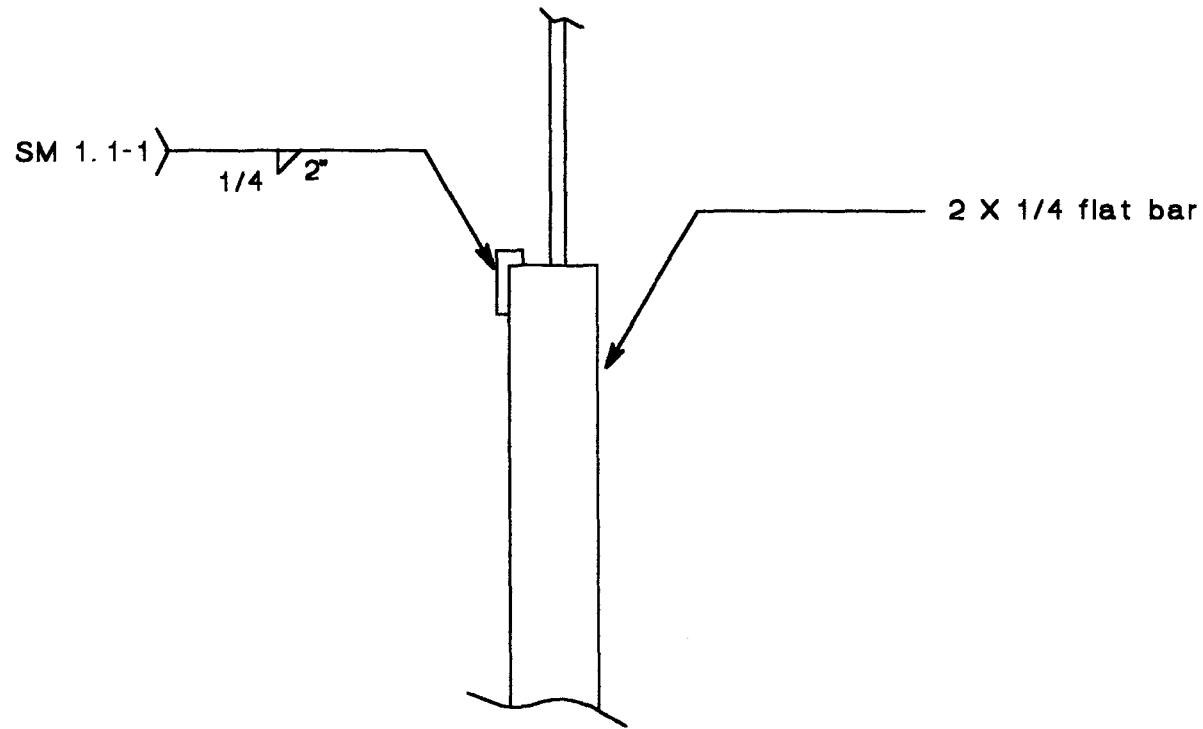
TYPE 10 REPAIR

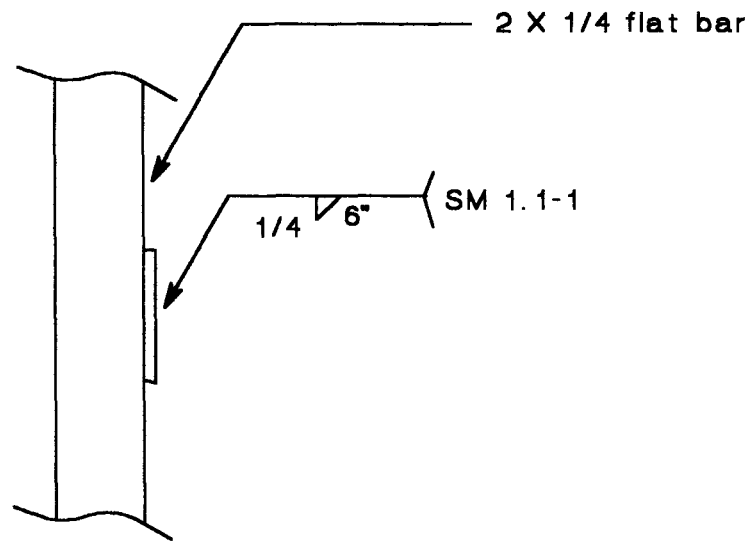
MID ATLANTIC ENVIRONMENTAL	
EMERGENCY REPAIRS FOR RED HILL TANKS	
Tank #7 RECOMMENDED REPAIR DRAWINGS	
Repair No.: 017	File: 7R017
Upper Dome	Quadrant: D
Course: A	Plate: 19
Drawn by: Tom Kitchen	Date: 5/4/98

TYPE 10 REPAIR

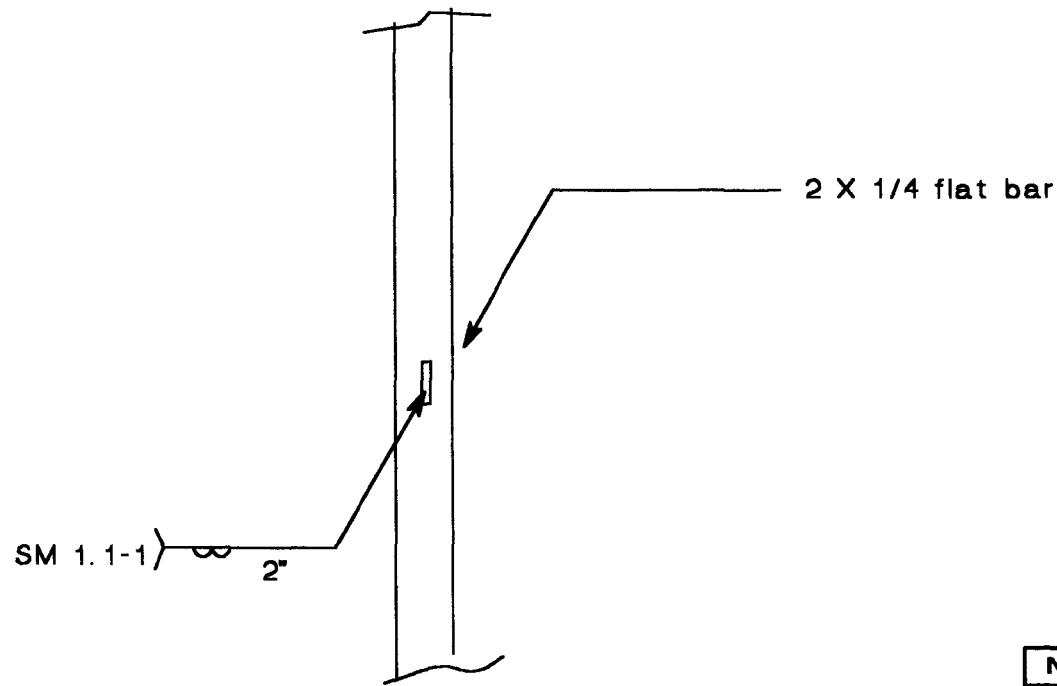
MID ATLANTIC ENVIRONMENTAL	
EMERGENCY REPAIRS FOR RED HILL TANKS	
Tank #7 RECOMMENDED REPAIR DRAWING	
Repair No.: 018	File: 7R018
Upper Dome	Quadrant: D
Course: A	Plate: 19
Drawn by: Tom Klitcher	Date: 5/4/98

TYPE 10 REPAIR

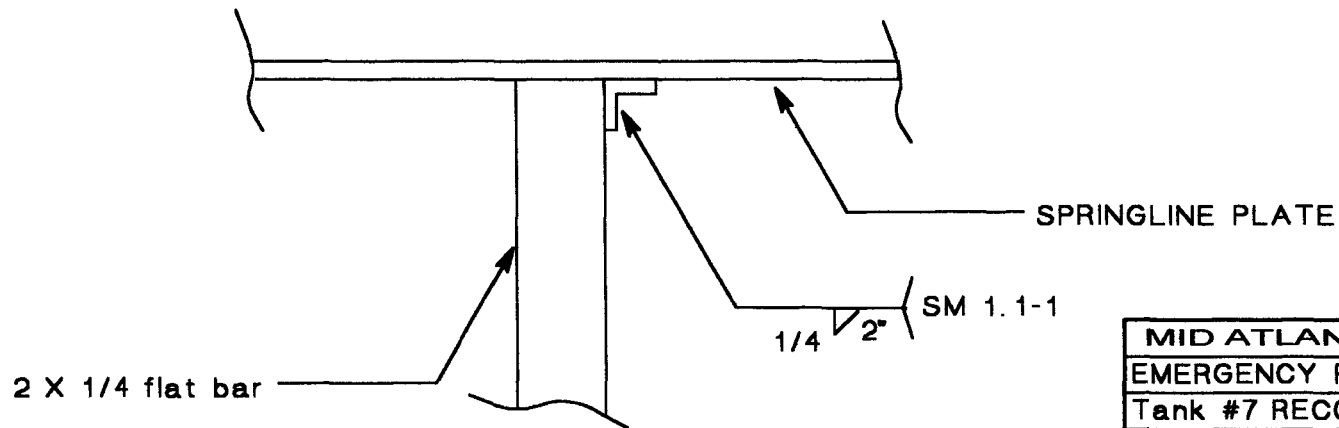
MID ATLANTIC ENVIRONMENTAL	
EMERGENCY REPAIRS FOR RED HILL TANKS	
Tank #7 RECOMMENDED REPAIR DRAWING	
Repair No. : 019	File: 7R019
Upper Dome	Quadrant: C
Course: EXTENSION	Plate: 18
Drawn by: Tom Kitchen	Date: 5/4/98

TYPE 10 REPAIR

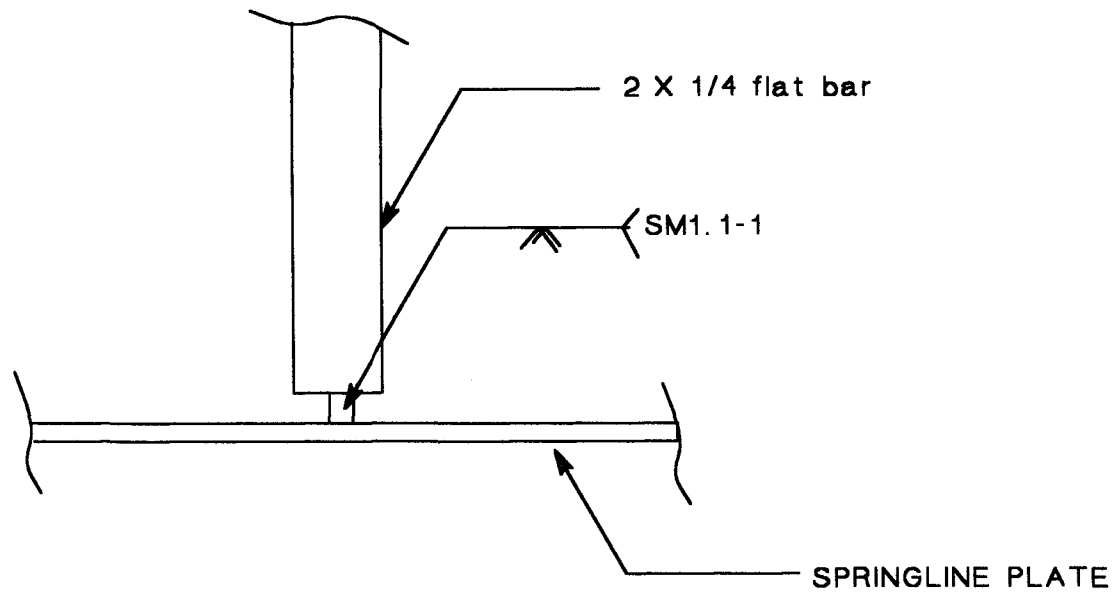
MID ATLANTIC ENVIRONMENTAL	
EMERGENCY REPAIRS FOR RED HILL TANKS	
Tank #7 RECOMMENDED REPAIR DRAWING	
Repair No. : 020	File: 7R020
Upper Dome	Quadrant: C
Course: A	Plate: 18
Drawn by: Tom Klitcher	Date: 5/4/98

TYPE 10 REPAIR

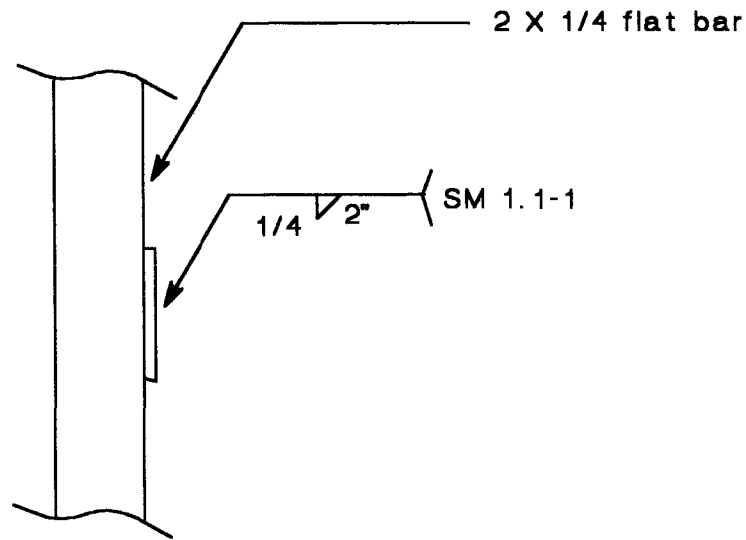
MID ATLANTIC ENVIRONMENTAL	
EMERGENCY REPAIRS FOR RED HILL TANKS	
Tank #7 RECOMMENDED REPAIR DRAWINGS	
Repair No. : 021	File: 7R021
Upper Dome	Quadrant: C
Course: A	Plate: 1C
Drawn by: Tom Kitchen	Date: 5/4/98

TYPE 10 REPAIR

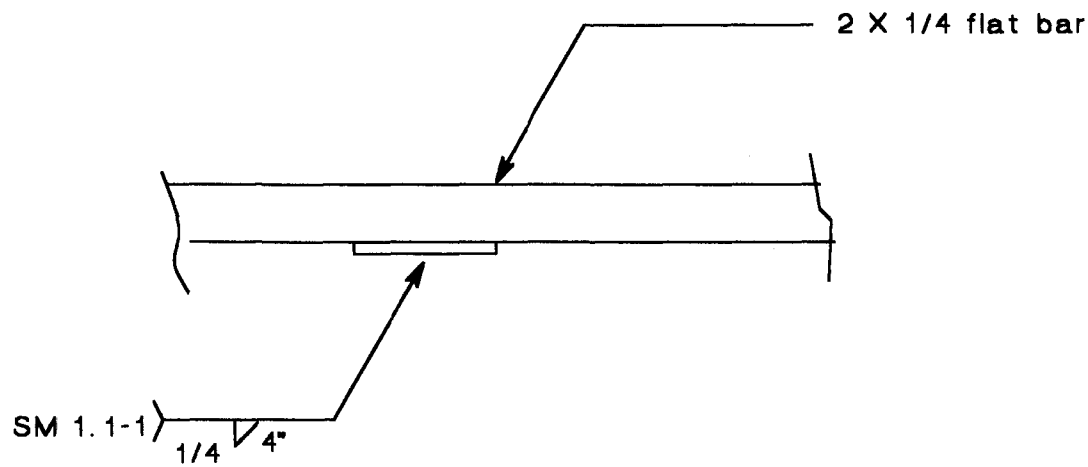
MID ATLANTIC ENVIRONMENTAL	
EMERGENCY REPAIRS FOR RED HILL TANKS	
Tank #7 RECOMMENDED REPAIR DRAWING	
Repair No.: 022	File: 7R022
Upper Dome	Quadrant: C
Course: EXTENSION	Plate: 18
Drawn by: Tom Kitchen	Date: 5/4/98

TYPE 10 REPAIR

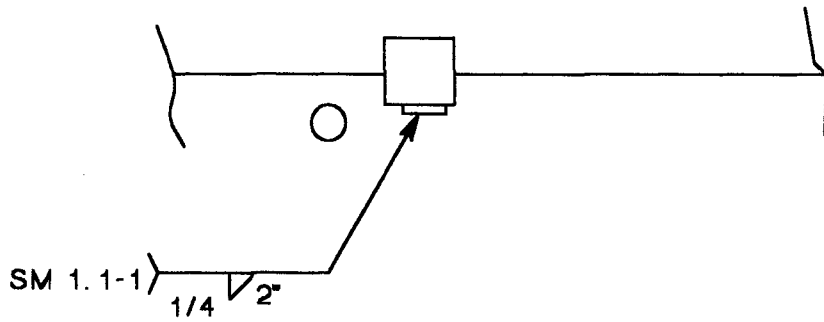
MID ATLANTIC ENVIRONMENTAL	
EMERGENCY REPAIRS FOR RED HILL TANKS	
Tank #7 RECOMMENDED REPAIR DRAWING	
Repair No.: 023	File: 7R023
CYLINDER	Quadrant: D
Course: 6	Plate: 21
Drawn by: Tom Kitchen	Date: 5/4/98

TYPE 10 REPAIR

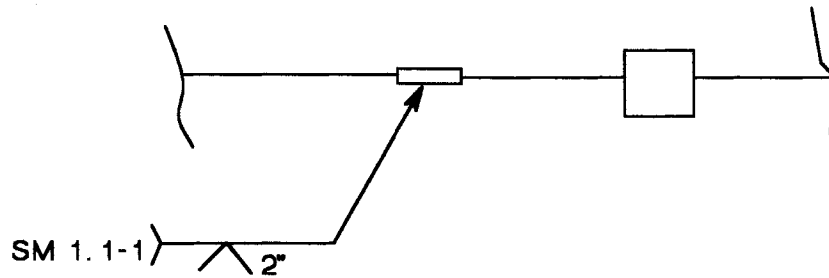
MID ATLANTIC ENVIRONMENTAL	
EMERGENCY REPAIRS FOR RED HILL TANKS	
Tank #7 RECOMMENDED REPAIR DRAWING	
Repair No.: 024	File: 7R024
CYLINDER	Quadrant: C
Course: 10	Plate: 12
Drawn by: Tom Klitcher	Date: 5/4/98

TYPE 9 REPAIR

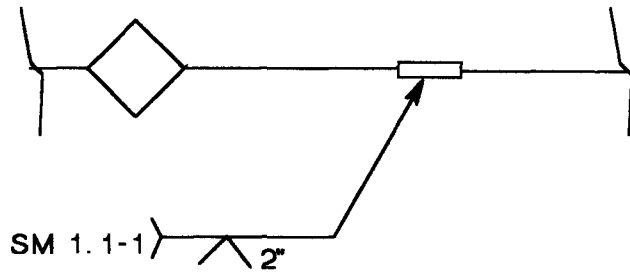
MID ATLANTIC ENVIRONMENTAL	
EMERGENCY REPAIRS FOR RED HILL TANKS	
Tank #7 RECOMMENDED REPAIR DRAWING	
Repair No.: 025	File: 7R025
CYLINDER	Quadrant: D
Course: 13	Plate: 21
Drawn by: Tom Klitcher	Date: 5/4/98

TYPE 9 REPAIR

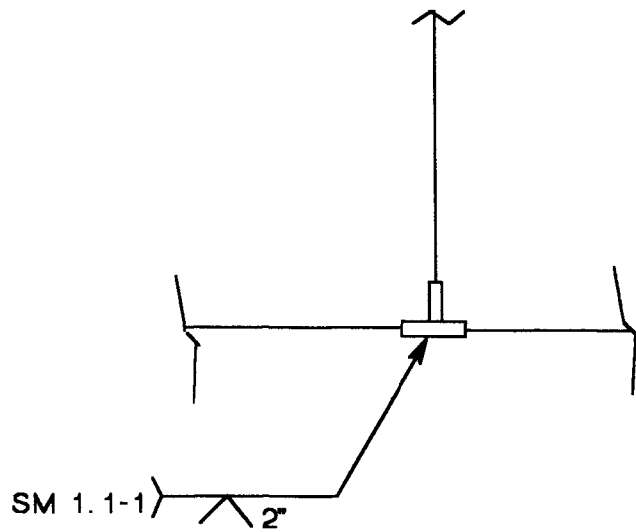
MID ATLANTIC ENVIRONMENTAL	
EMERGENCY REPAIRS FOR RED HILL TANKS	
Tank #7 RECOMMENDED REPAIR DRAWING	
Repair No.: 026	File: 7R026
CYLINDER	Quadrant: D
Course: 13	Plate: 21
Drawn by: Tom Kitchen	Date: 5/4/98

TYPE 9 REPAIR

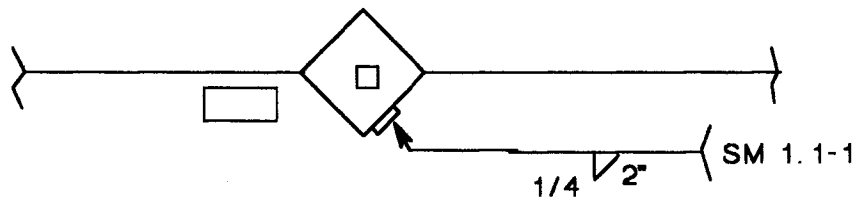
MID ATLANTIC ENVIRONMENTAL	
EMERGENCY REPAIRS FOR RED HILL TANKS	
Tank #7 RECOMMENDED REPAIR DRAWINGS	
Repair No.: 027	File: 7R027
CYLINDER	Quadrant: D
Course: 13	Plate: 21
Drawn by: Tom Kitchen	Date: 5/4/98

TYPE 10 REPAIR

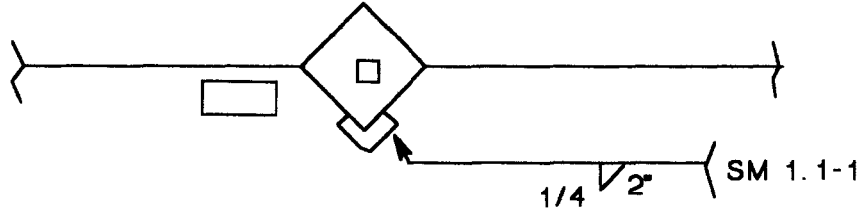
MID ATLANTIC ENVIRONMENTAL	
EMERGENCY REPAIRS FOR RED HILL TANKS	
Tank #7 RECOMMENDED REPAIR DRAWINGS	
Repair No.: 028	File: 7R028
CYLINDER	Quadrant: D
Course: 16	Plate: 21
Drawn by: Tom Kitchen	Date: 5/4/98

TYPE 10 REPAIR

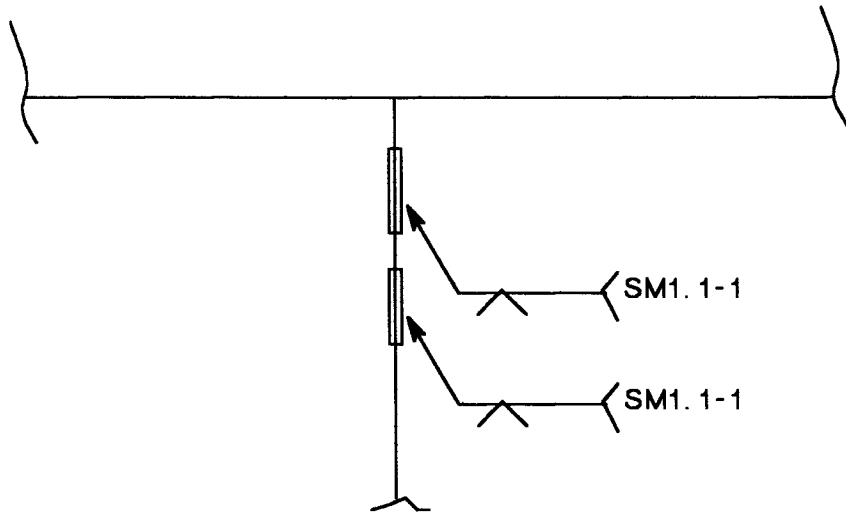
<b>MID ATLANTIC ENVIRONMENTAL</b>	
<b>EMERGENCY REPAIRS FOR RED HILL TANKS</b>	
<b>Tank #7 RECOMMENDED REPAIR DRAWING</b>	
Repair No.: 029	File: 7R029
CYLINDER	Quadrant: D
Course: 14	Plate: 22
Drawn by: Tom Klitcher	Date: 5/4/98

TYPE 10 REPAIR

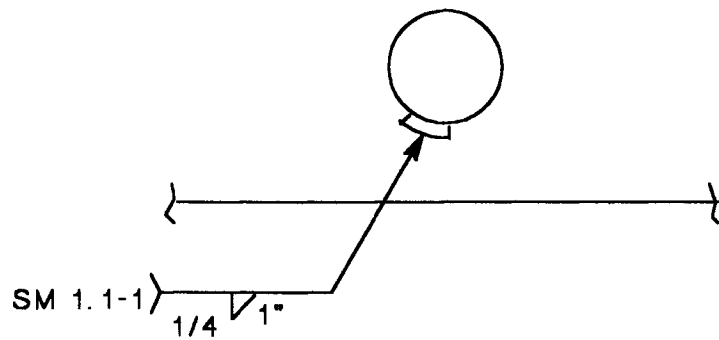
MID ATLANTIC ENVIRONMENTAL	
EMERGENCY REPAIRS FOR RED HILL TANKS	
Tank #7 RECOMMENDED REPAIR DRAWING	
Repair No.: 030	File: 7R030
cylinder	Quadrant: C
Course: 25	Plate: 15
Drawn by: Tom Klitcher	Date: 5/4/98

TYPE 10 REPAIR
