MID ATLANTIC ENVIRONMENTAL	
EMERGENCY REPAIRS FOR RED HILL TANKS	
Tank #8 RECOMMENDED REPAIR DRAWING	
Repair No.: 014	File: 8r014
LOWER DOME	Quadrant: B
Course: 3	PLATE: 10
Drawn by: Tom Kitchen	Date: 5/4/98

**Dames & Moore**  
Emergency Repairs For Red Hill Tanks at the Fleet Industrial & Supply Center  
Contract No. N62742-96-C-1356

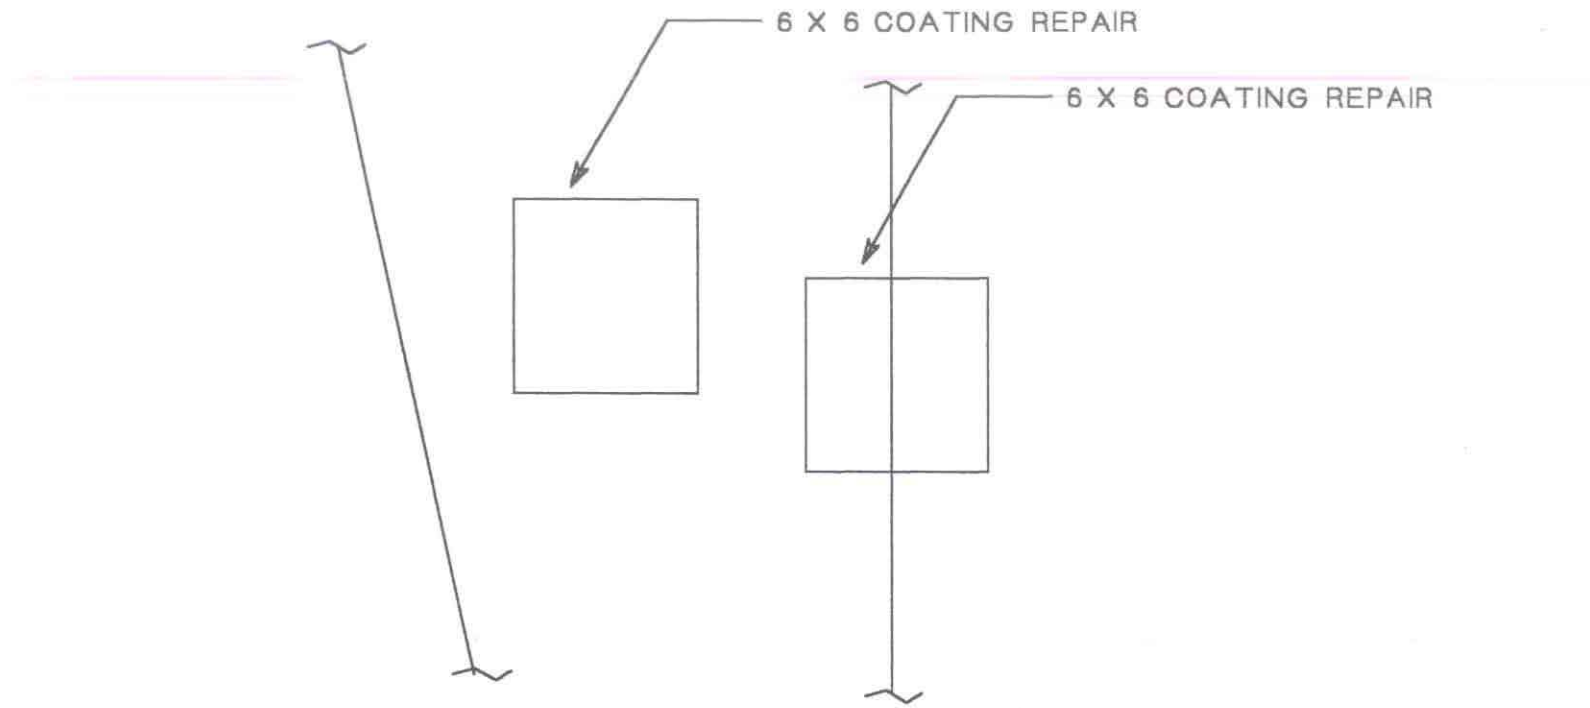
TYPE 9 REPAIR

DEFECT INSPECTED BY TK & JF 3/16/98

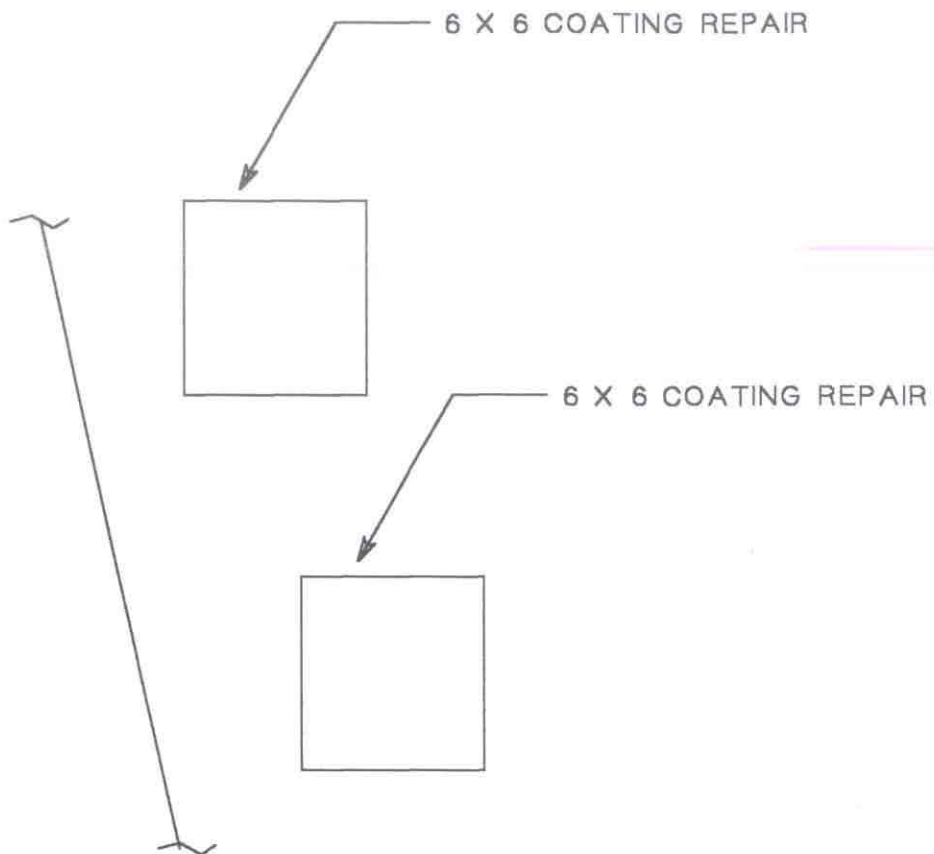
MID ATLANTIC ENVIRONMENTAL	
EMERGENCY REPAIRS FOR RED HILL TANKS	
Tank #8 RECOMMENDED REPAIR DRAWING	
Repair No.: 015	File: 8r015
LOWER DOME	Quadrant: B
Course: 3	PLATE: 10
Drawn by: Tom Kitchen	Date: 5/4/98

TYPE 8 REPAIR

DEFECT INSPECTED BY TK & JF 3/16/98

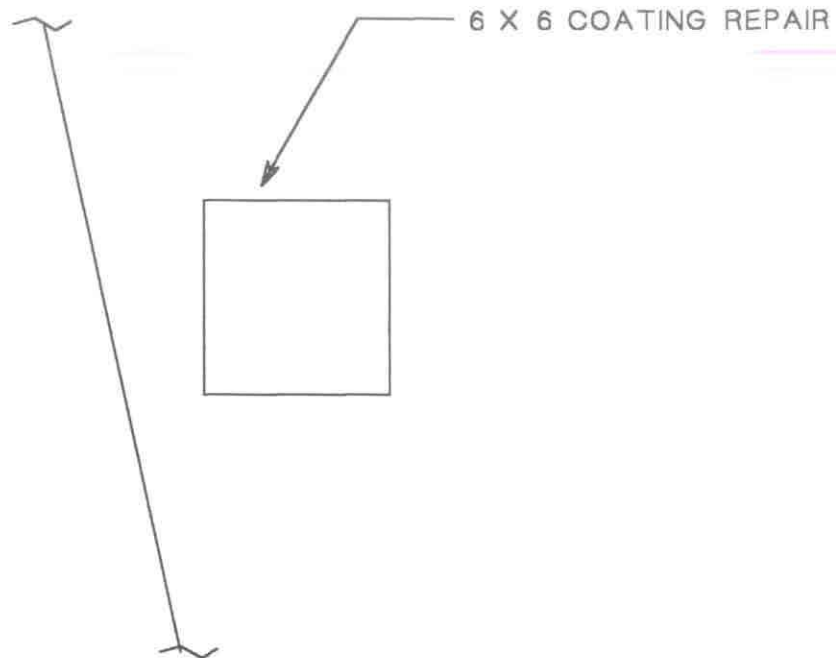
MID ATLANTIC ENVIRONMENTAL	
EMERGENCY REPAIRS FOR RED HILL TANKS	
Tank #8 RECOMMENDED REPAIR DRAWING	
Repair No.: 016	File: 8r016
LOWER DOME	Quadrant: B
Course: 3	PLATE: 19
Drawn by: Tom Kitchen	Date: 5/4/98

TYPE 8 REPAIR

6 X 8 COATING REPAIR

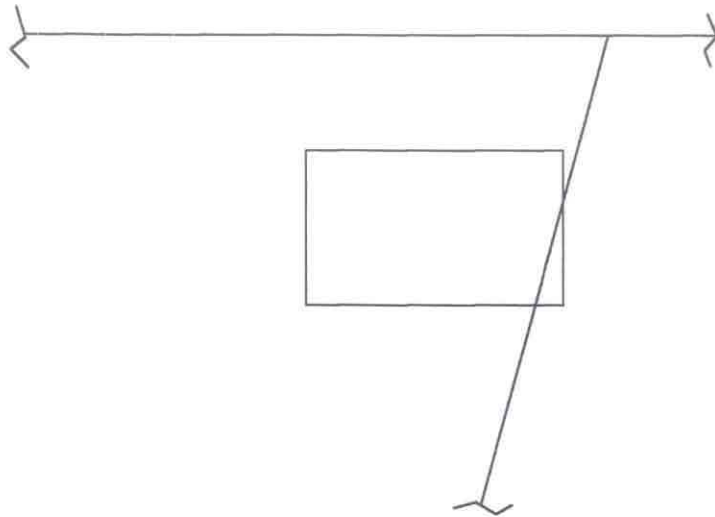
MID ATLANTIC ENVIRONMENTAL	
EMERGENCY REPAIRS FOR RED HILL TANKS	
Tank #8 RECOMMENDED REPAIR DRAWING	
Repair No.: 017	File: 8r017
LOWER DOME	Quadrant: B
Course: 3	PLATE: 8
Drawn by: Tom Kitchen	Date: 5/4/98

TYPE 8 REPAIR

DEFECT INSPECTED BY TK & JF 3/16/98

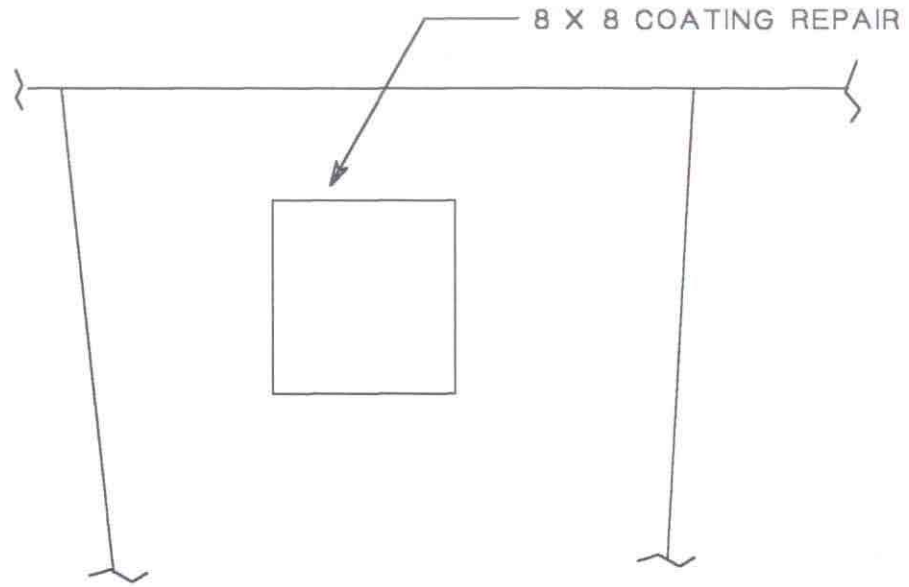
MID ATLANTIC ENVIRONMENTAL	
EMERGENCY REPAIRS FOR RED HILL TANKS	
Tank #8 RECOMMENDED REPAIR DRAWING	
Repair No.: 018	File: 8r018
LOWER DOME	Quadrant: B
Course: 2	PLATE: 10
Drawn by: Tom Kitchen	Date: 5/4/98

TYPE 8 REPAIR

DEFECT INSPECTED BY TK & JF 3/16/98

SCATTERED BLISTERS APPROXIMATE AREA OF COATING  
REPAIR EQUAL 2 SQUARE METERS

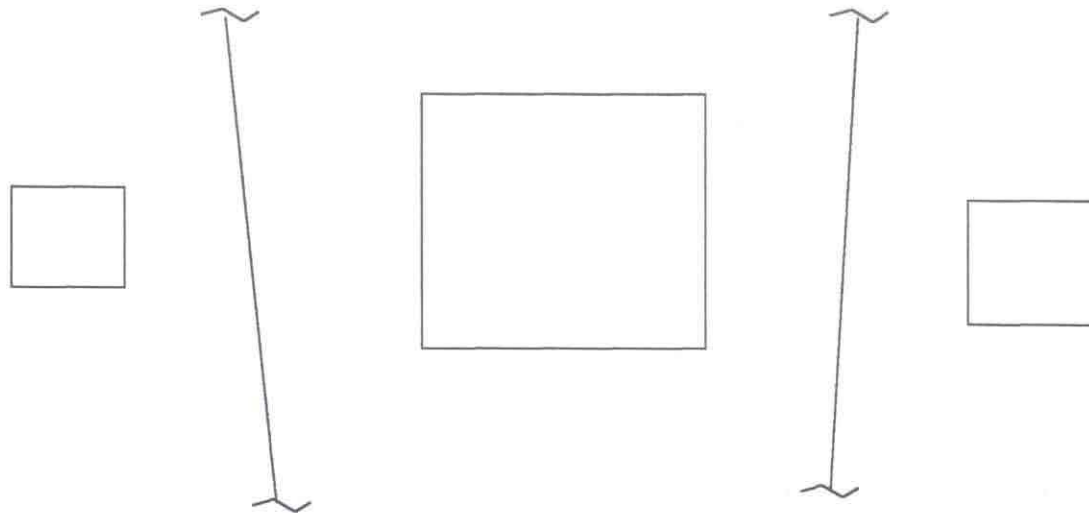
MID ATLANTIC ENVIRONMENTAL	
EMERGENCY REPAIRS FOR RED HILL TANKS	
Tank #8 RECOMMENDED REPAIR DRAWING	
Repair No.: 019 & 020	File: 8r019
LOWER DOME	Quadrant: B
Course: 2	PLATE: 11
Drawn by: Tom Kitchen	Date: 5/4/98

TYPE 8 REPAIR

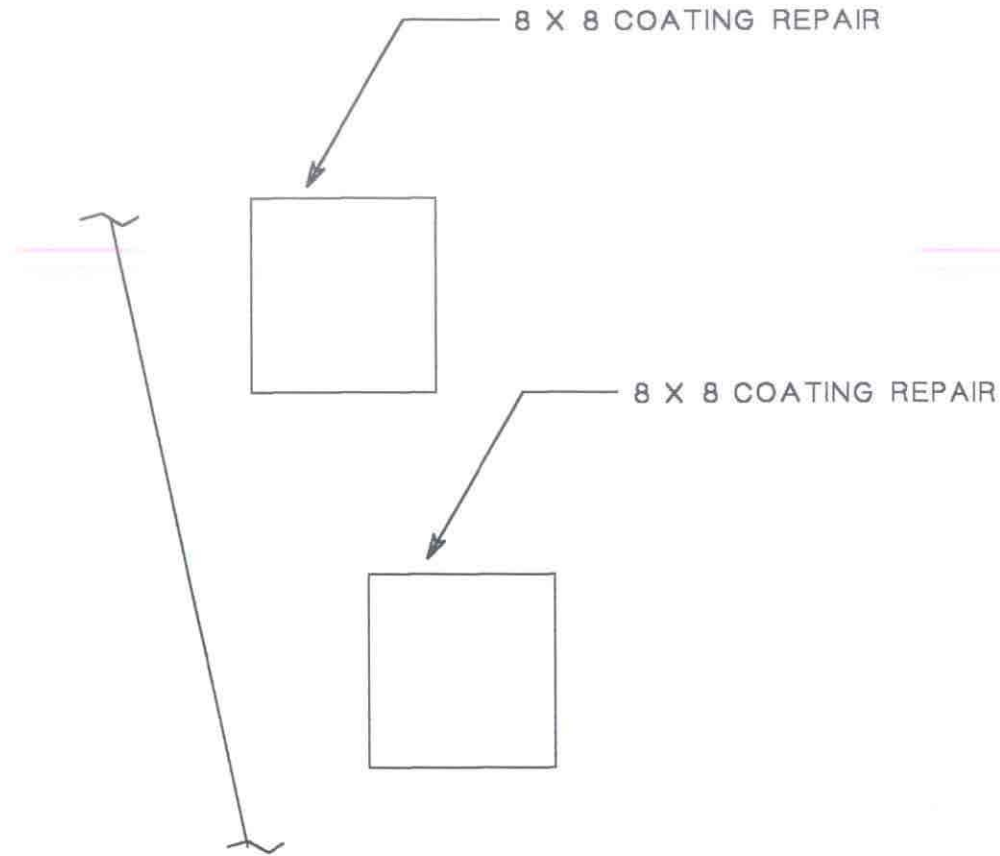
MID ATLANTIC ENVIRONMENTAL	
EMERGENCY REPAIRS FOR RED HILL TANKS	
Tank #8 RECOMMENDED REPAIR DRAWING	
Repair No.: 021	File: 8r021
LOWER DOME	Quadrant: A
Course: 2	PLATE: 2
Drawn by: Tom Kitchen	Date: 5/4/98

TYPE 8 REPAIR

DEFECT INSPECTED BY TK & JF 7/1/98

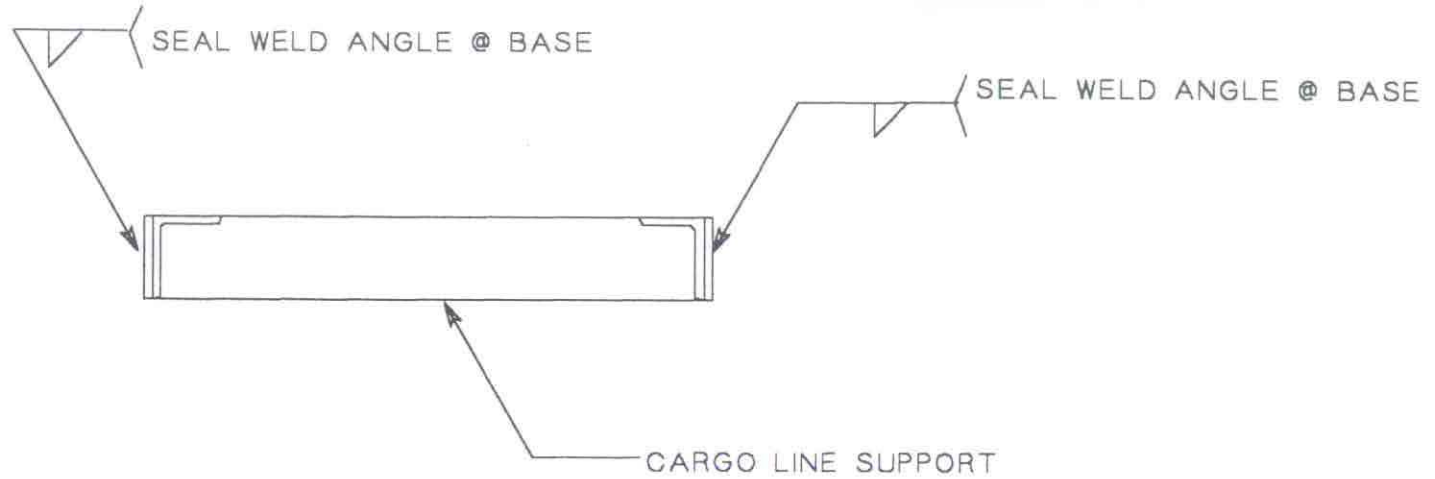
MID ATLANTIC ENVIRONMENTAL	
EMERGENCY REPAIRS FOR RED HILL TANKS	
Tank #8 RECOMMENDED REPAIR DRAWING	
Repair No.: 022	File: 8r022
LOWER DOME	Quadrant: B
Course: 1	PLATE: 12
Drawn by: Tom Kitchen	Date: 7/1/98

TYPE 10 REPAIR

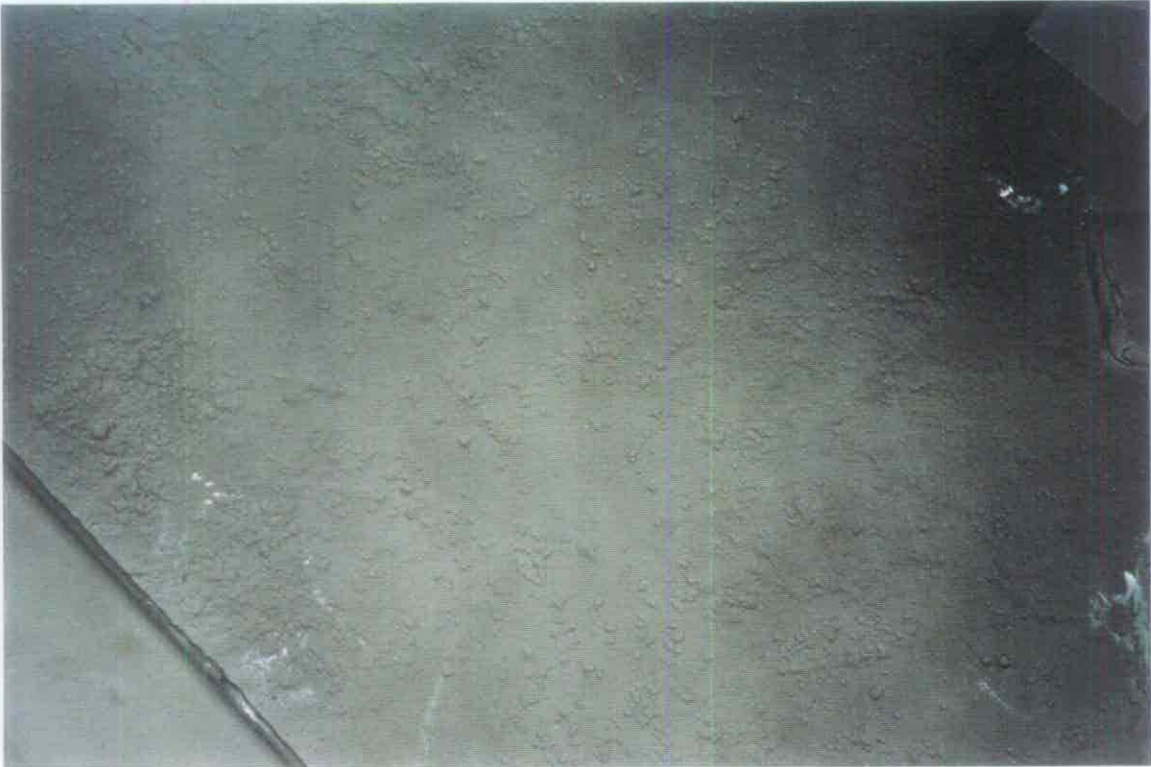
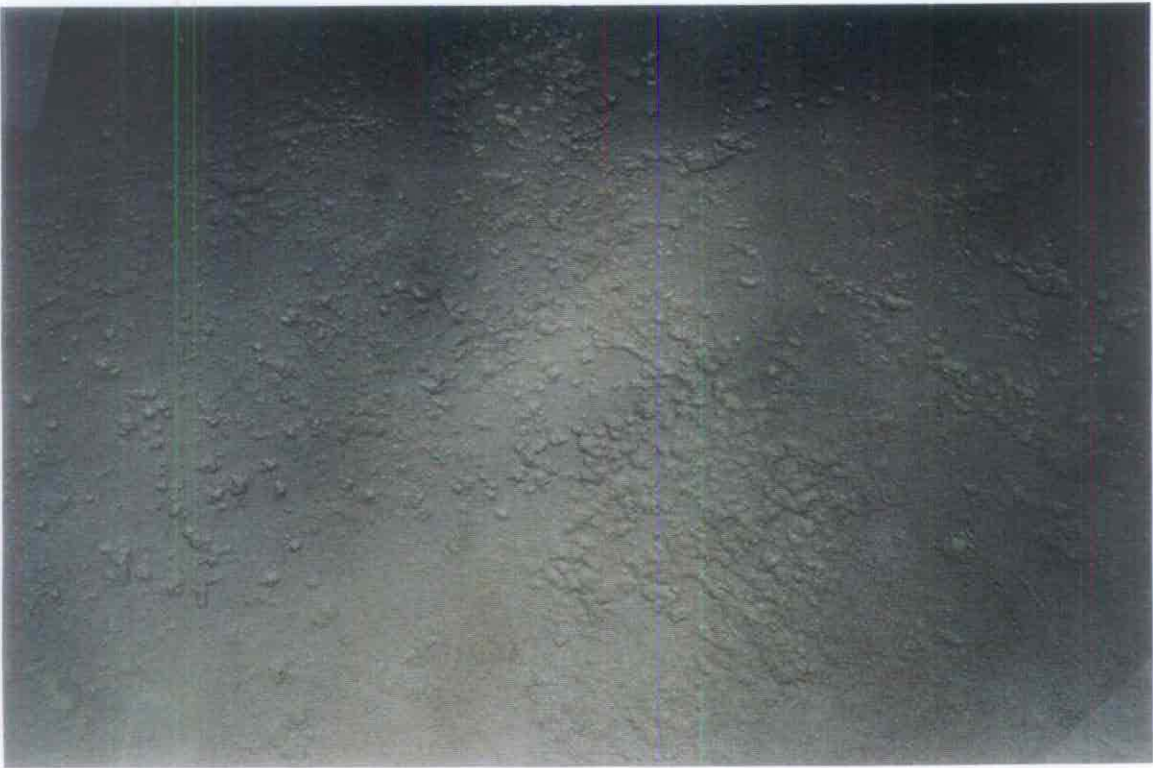
**PICTURES OF PITTING AT BOTTOM OF TANK**
