Section 9

RECOMMENDED REPAIRS

MID ATLANTIC ENVIRONMENTAL	
EMERGENCY REPAIRS FOR RED HILL TANKS	
Tank #7 RECOMMENDED REPAIR DRAWINGS	
Repair No.: 001	File: 7r001
Upper Dome	Quadrant: D
Course: B	Plate: 19
Drawn by: Tom Kitchen	Date: 5/4/98

Dames & Moore
Emergency Repairs For Red Hill Tanks at the Fleet Industrial & Supply Center
Contract No. N62742-96-C-1356

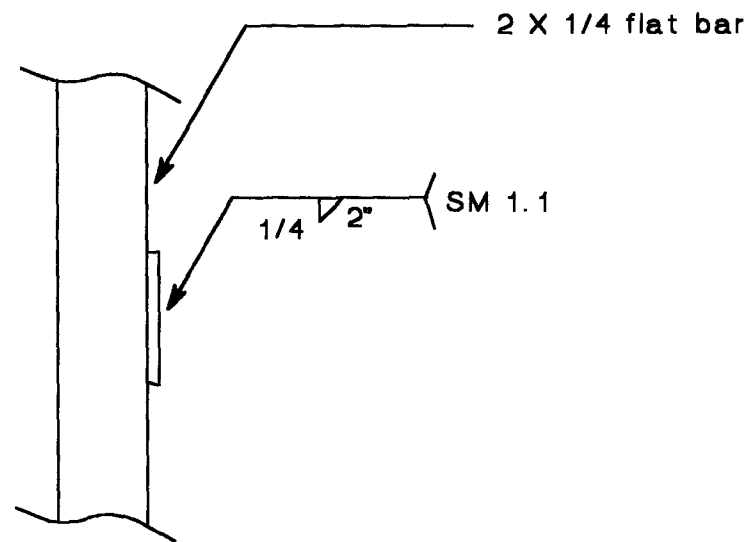
INSPECTED 3/27/98 BY JF & TK

TYPE 10 REPAIR

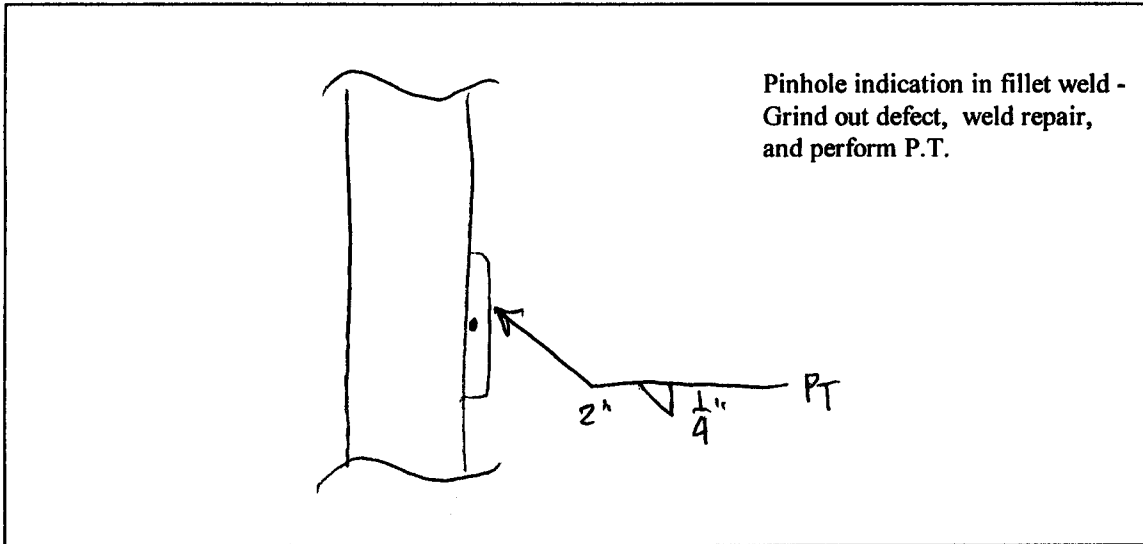
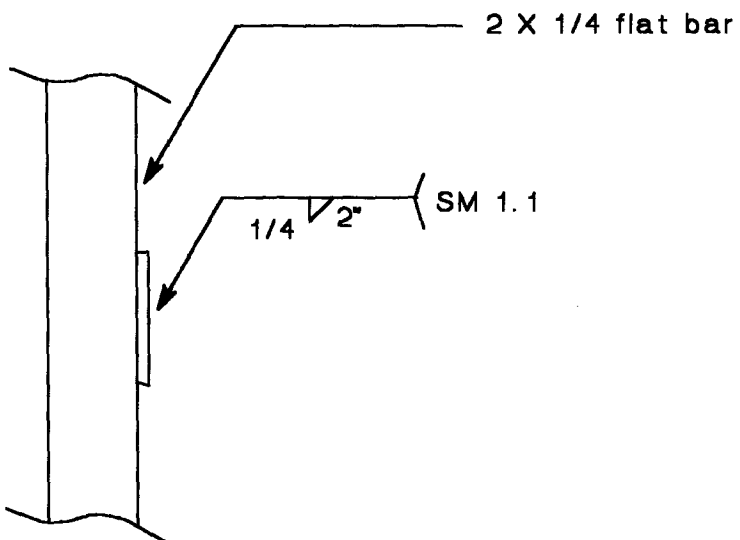
Tank No.: 7 Repair No.: 002 Type: 10 Location: D 22 - B

INSPECTED 3/27/98 BY JF & TK

TYPE 10 REPAIR

Weld Repair

NDT Performed: Visual Vacuum Box Dye Penetrant

Coating Type: Epoxy

NDT Performed: Visual: DFT: Average DFT: 8-15 mils

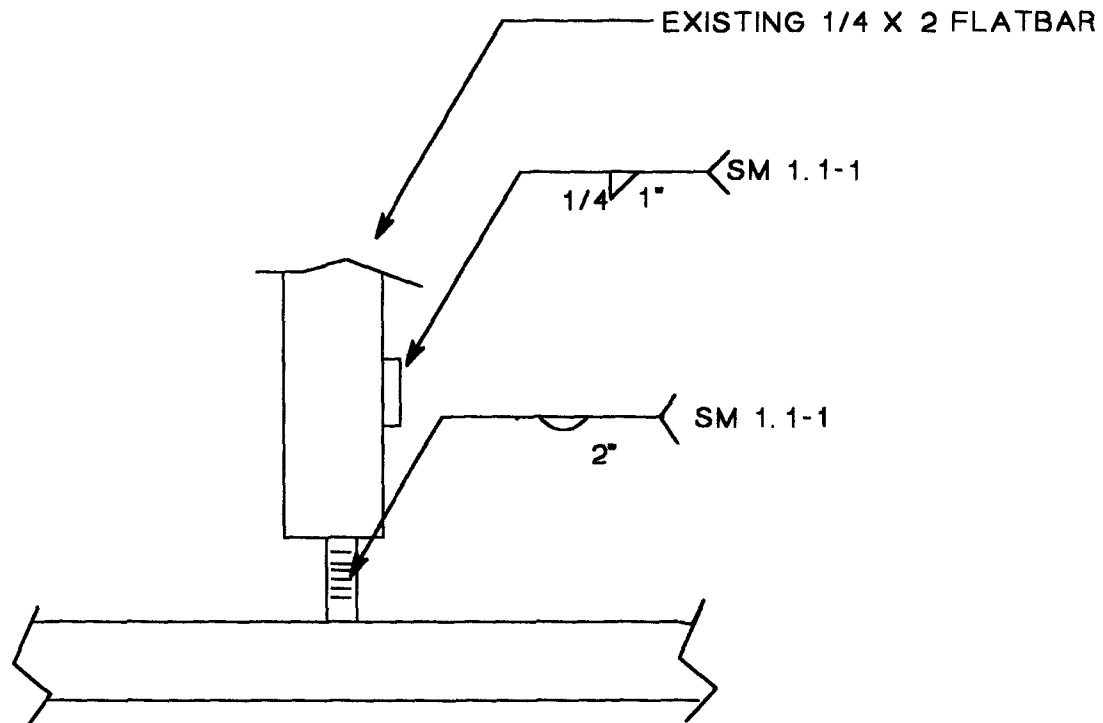
MID ATLANTIC ENVIRONMENTAL	
EMERGENCY REPAIRS FOR RED HILL TANKS	
Tank #7 AS BUILT DRAWINGS	
Repair No.: 003	File: 7R003
Upper Dome	Quadrant: D
Course: A	Plate: 22
Drawn by: Tom Kitchen	Date: 5/4/98

DEFECT INSPECTED 3/27/98 BY JF & TK

EXISTING 1/4 X 2 FLATBAR

TYPE 10 REPAIR

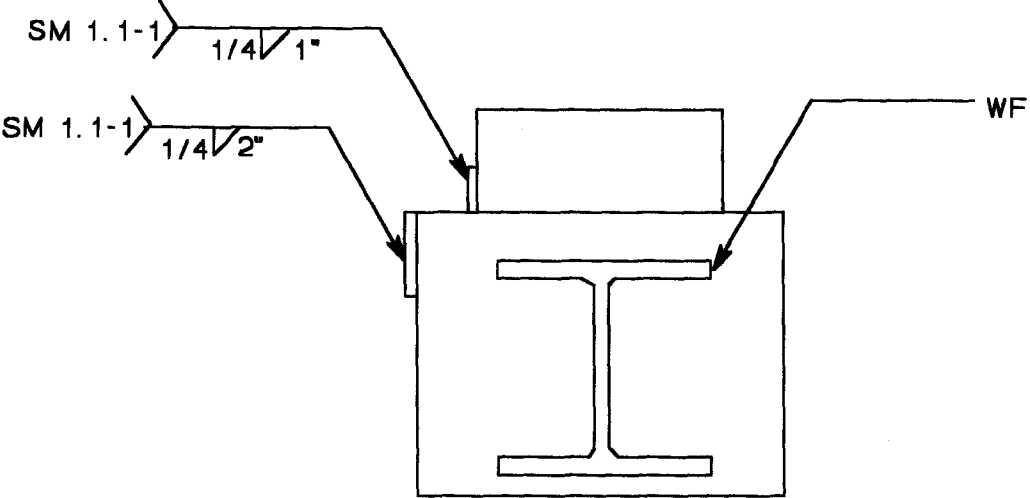
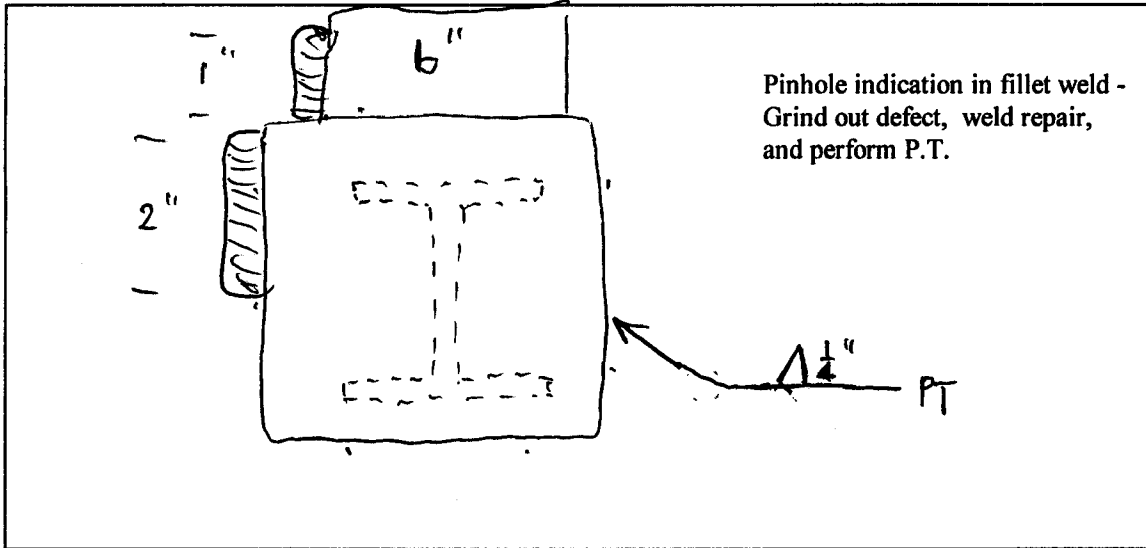
Tank No.: 7 Repair No.: 004 Type: 10 Location: D22-A

Defect Inspected 3/27/98 by JF 7 TK

TYPE 10 REPAIR

Weld Repair

NDT Performed: Visual Vacuum Box Dye Penetrant

Coating Type: Epoxy

NDT Performed: Visual: DFT: Average DFT: 8-15 mils

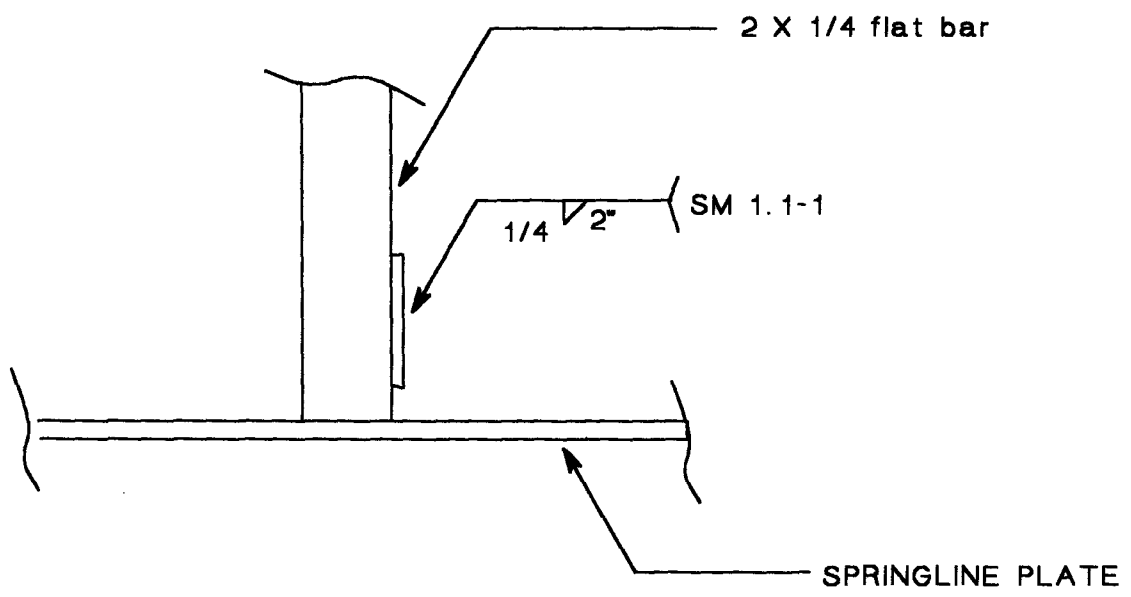
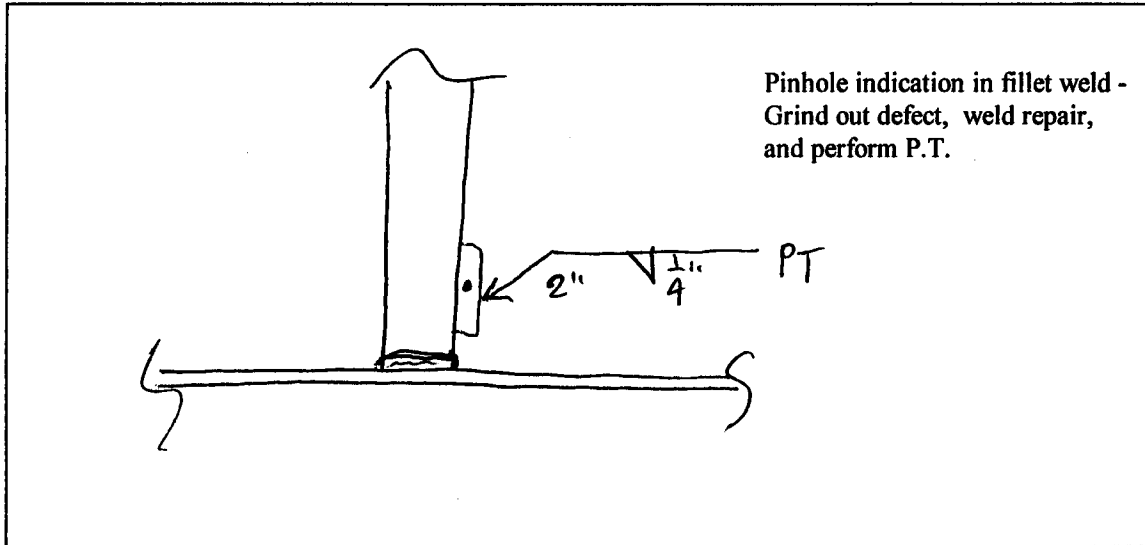
Tank No.: 7 Repair No.: 005 Type: 10 Location: D 22 - A

Inspected 3/27/98 by JF & TK

TYPE 10 REPAIR

Weld Repair

NDT Performed: Visual Vacuum Box Dye Penetrant

Coating Type: Epoxy

NDT Performed: Visual: DFT: Average DFT: 8-15 mls

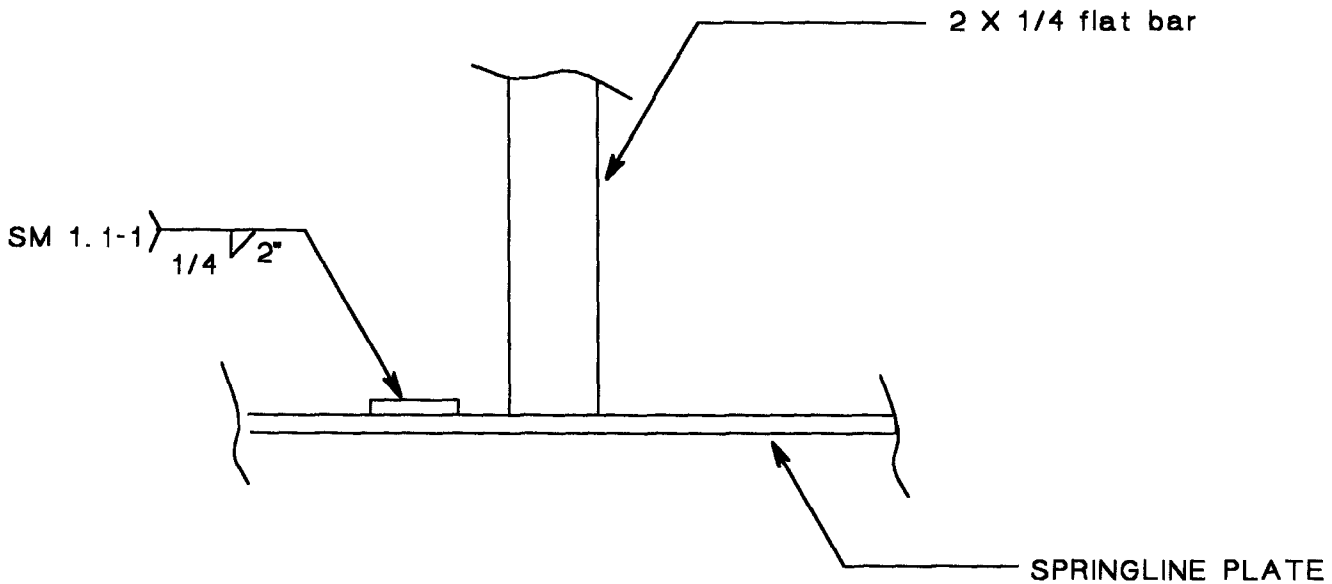
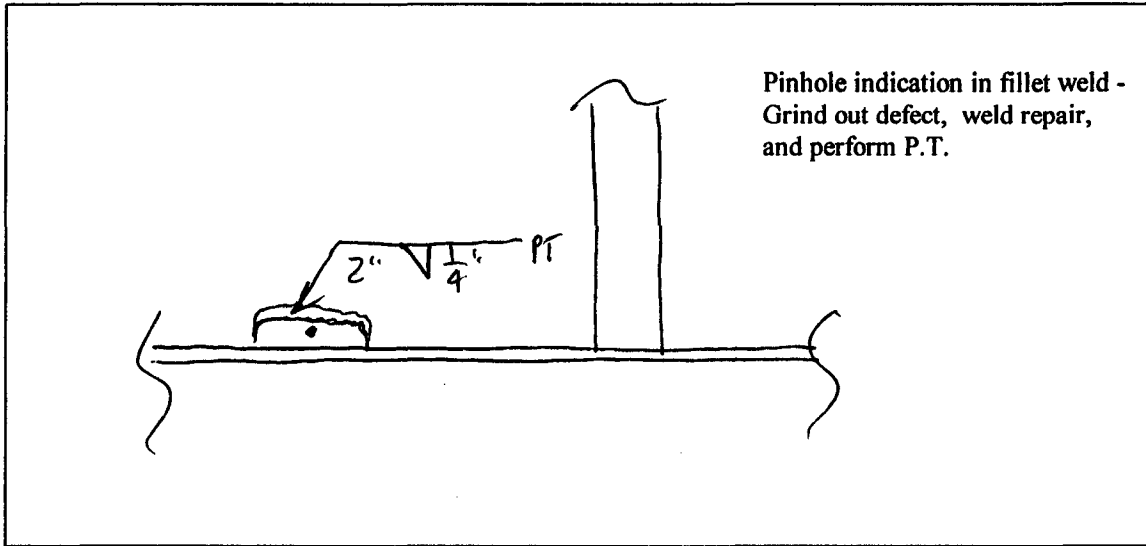
Tank No.: 7 Repair No.: 006 Type: 10 Location: D22-A

Inspected 3/27/98 by JF & TK

TYPE 10 REPAIR

Weld Repair

NDT Performed: Visual Vacuum Box Dye Penetrant

Coating Type: Epoxy

NDT Performed: Visual: DFT: Average DFT: 8-15 mils

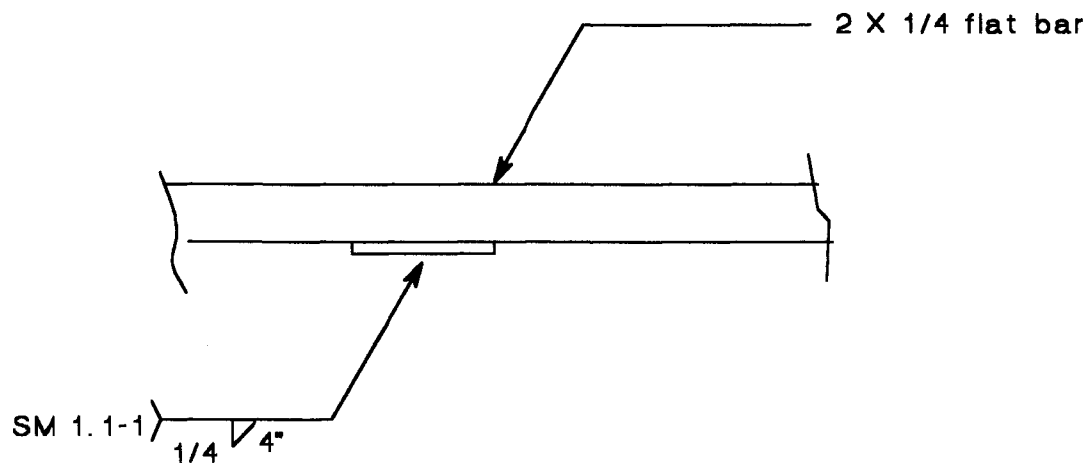
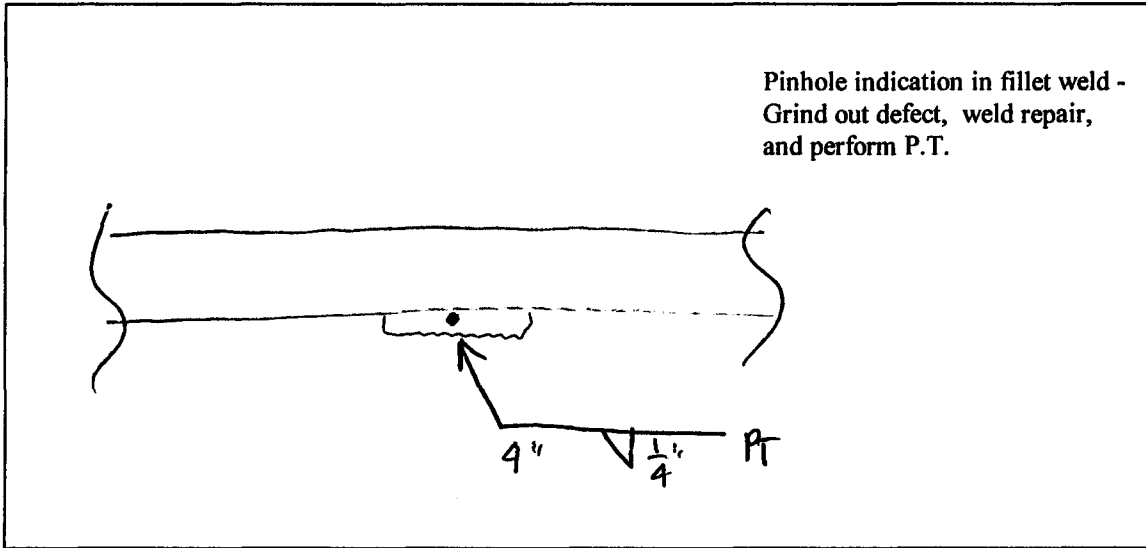
Tank No.: 7 Repair No.: 007 Type: 10 Location: D22-EXT

Inspected 3/27/98 by JF & TK

TYPE 10 REPAIR

Weld Repair

NDT Performed: Visual Vacuum Box Dye Penetrant

Coating Type: Epoxy

NDT Performed: Visual: DFT: Average DFT: 8-15 mils

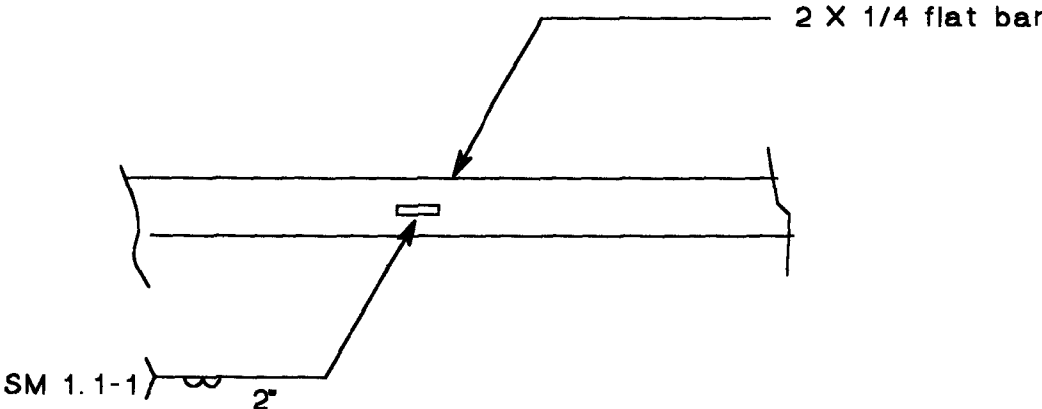
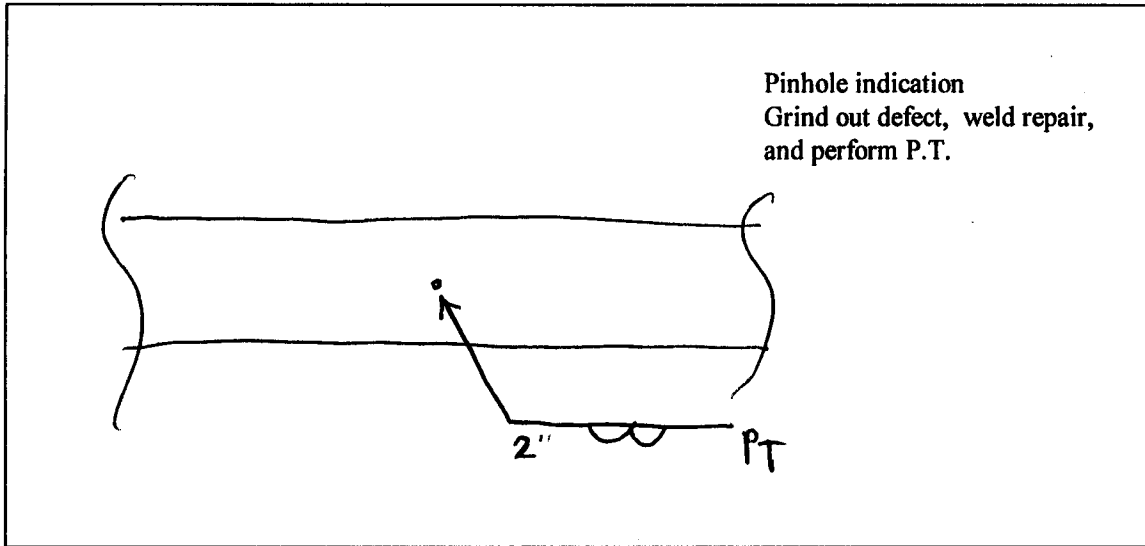
Tank No.: 7 Repair No.: 008 Type: 10 Location: D22-EXT

Inspected 3/27/98 by JF & TK

TYPE 10 REPAIR

Weld Repair

NDT Performed: Visual Vacuum Box Dye Penetrant

Coating Type: Epoxy

NDT Performed: Visual: DFT: Average DFT: 8-15 mils

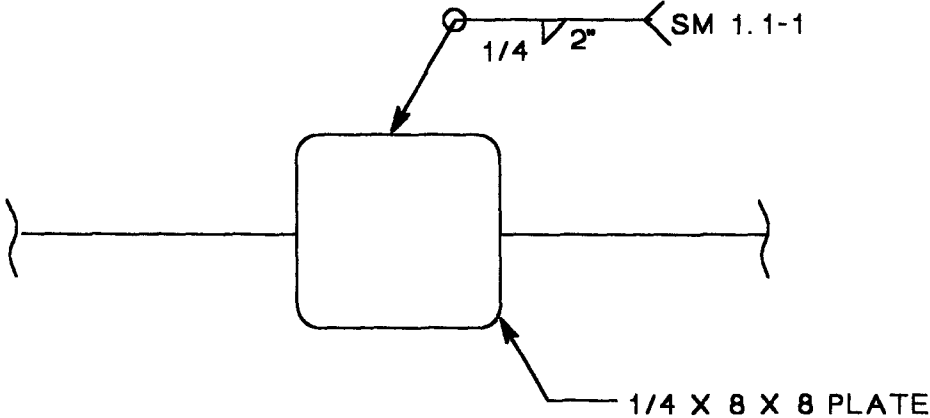
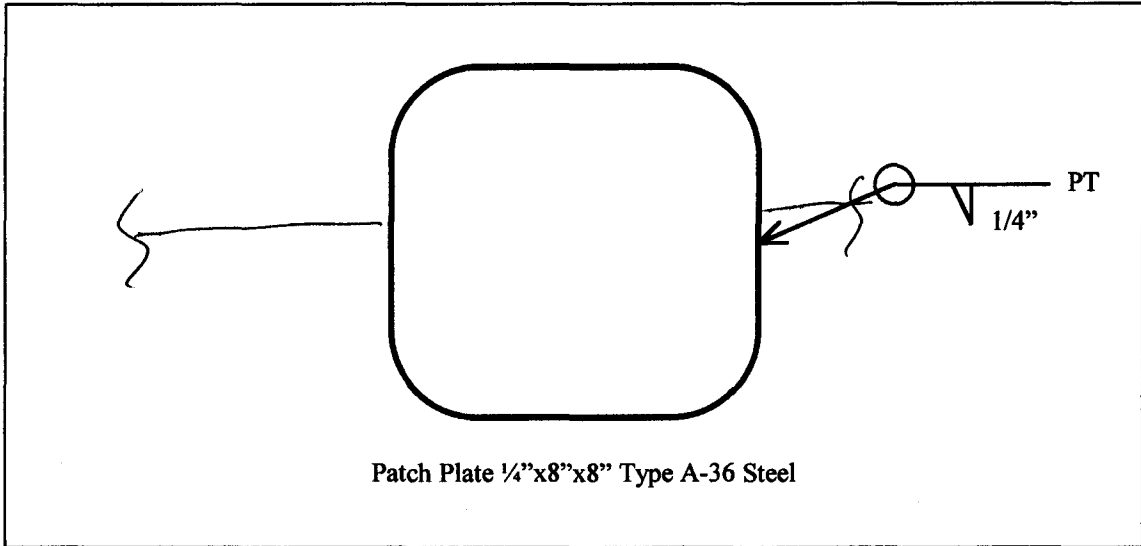
Tank No.: 7 Repair No.: 009 Type: 5 Location: D22-07

Inspected 3/27/98 by JF & TK

TYPE 5 REPAIR

Weld Repair

NDT Performed: Visual Vacuum Box Dye Penetrant

Coating Type: Epoxy

NDT Performed: Visual: DFT: Average DFT: 8-15 mils

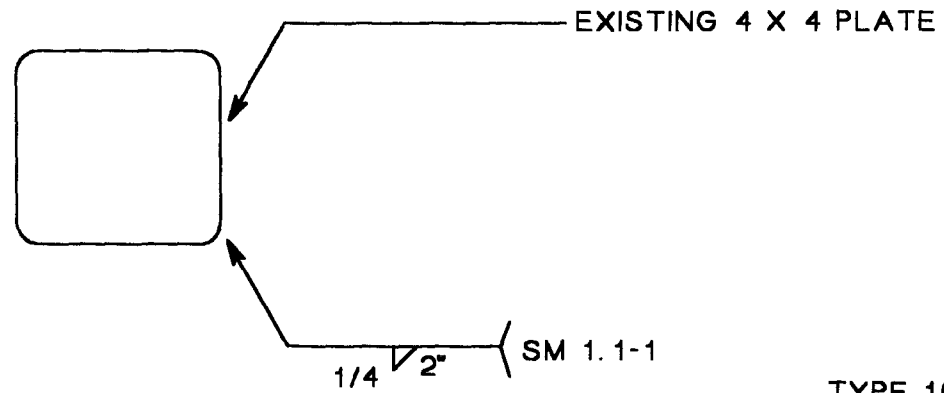
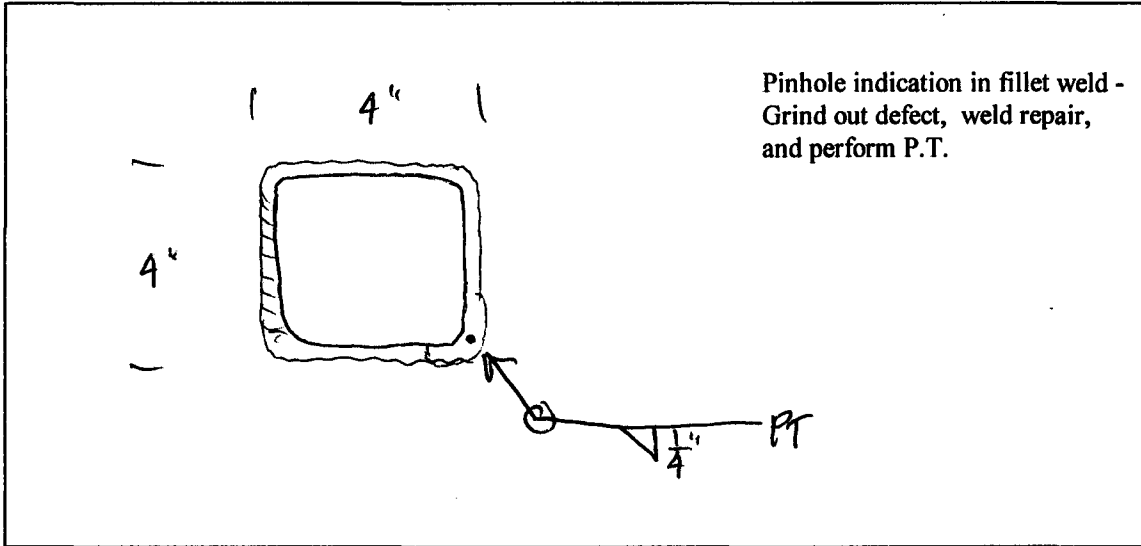
Tank No.: 7 Repair No.: 010 Type: 10 Location: D22-28

Inspected 3/27/98 by JF & TK

TYPE 10 REPAIR

Weld Repair

NDT Performed: Visual Vacuum Box Dye Penetrant

Coating Type: Epoxy

NDT Performed: Visual: DFT: Average DFT: 8-15 mils

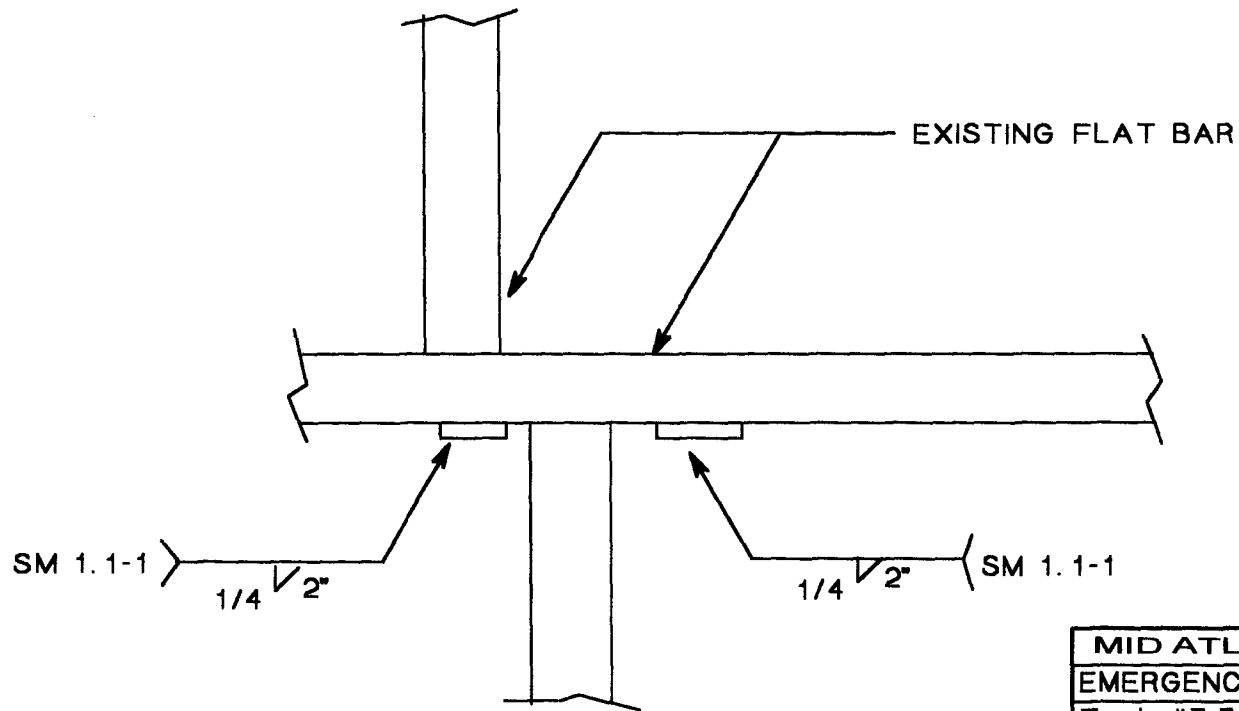
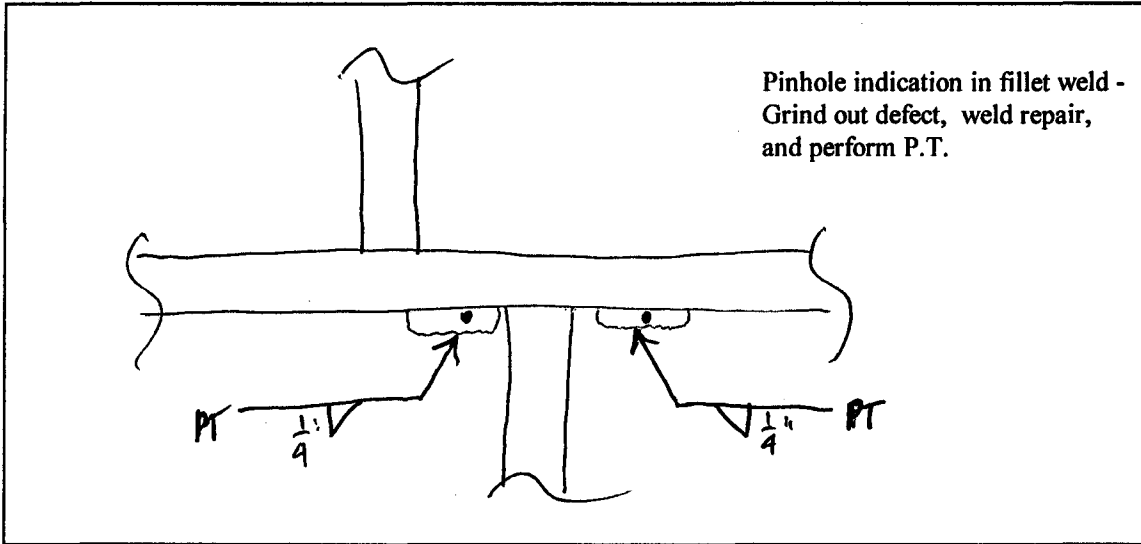
Tank No.: 7 Repair No.: 011 Type: 10 Location: C17-A

Inspected 3/27/98 by JF & TK

TYPE 10 REPAIR

Weld Repair

NDT Performed: Visual Vacuum Box Dye Penetrant

Coating Type: Epoxy

NDT Performed: Visual: DFT: Average DFT: 8-15 mils

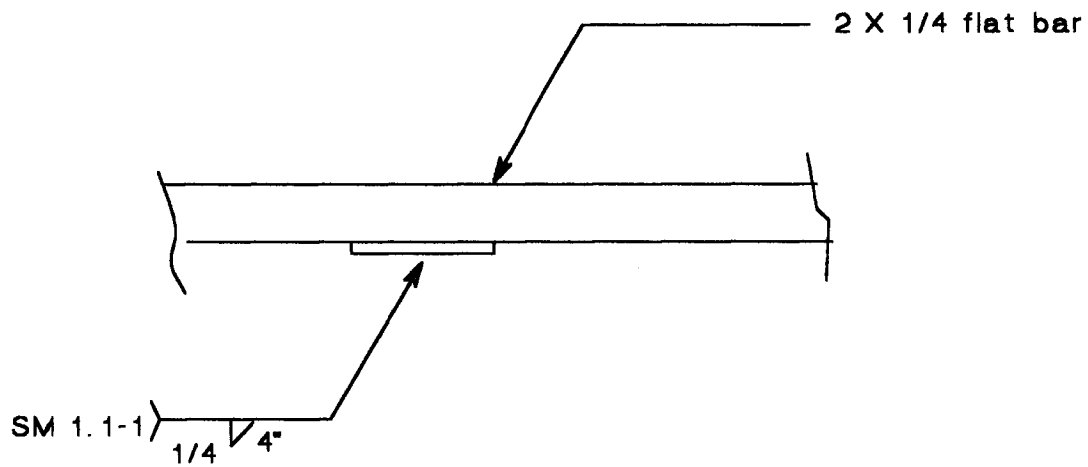
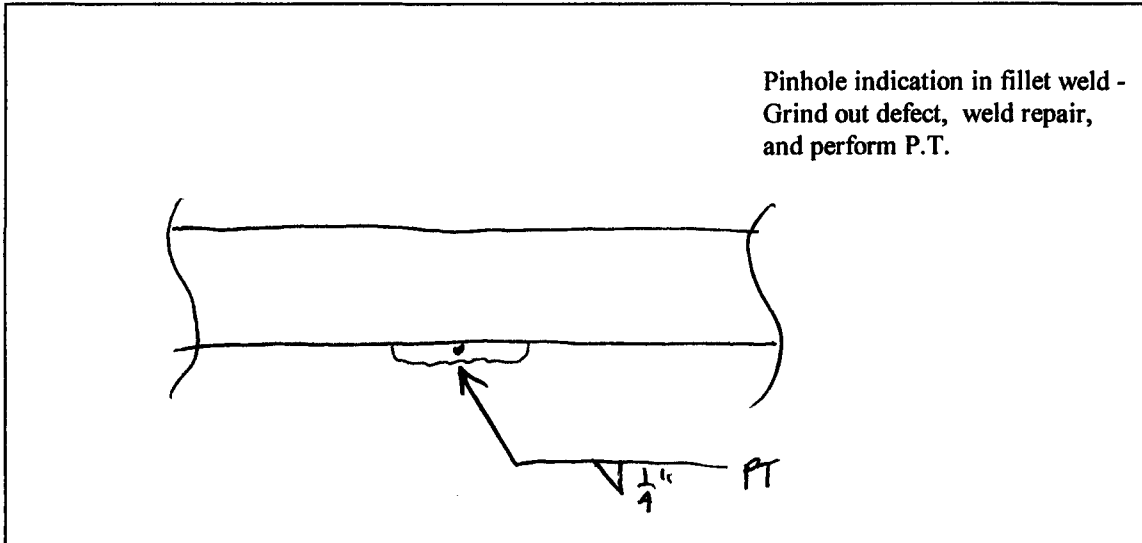
Tank No.: 7 Repair No.: 012 Type: 10 Location: D22-A/B

Inspected 3/27/98 by JF & TK

TYPE 10 REPAIR

Weld Repair

NDT Performed: Visual Vacuum Box Dye Penetrant

Coating Type: Epoxy

NDT Performed: Visual: DFT: Average DFT: 8-15 mils

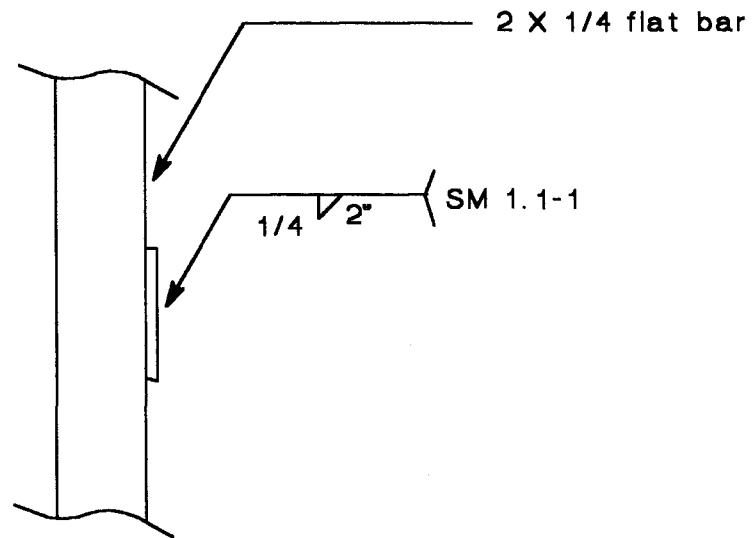
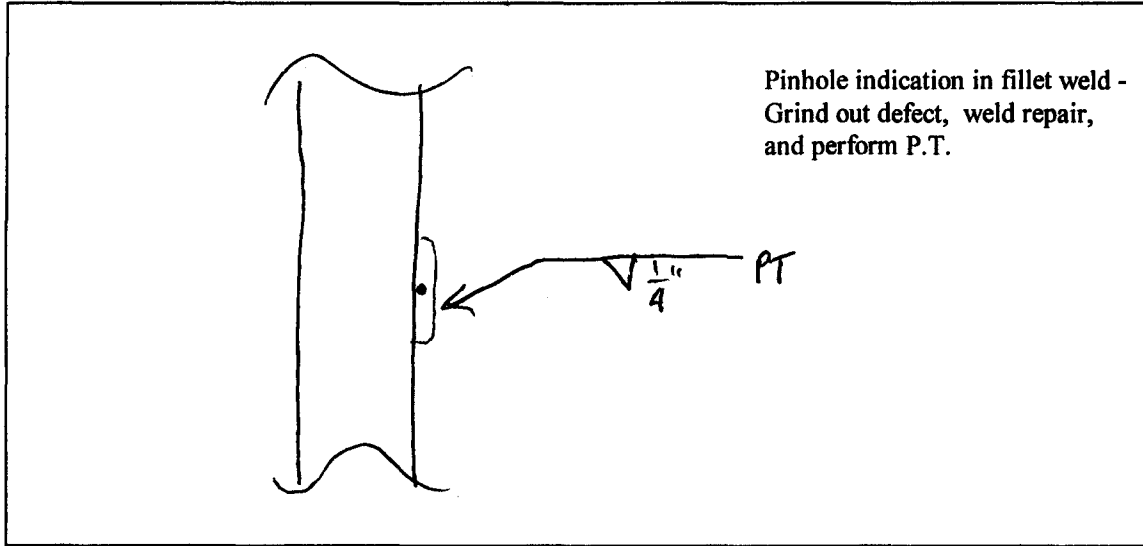
Tank No.: 7 Repair No.: 013 Type: 10 Location: D22-A

Inspected 3/27/98 by JF & TK

TYPE 10 REPAIR

Weld Repair

NDT Performed: Visual Vacuum Box Dye Penetrant

Coating Type: Epoxy

NDT Performed: Visual: DFT: Average DFT: 8-15 mils

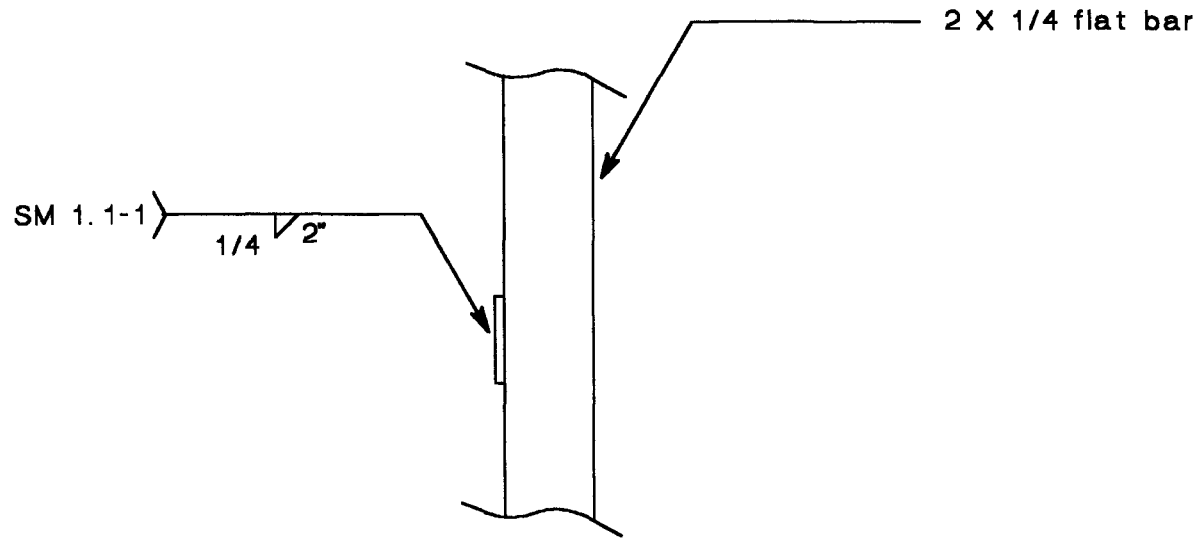
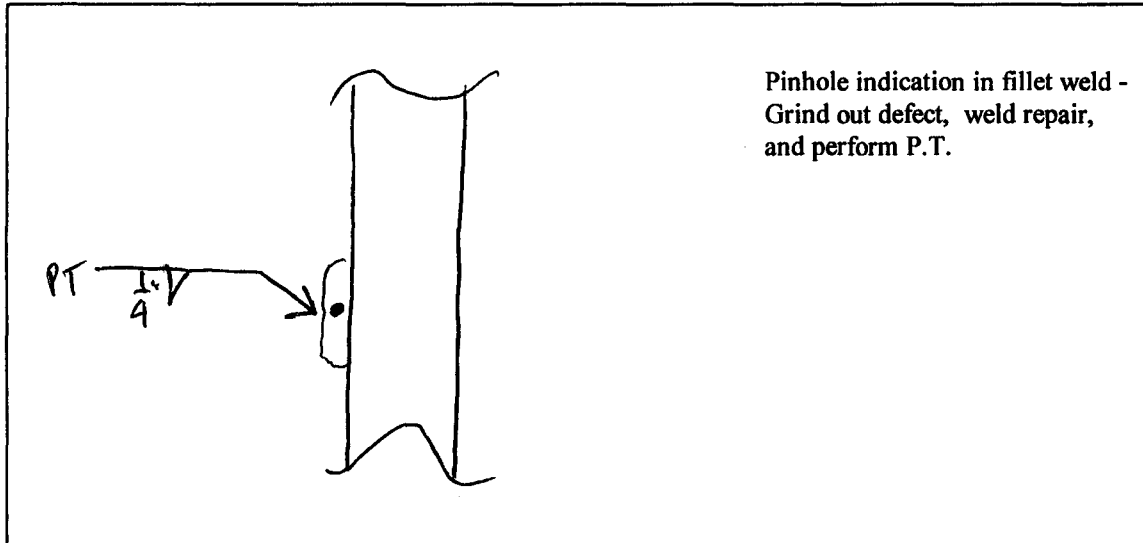
Tank No.: 7 Repair No.: 014 Type: 10 Location: D21 - A

Inspected 3/27/98 by JF & TK

TYPE 10 REPAIR

Weld Repair

NDT Performed: Visual Vacuum Box Dye Penetrant

Coating Type: Epoxy

NDT Performed: Visual: DFT: Average DFT: 8-15 mils

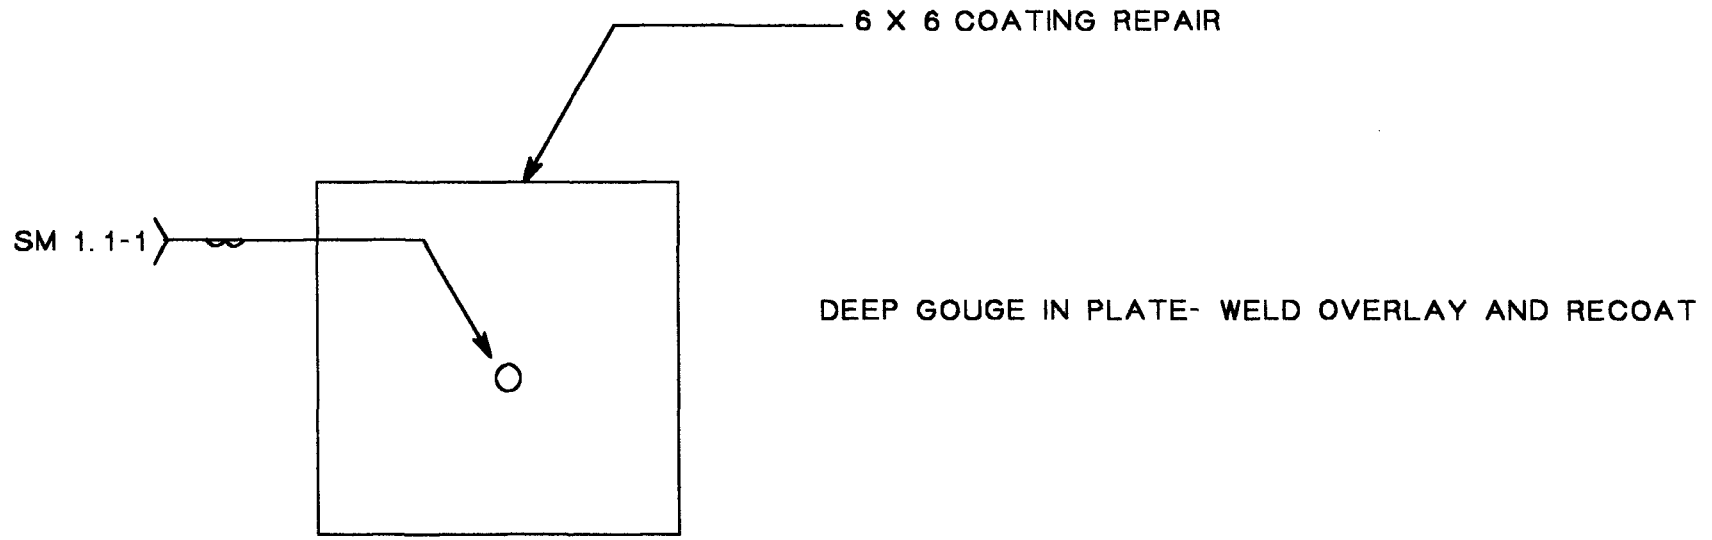
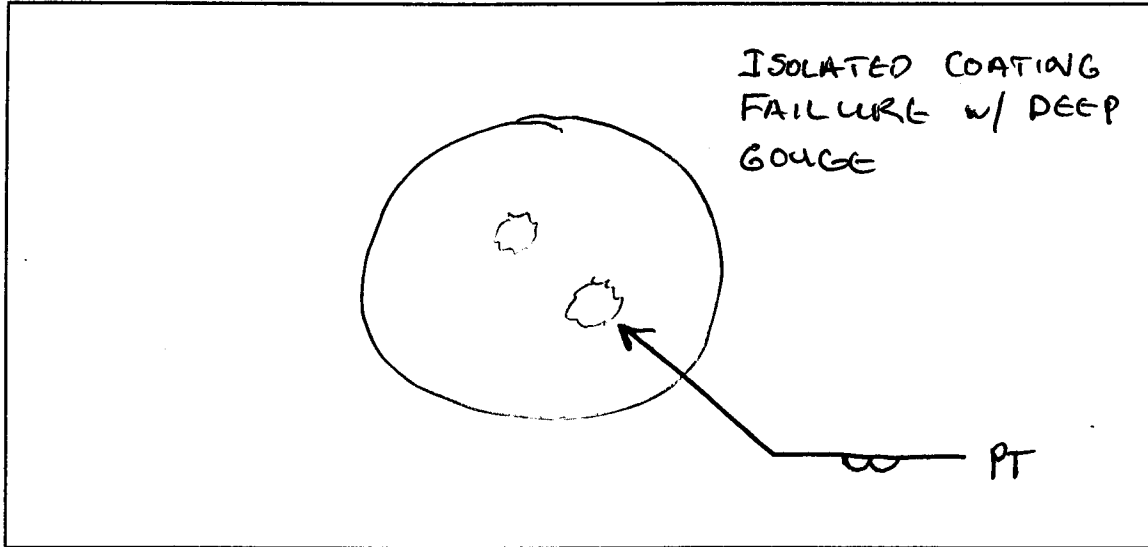
Tank No.: 7 Repair No.: 015 Type: 82 Location: D21-A

Inspected 3/27/98 by JF & TK

TYPE 2 REPAIR

Weld Repair ~~N/A~~

NDT Performed: Visual Vacuum Box Dye Penetrant

Coating Type: Epoxy

NDT Performed: Visual: DFT: Average DFT: 8-15 mils
