Engineering Report

Red Hill Tank #10

**PRL 96-21
Emergency Repairs for Red Hill Tanks**

Contract No N00604-97-R-0013

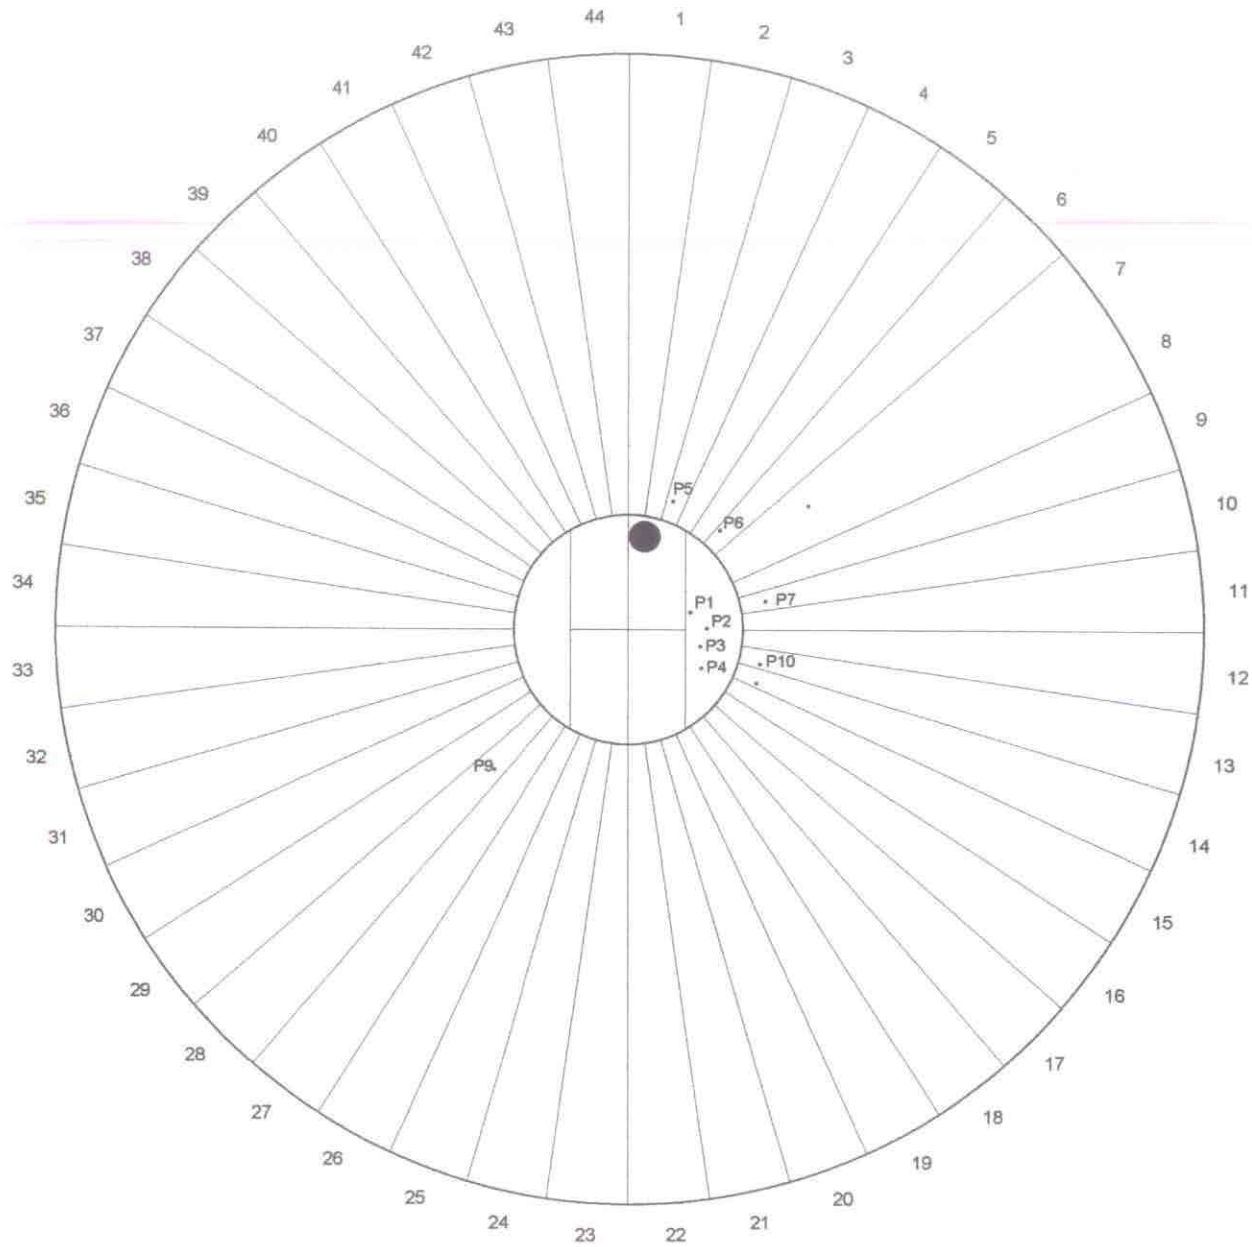
Bottom Layout with Pit Indications

7.5.1 Bottom Layout With Pit Indications

- P1 = 0.08
- P2 = 0.09
- P3 = 0.10
- P4 = 0.07
- P5 = 0.07
- P6 = 0.06
- P7 = 0.09
- P8 = 0.11
- P9 = 0.12
- P10 = 0.11

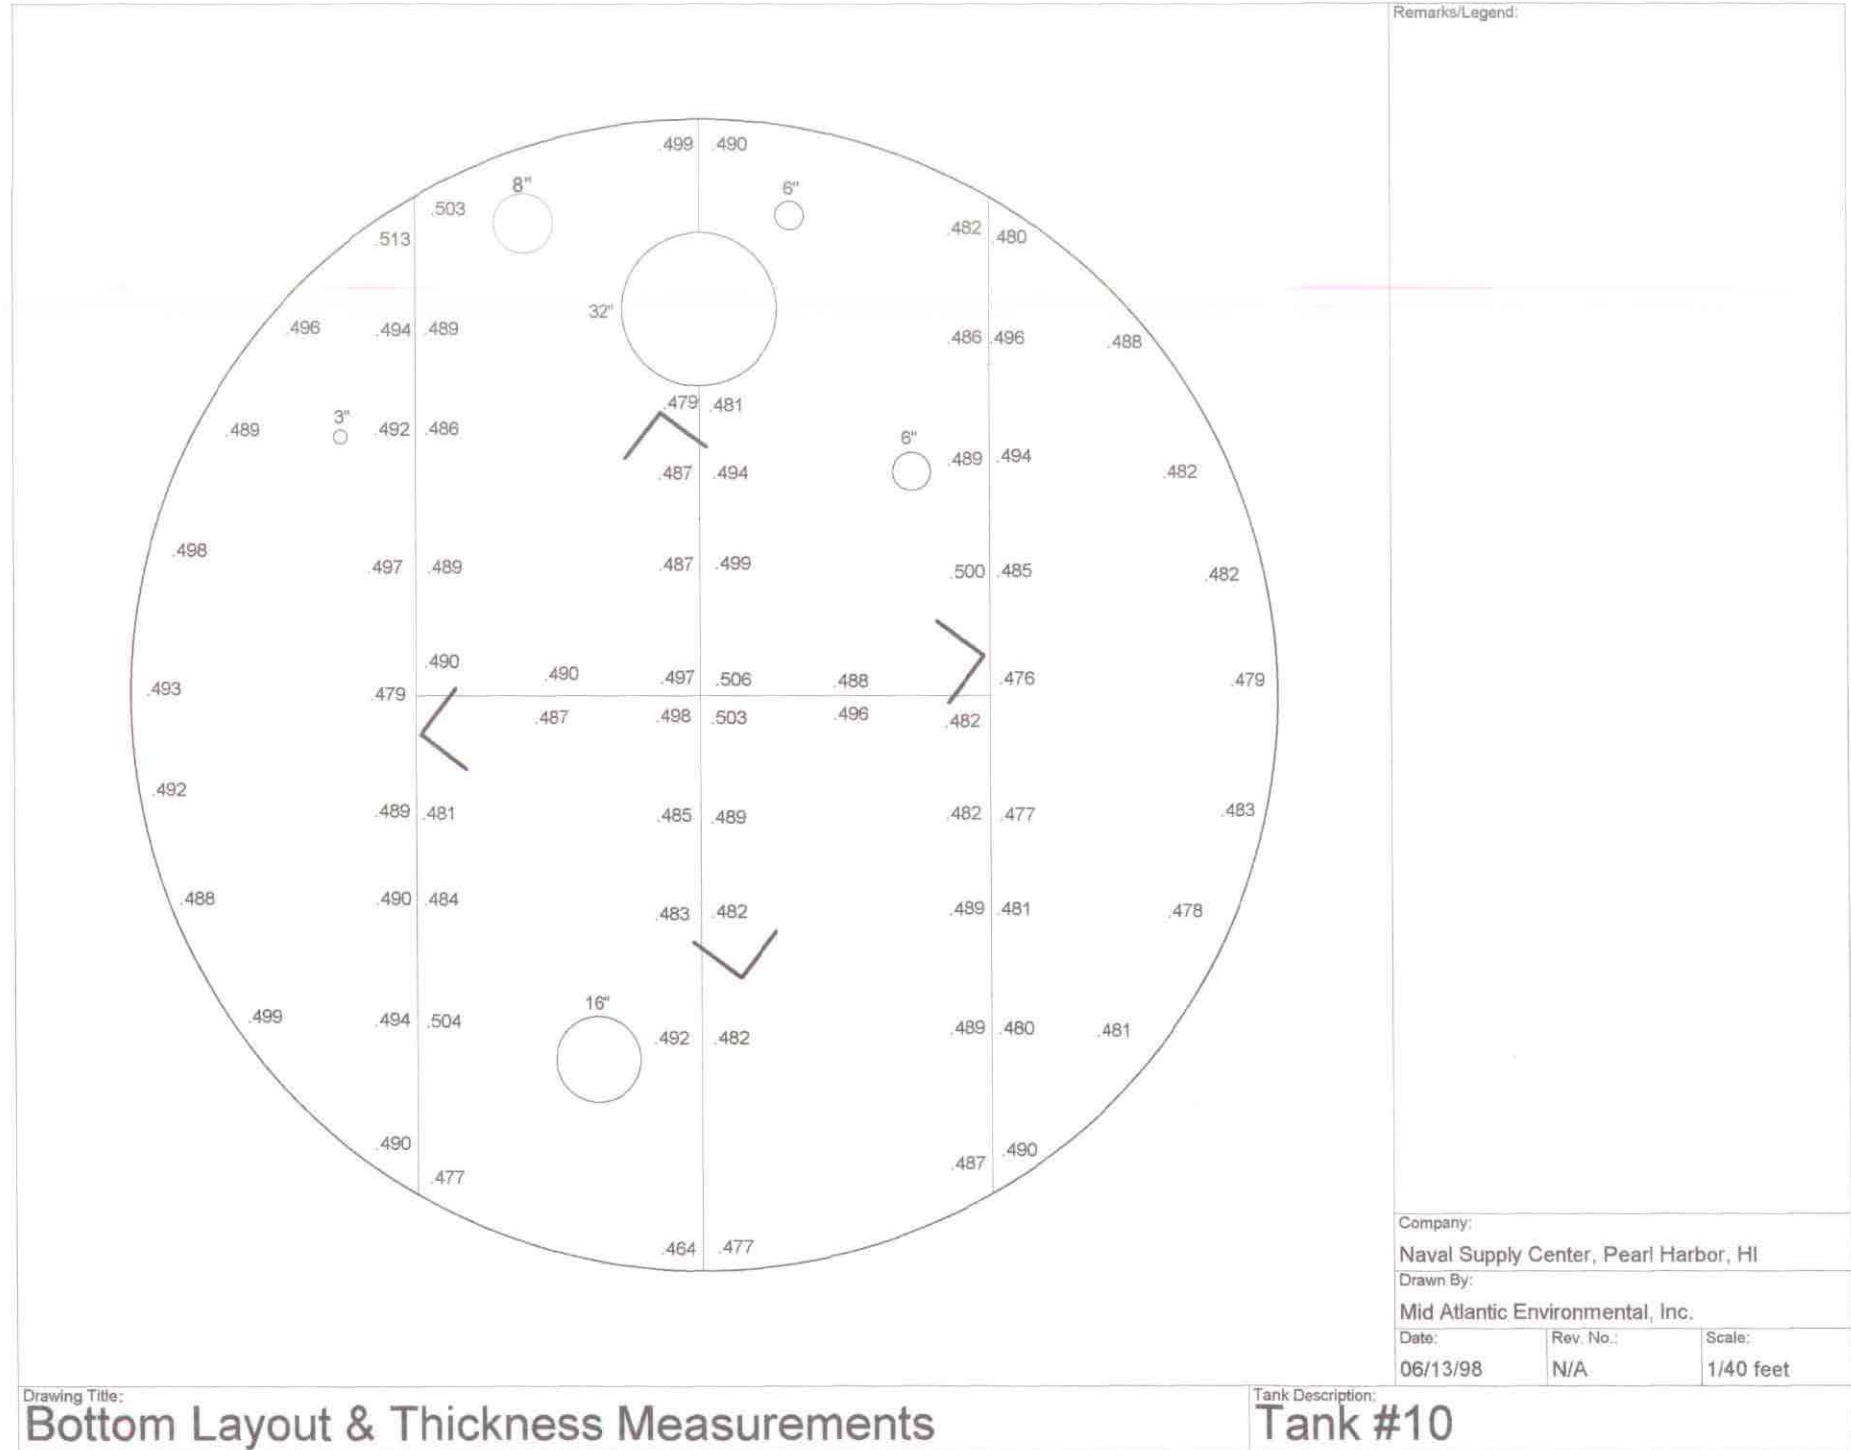
Drawing Title:
Bottom Layout & Thickness Measurements

7.5.2 Bottom Layout & Thickness Measurements

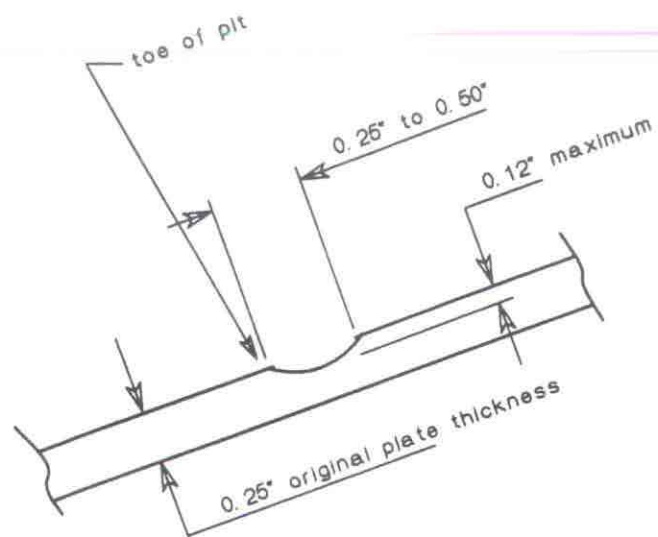
SECTION VIEW AT TYPICAL PIT

- 3.0 Only pits over 0.06 inches deep were identified. Twenty pitted areas were identified and measured in the first ascending plates of the lower dome. The deepest pit recorded on the ascending plates was 0.12 inches. The metal thickness at the identified pits is greater than 0.10 and the scheduled repair by providing a welded patch plate over the pit is not applicable and no repair is necessary to maintain the integrity of the tank. (The method of repair specified by contract is provided on sheet M-9 of NAVFAC DWG. NO. 7927658, REPAIR TYPE 1.)

Twenty pits were identified and measured on the first ascending plates in the area to be coated at the bottom of tank #10. The deepest pit measured 0.12 inches. A sketch showing the dimensions of a typical pit is shown below.

- 4.0 Pitting at the bottom of tank #16 was similar to #10 and did not require the scheduled repairs. However the sharp edges at the toe of pit caused problems with the coating application. To correct this problem on tank #10 Mid Atlantic Environmental advises smoothing the sharp edge mechanically or by applying primer coat with a stiff brush as proscribed by NAVFAC SPECIFICATION N62472-96-C-1356, Section 09970, 3.9.5, Application of Polyurethane Coating System, which states, "For blasted areas which are pitted, work the wash primer into the crevices, and pits with a stiff brush (100 mm brush cut 25mm long, for example)"

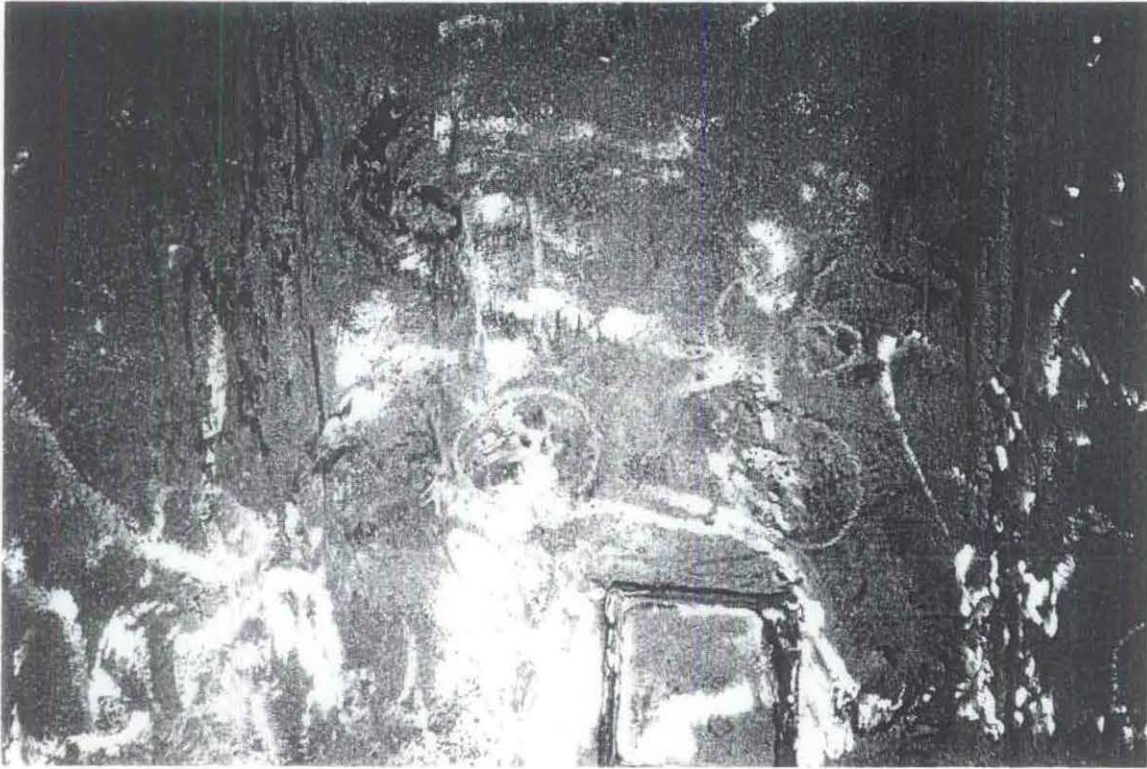
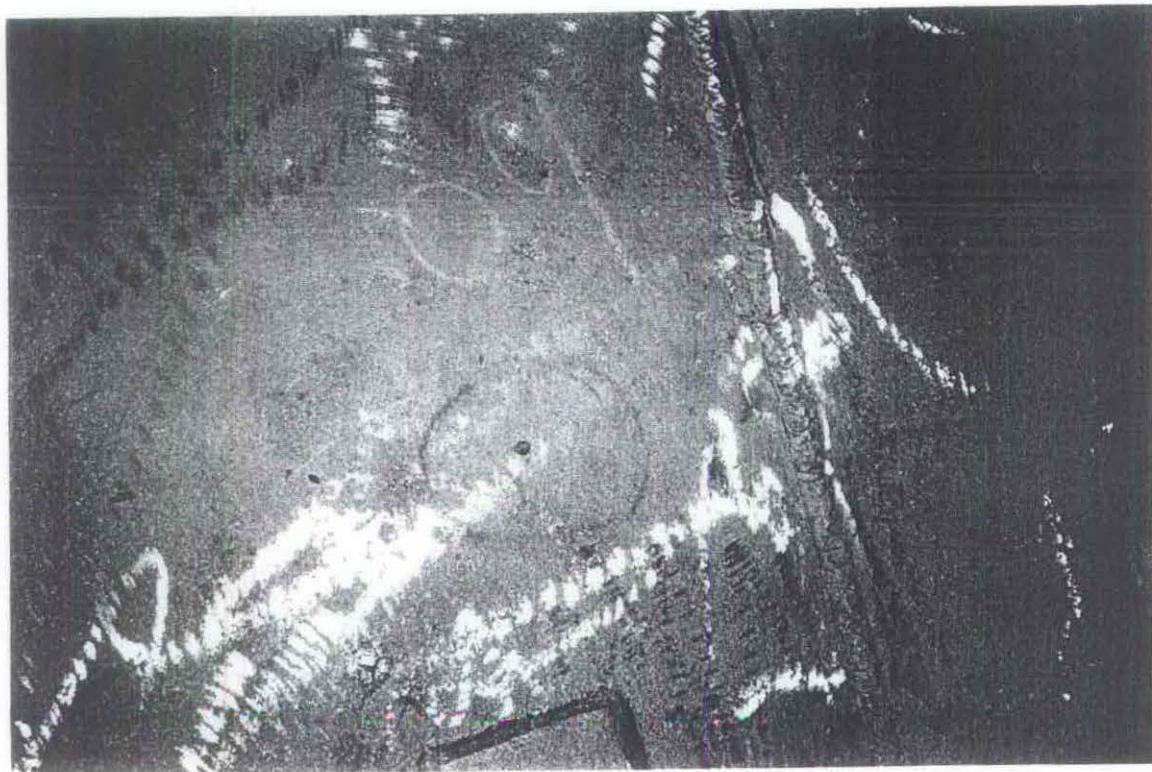
PICTURES SHOWING PITTING ON FIRST ASCENDING PLATES

7.2.1 The original bottom thickness was determined to be 0.500 inches and the first ascending plate to be 0.250 inches. The ultrasonic thickness measurements taken determined that backside corrosion in this area is not a problem. Pitting is not a problem since the remaining metal thickness is well within the 0.10 inches of metal required by API Standard 653 by the next inspection. Also the coating to be applied to the tank bottom should prevent any increase in pit depth. The surface contamination test results yielded 0% ferrous salts, 32 ppm NaCl and a pH level of 7. These results are within the limits set forth in the KTA SCAN Kit technical data and the NACE technical committee report on Surface Preparation of Contaminated Steel Surfaces. The Caustic Soda test of the tank bottom indicated that all Flame Sprayed Aluminum had been removed. By visual inspection, scattered pitting was observed on the tank bottom and first ascending plates. The deeper pits were measured and recorded on the Bottom Layout With Pit Indications drawing. Pictures of typical pitting on the first ascending plate are included in Section 11 of this report.

- 5.0 A drawing showing the contour of the pits and pictures taken at the bottom are attached to this report.
- 6.0 Mid Atlantic identified 20 pits in the first ascending plates, which measured over 0.06 inches deep. There were an estimated 100 that measured less than 0.06 inches deep. Mid Atlantic does not consider this to be excessive or abnormal for steel, which has been in service for nearly 60 years.
