Engineering Report

Red Hill Tank #10

**PRL 96-21
Emergency Repairs for Red Hill Tanks**

Contract No N00604-97-R-0013

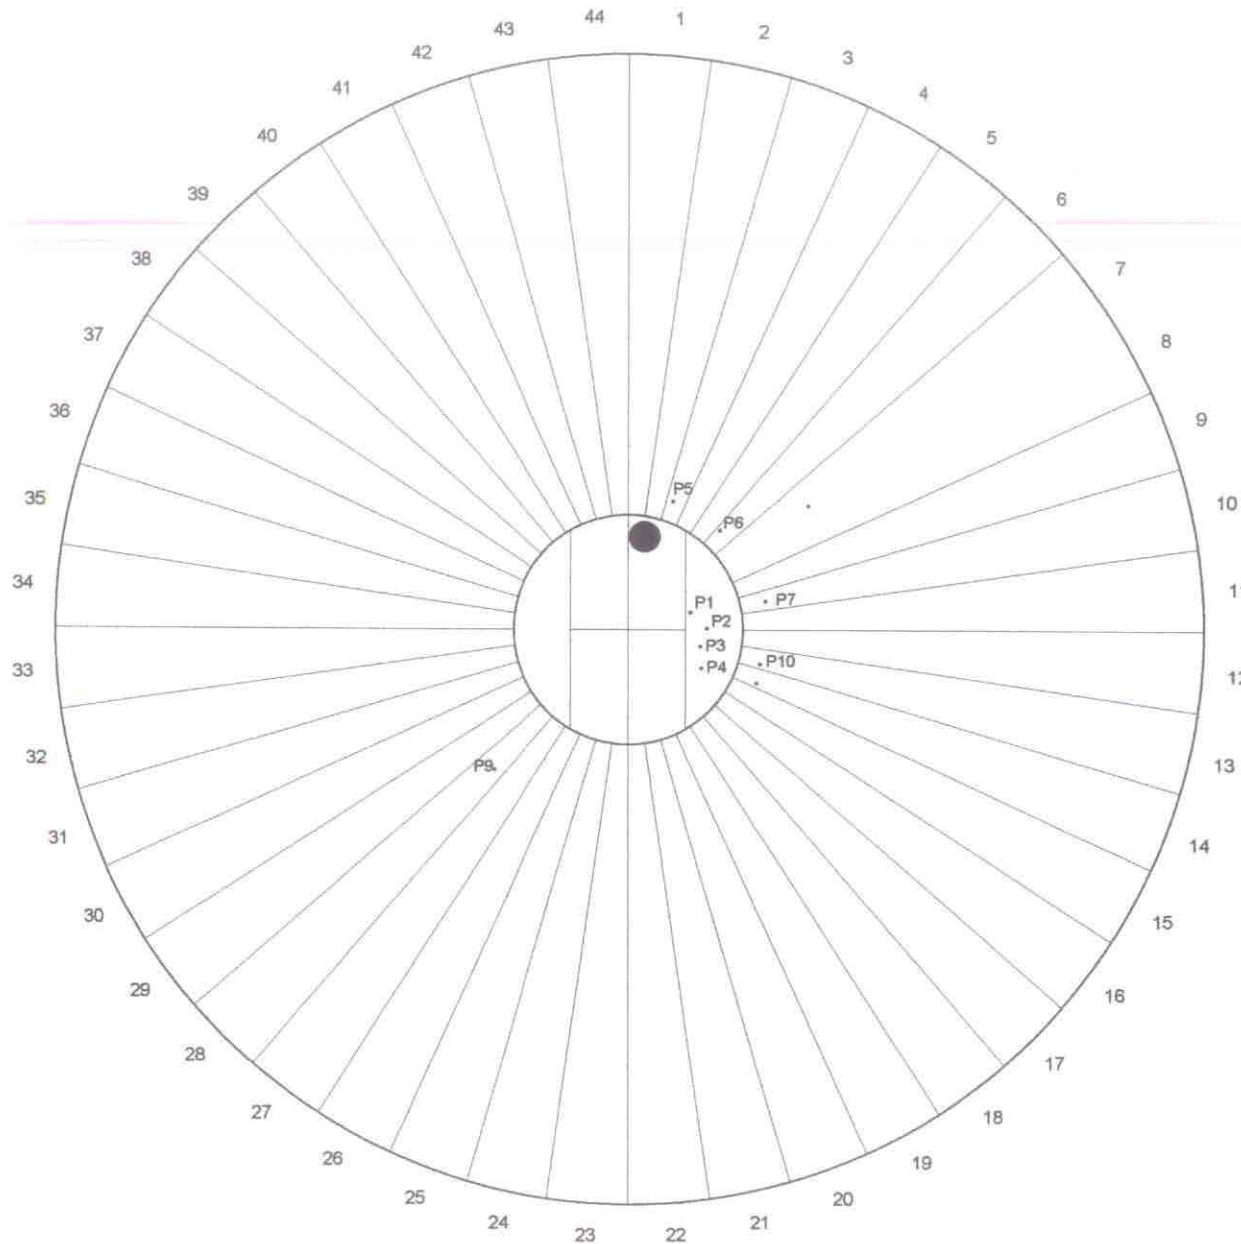
Bottom Layout with Pit Indications

7.2.1 The original bottom thickness was determined to be 0.500 inches and the first ascending plate to be 0.250 inches. The ultrasonic thickness measurements taken determined that backside corrosion in this area is not a problem. Pitting is not a problem since the remaining metal thickness is well within the 0.10 inches of metal required by API Standard 653 by the next inspection. Also the coating to be applied to the tank bottom should prevent any increase in pit depth. The surface contamination test results yielded 0% ferrous salts, 32 ppm NaCl and a pH level of 7. These results are within the limits set forth in the KTA SCAN Kit technical data and the NACE technical committee report on Surface Preparation of Contaminated Steel Surfaces. The Caustic Soda test of the tank bottom indicated that all Flame Sprayed Aluminum had been removed. By visual inspection, scattered pitting was observed on the tank bottom and first ascending plates. The deeper pits were measured and recorded on the Bottom Layout With Pit Indications drawing. Pictures of typical pitting on the first ascending plate are included in Section 11 of this report.

- P1 = 0.08
- P2 = 0.09
- P3 = 0.10
- P4 = 0.07
- P5 = 0.07
- P6 = 0.06
- P7 = 0.09
- P8 = 0.11
- P9 = 0.12
- P10 = 0.11

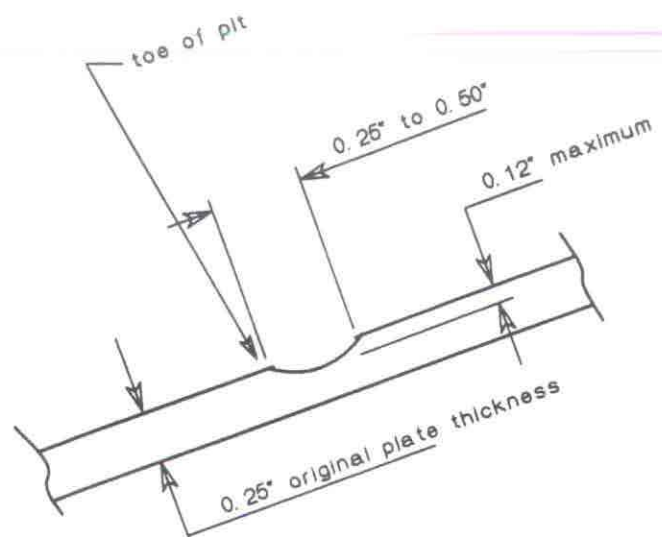
SECTION VIEW AT TYPICAL PIT

- 3.0 Only pits over 0.06 inches deep were identified. Twenty pitted areas were identified and measured in the first ascending plates of the lower dome. The deepest pit recorded on the ascending plates was 0.12 inches. The metal thickness at the identified pits is greater than 0.10 and the scheduled repair by providing a welded patch plate over the pit is not applicable and no repair is necessary to maintain the integrity of the tank. (The method of repair specified by contract is provided on sheet M-9 of NAVFAC DWG. NO. 7927658, REPAIR TYPE 1.)

Twenty pits were identified and measured on the first ascending plates in the area to be coated at the bottom of tank #10. The deepest pit measured 0.12 inches. A sketch showing the dimensions of a typical pit is shown below.

- 4.0 Pitting at the bottom of tank #16 was similar to #10 and did not require the scheduled repairs. However the sharp edges at the toe of pit caused problems with the coating application. To correct this problem on tank #10 Mid Atlantic Environmental advises smoothing the sharp edge mechanically or by applying primer coat with a stiff brush as proscribed by NAVFAC SPECIFICATION N62472-96-C-1356, Section 09970, 3.9.5, Application of Polyurethane Coating System, which states, "For blasted areas which are pitted, work the wash primer into the crevices, and pits with a stiff brush (100 mm brush cut 25mm long, for example)"

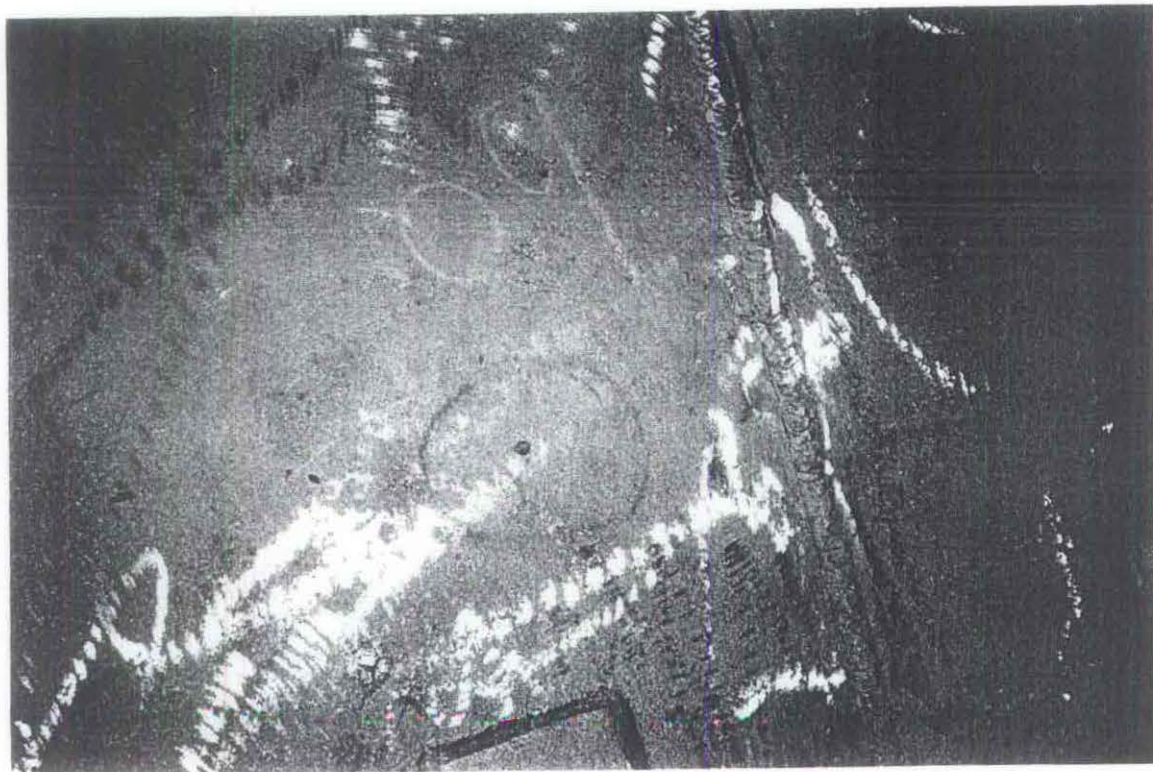
PICTURES SHOWING PITTING ON FIRST ASCENDING PLATES

- 5.0 A drawing showing the contour of the pits and pictures taken at the bottom are attached to this report.
- 6.0 Mid Atlantic identified 20 pits in the first ascending plates, which measured over 0.06 inches deep. There were an estimated 100 that measured less than 0.06 inches deep. Mid Atlantic does not consider this to be excessive or abnormal for steel, which has been in service for nearly 60 years.
