LTR	DESCRIPTION	BY	DATE
REVISIONS			
MID ATLANTIC ENVIRONMENTAL			
EMERGENCY REPAIRS FOR RED HILL TANKS			
Tank #10			
Repair No. 090	File:10r090		
Upper dome	Quadrant: A		
Course: B & C	Plate: 1 & 2		
Drawn by: M. Moulton	Date: 12/20/97

Dames & Moore
Emergency Repairs For Red Hill Tanks at the Fleet Industrial & Supply Center
Contract No. N62742-96-C-1356

Repair Record

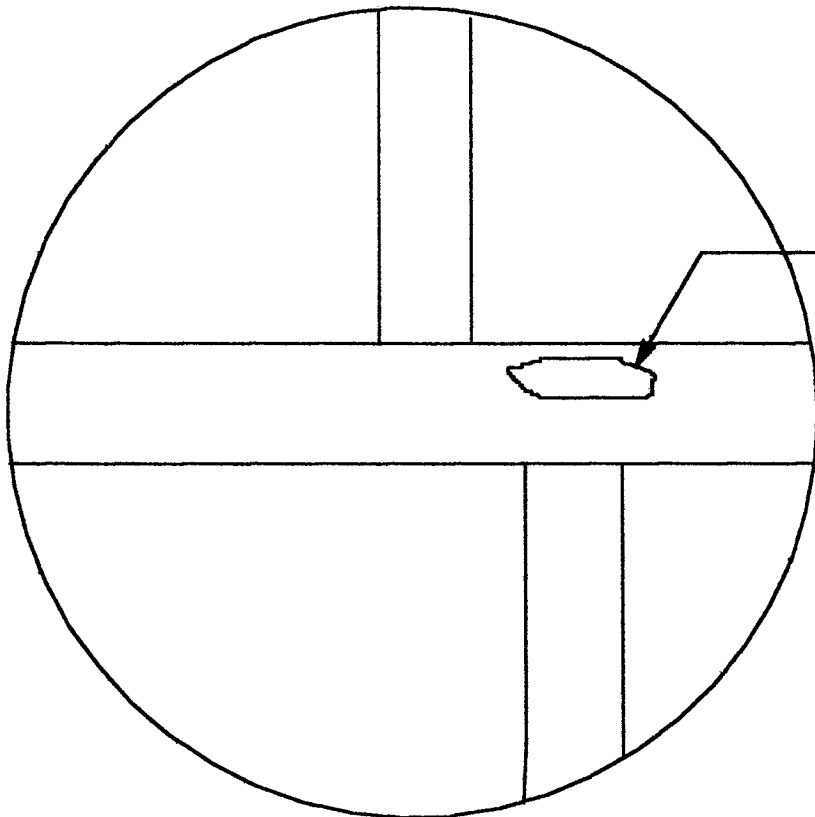
Repair Type 8

Needlegun and recoat

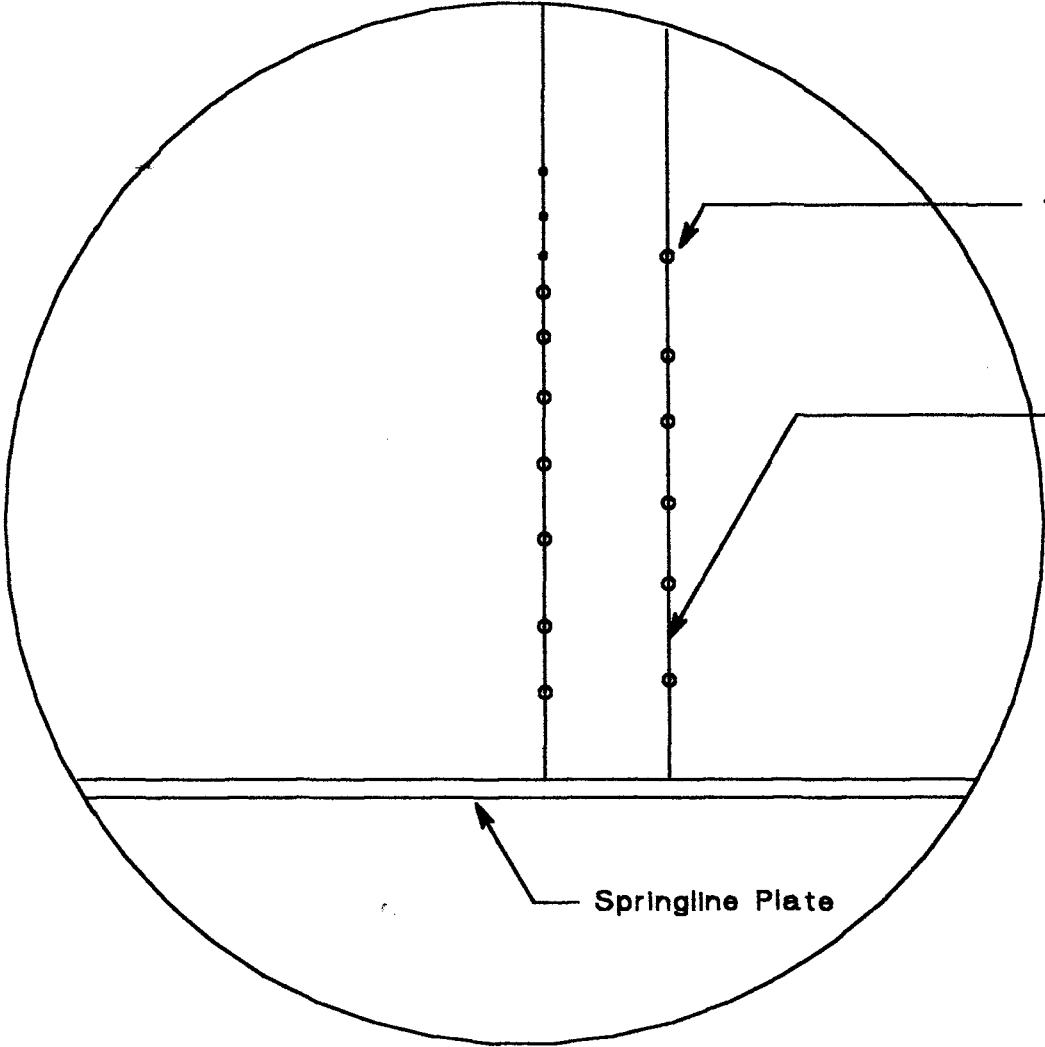
REPAIR TYPE 11

16 Porosetuo in weld

1/4 80°
1/4 80° SM 1.1-1

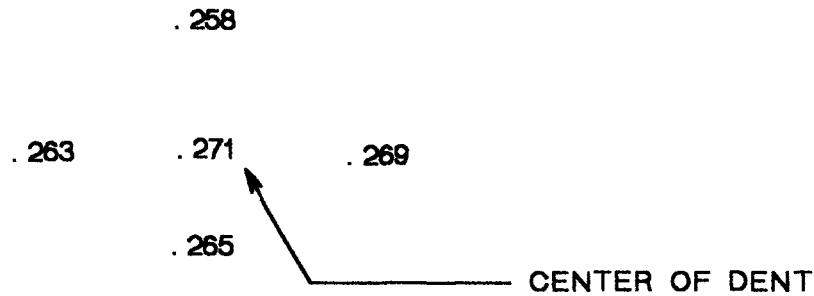
TYPE 7 REPAIR

NOTE: DENT OCCURED BEFORE PAINTING. PAINT REPAIR NOT NECESSARY

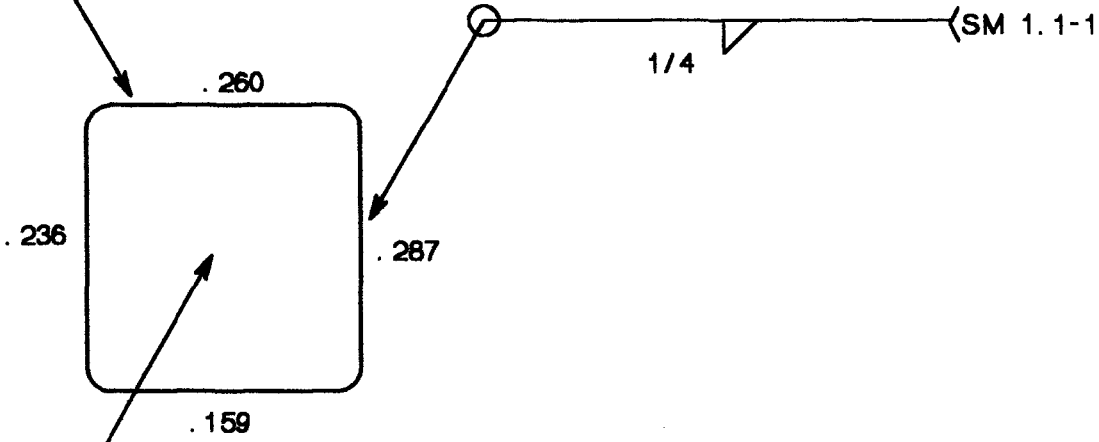
Repair type 5

LEAK IN TANK SKIN

plate 1/4 X 5 X 5

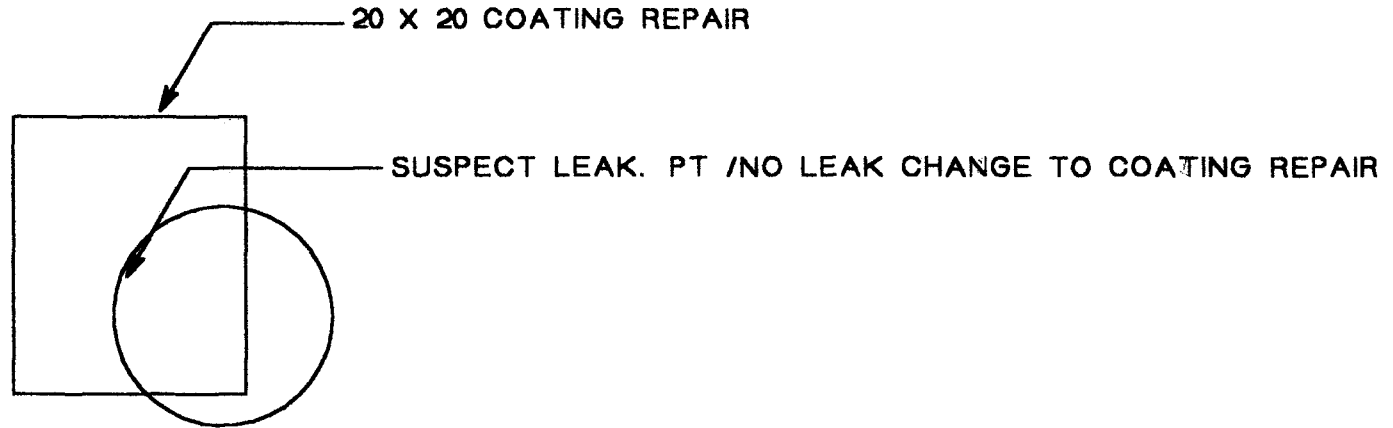
TYPE B REPAIR

NO DEFECTS FOUND

CLEAN TO BARE METAL + PERFORM P.T.

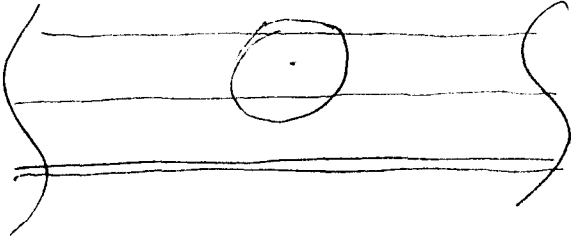
NO DEFECTS FOUND
Type 8
