| LTR | DESCRIPTION | BY | DATE |
|--|---|---|---|
| MID ATLANTIC ENVIRONMENTAL<br>EMERGENCY REPAIRS FOR RED HILL TANKS | | | |

**Dames & Moore**  
Emergency Repairs For Red Hill Tanks at the Fleet Industrial & Supply Center  
Contract No. N62742-96-C-1356

Repair Record

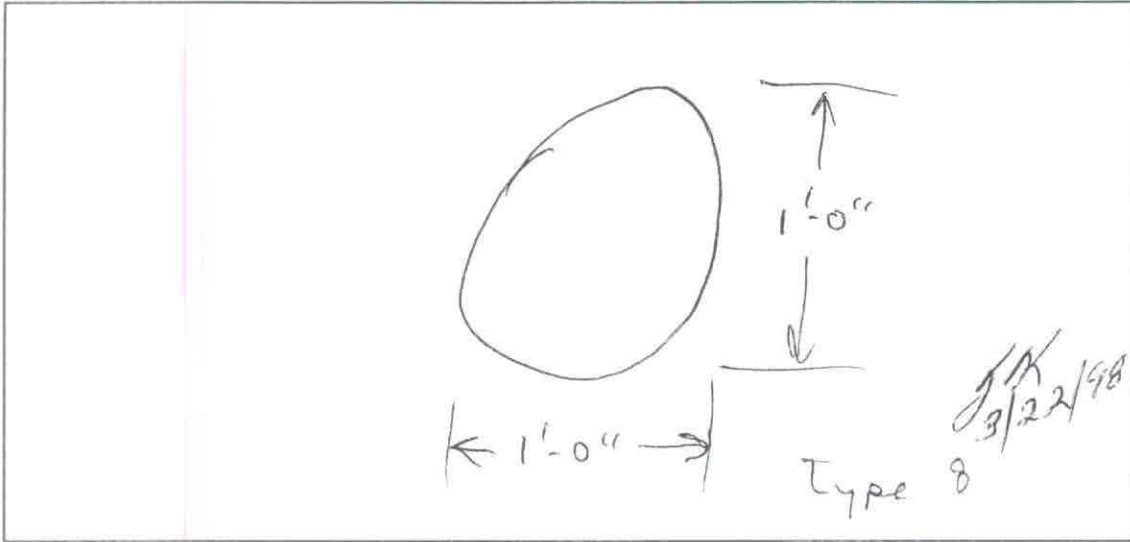
Tank No.: 10 Repair No.: 340 Type: 8 Location: A

12 X 12 COATING REPAIR

TYPE 8 REPAIR

Coating Repair

Coating Type: Epoxy

NDT Performed: Visual:  DFT:  Average DFT: 8 mils - 15 mils

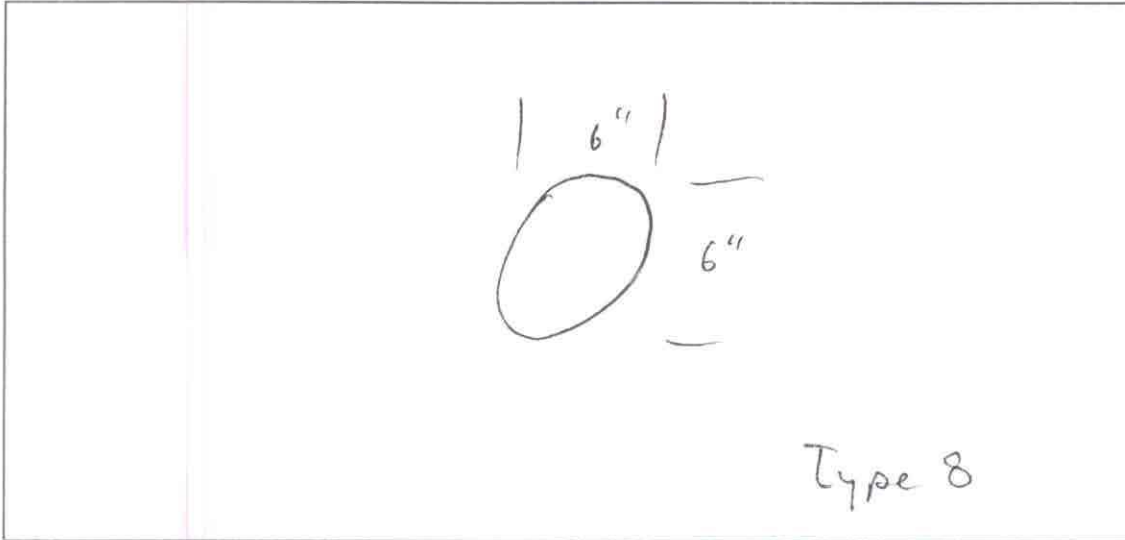
Tank No.: 10    Repair No.: 341    Type: 8    Location: A

6 X 6 COATING REPAIR

TYPE 8 REPAIR

Coating Repair

Coating Type: Epoxy

NDT Performed:                      Visual:     DFT:     Average DFT: 8 mils - 15 mils

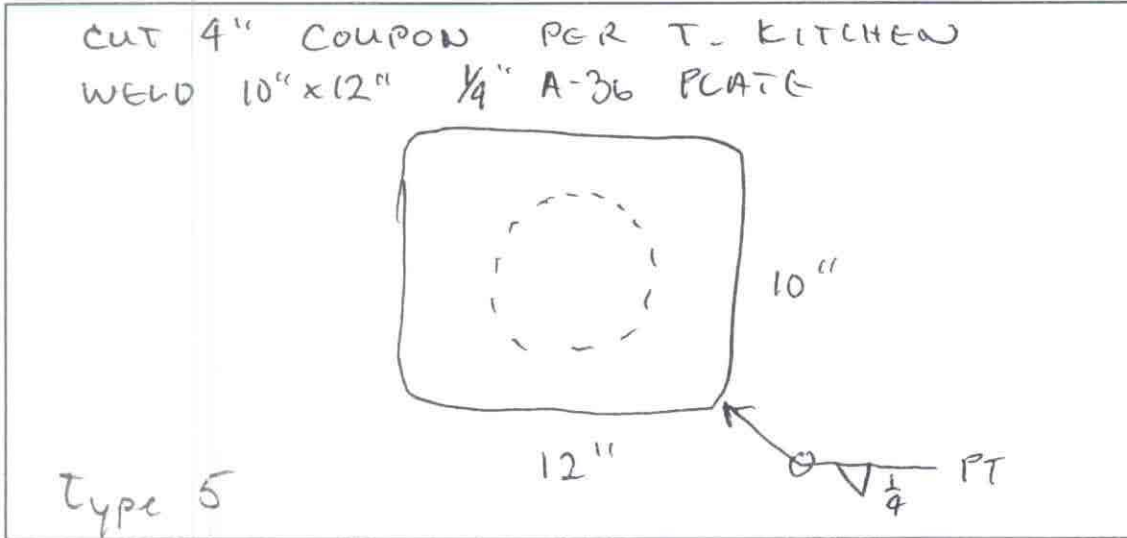
Tank No.: 10    Repair No.: 342    Type: 5    Location: B

TYPE 5 REPAIR

Weld Repair

WPS No.: SM1.1-1

Coating Repair

Coating Type: Epoxy

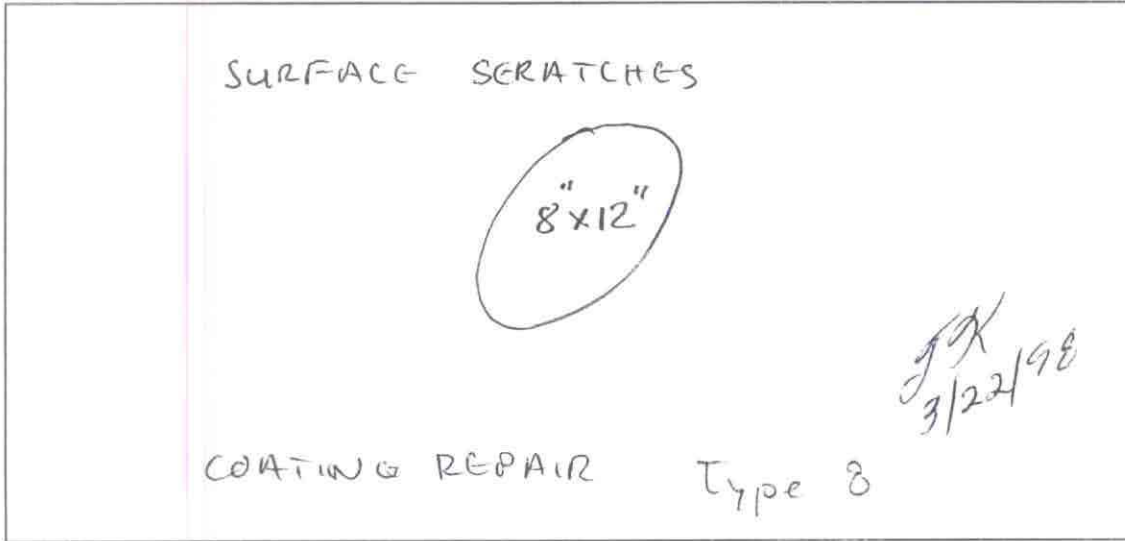
Tank No.: 10 Repair No.: 410 Type: 2 Location: A

8 X 12 COATING REPAIR

TYPE 8 REPAIR

Coating Repair

Coating Type: Epoxy

NDT Performed: Visual:  DFT:  Average DFT: 13 mils - 20 mils

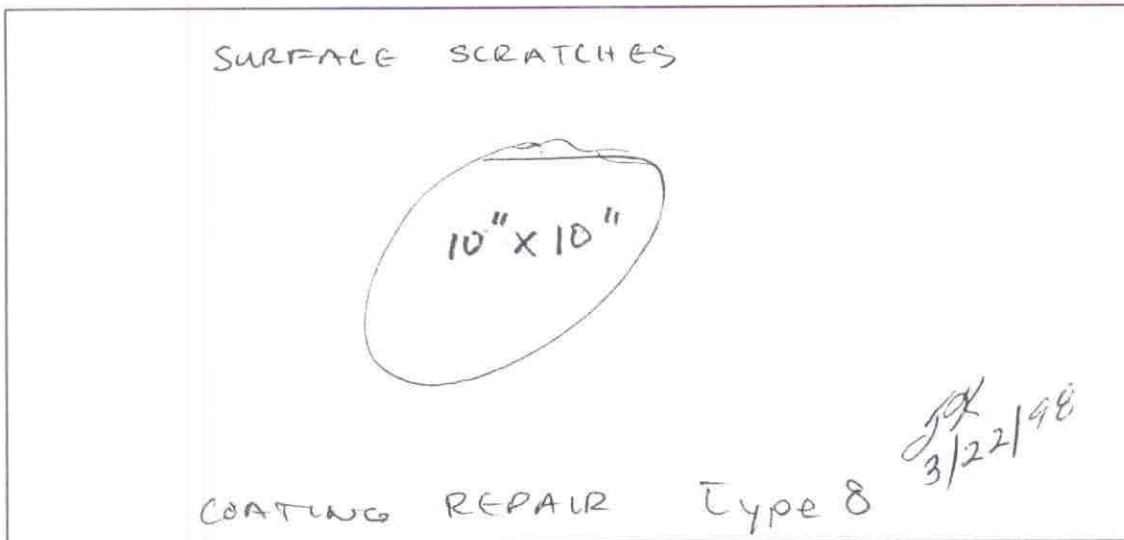
Tank No.: 10 Repair No.: 400 Type: 2 Location: A

10 X 10 COATING REPAIR

TYPE 8 REPAIR

Coating Repair

Coating Type: Epoxy

NDT Performed: Visual:  DFT:  Average DFT: 13 mils - 20 mils

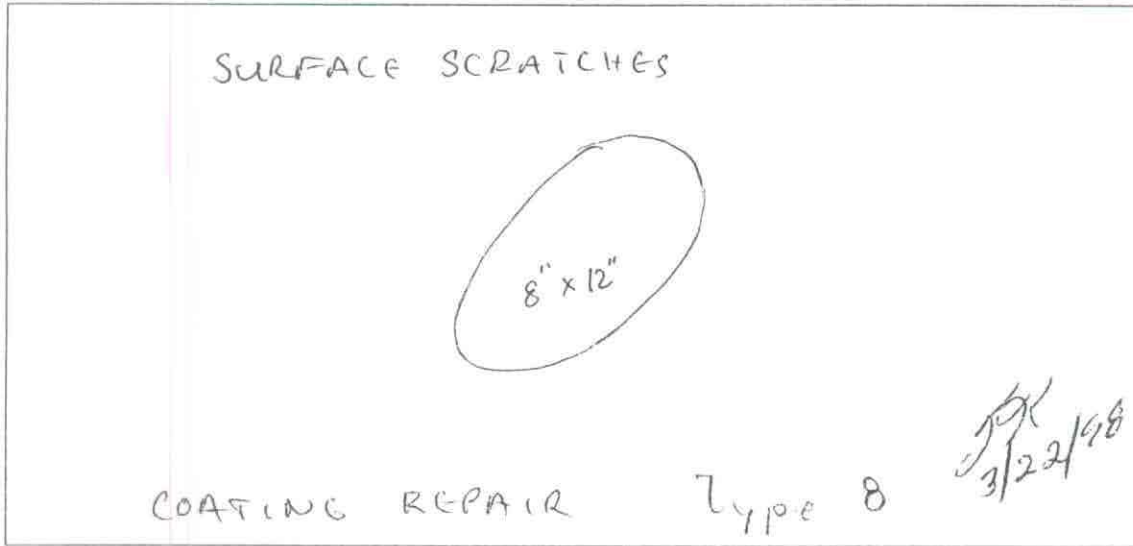
Tank No.: 10 Repair No.: 420 Type: 2 Location: A

8 X 12 COATING REPAIR

TYPE 8 REPAIR

Coating Repair

Coating Type: Epoxy

NDT Performed: Visual:  DFT:  Average DFT: 13mils - 20mils

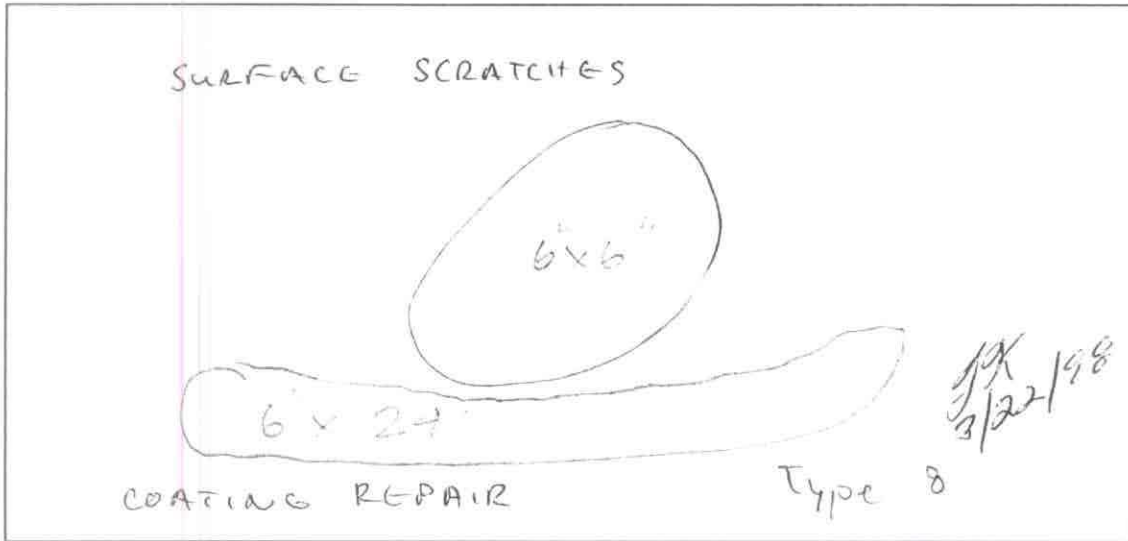
Tank No.: 10 Repair No.: ADD 610 Type: 8 Location: C

8 X 12 COATING REPAIR

6 X 24 coating repair

TYPE 8 REPAIR

Coating Repair

Coating Type: Epoxy

NDT Performed: Visual:  DFT:  Average DFT: 13mils - 20mils

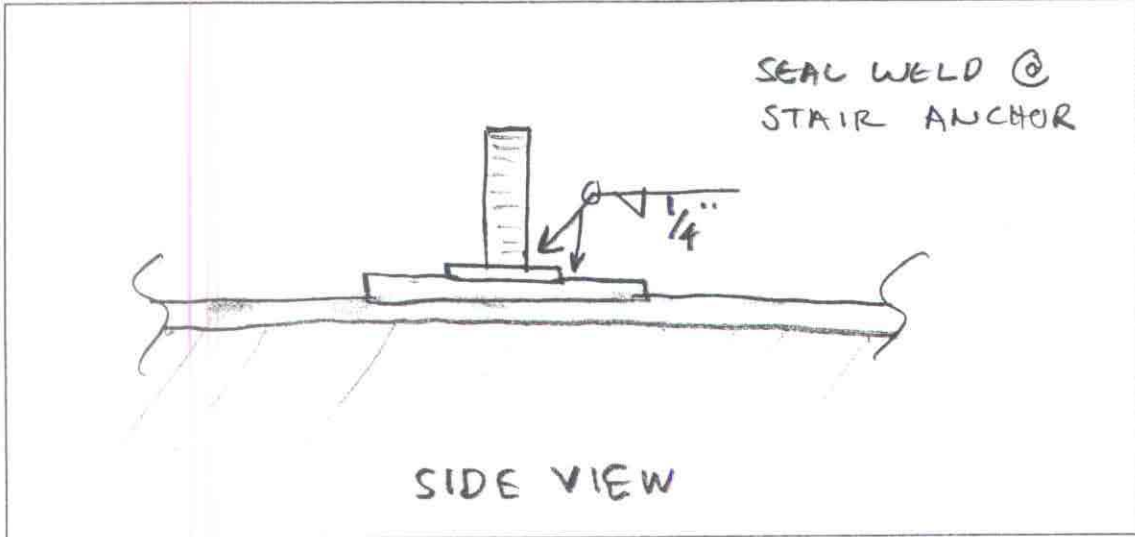
Tank No.: 10 Repair No.: 621 Type: \_\_\_\_\_ Location: Tank Bottom  
@ PL 17/18

TYPE 10 REPAIR

Weld Repair

WPS No.: SM1.1-1

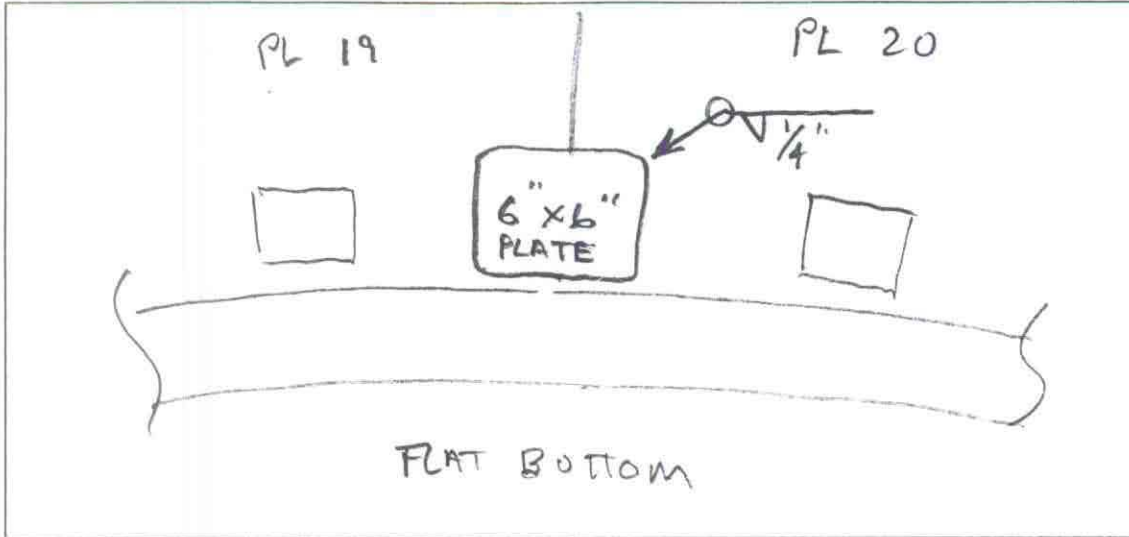
Tank No.: 10    Repair No.: 622    Type: 5    Location: Tank Bottom  
@ PL 19/20

TYPE 3 REPAIR

Weld Repair

WPS No.: SMI.1-1

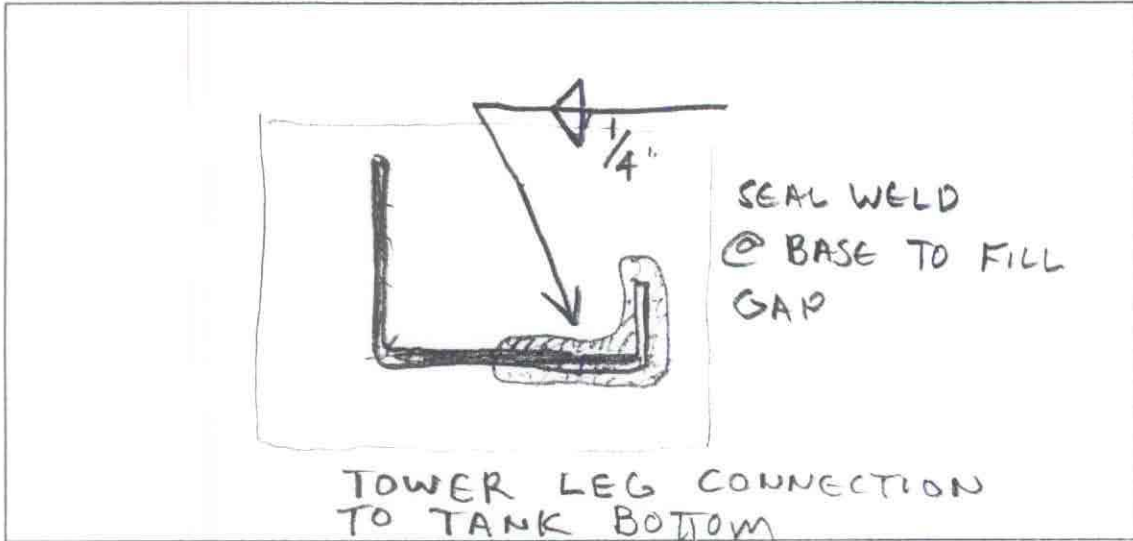
Tank No.: 10    Repair No.: 623    Type: \_\_\_\_\_    Location: Tank Bottom @ PL 1/2

TYPE 10 REPAIR

Weld Repair

WPS No.: SM1.1-1

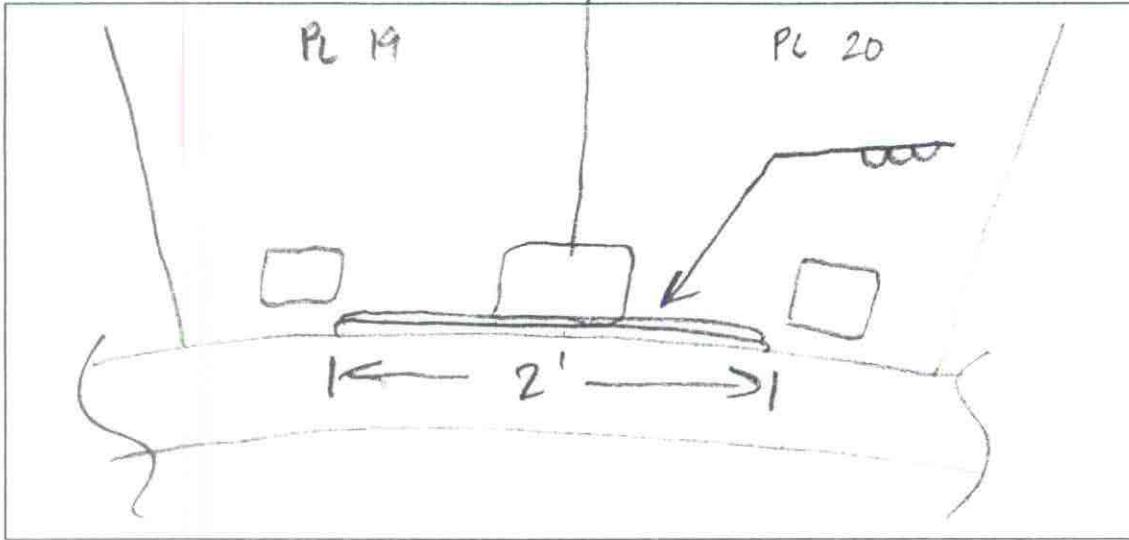
Tank No.: 10    Repair No.: 624    Type: \_\_\_\_\_    Location: Tank Bottom @ PL 19/20

TYPE 10 REPAIR

Weld Repair

WPS No.: Sm 1.1-1

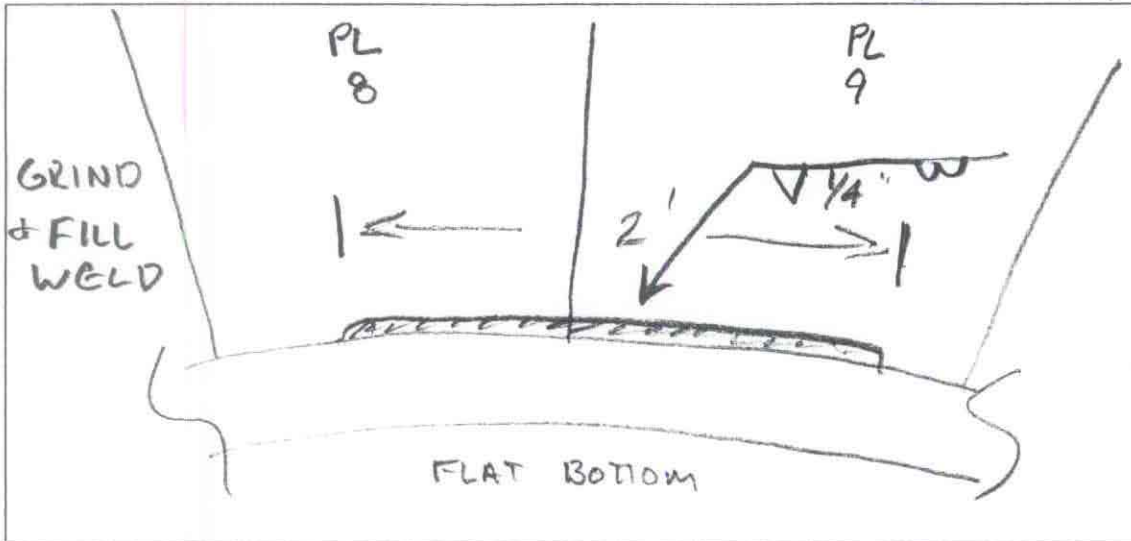
Tank No.: 10    Repair No.: 625    Type: \_\_\_\_\_    Location: Tank Bottom @ PL 8/9

TYPE 10 REPAIR

Weld Repair

WPS No.: SM1.1-1

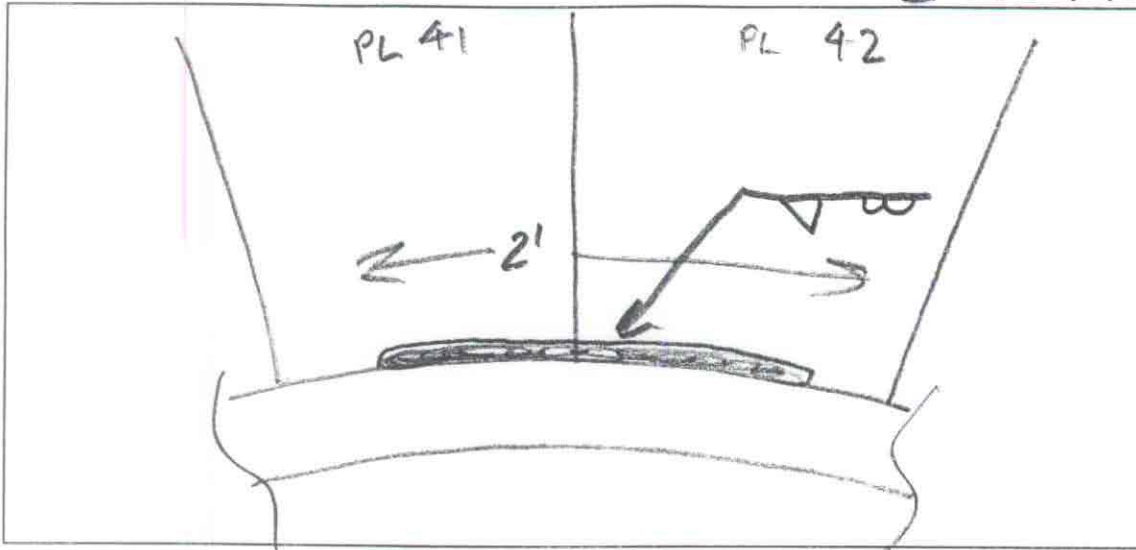
Tank No.: 10    Repair No.: 626    Type: \_\_\_\_\_    Location: Tank Bottom @ PL 41/42

TYPE 10 REPAIR

Weld Repair

WPS No.: SMI.1-1

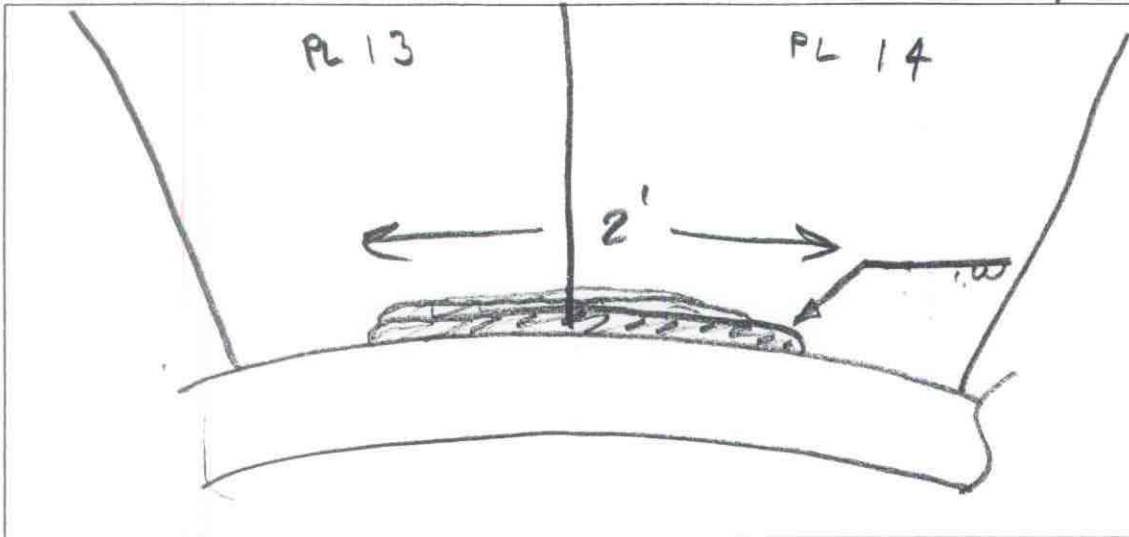
Tank No.: 10    Repair No.: 627    Type: \_\_\_\_\_    Location: Tank Bottom  
@ PL 13/14

TYPE 10 REPAIR

Weld Repair

WPS No.: SM1.1-1

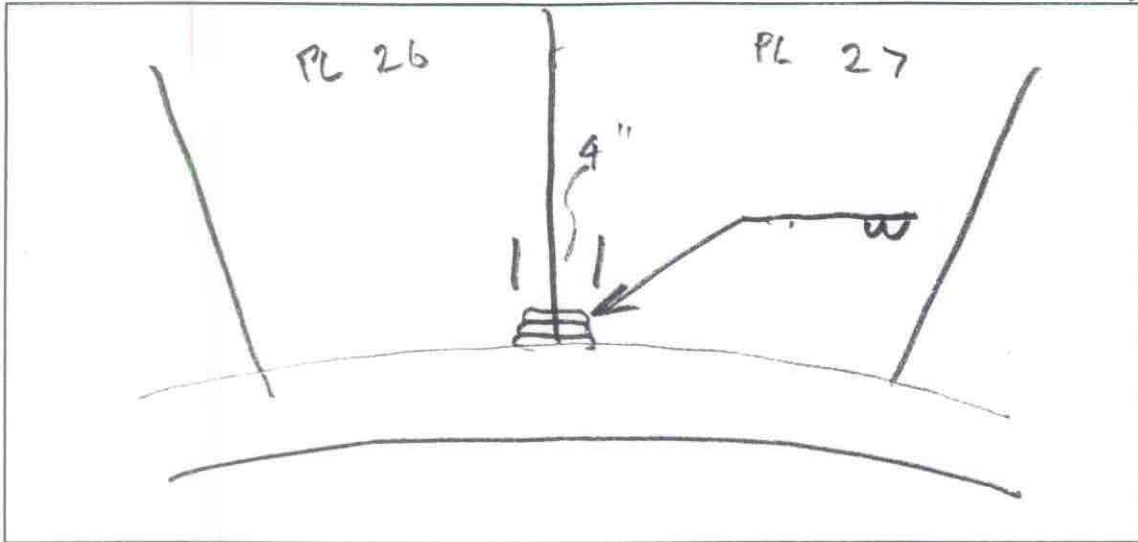
Tank No.: 10    Repair No.: 628    Type: \_\_\_\_\_    Location: Tank Bottom @ PL 26/27

TYPE 10 REPAIR

Weld Repair

WPS No.: SM1.1-1

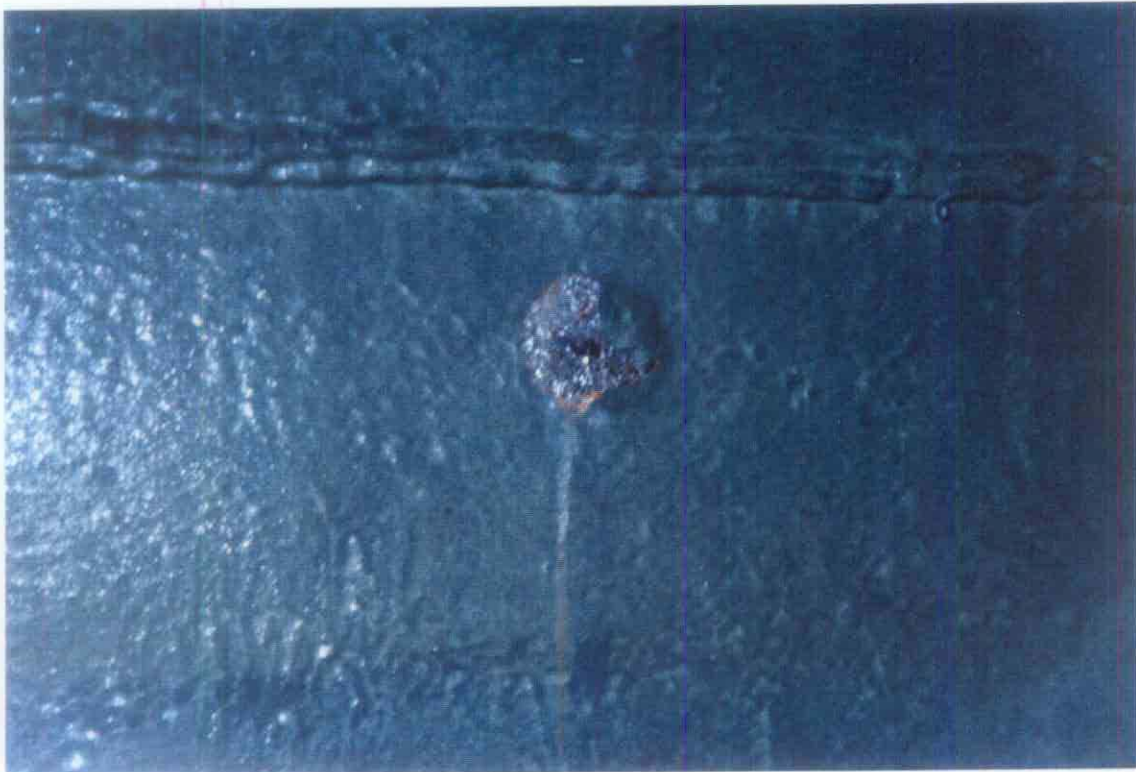
**PICTURE OF HOLE IN TANK WALL CAUSED BY BACKSIDE  
CORROSION**

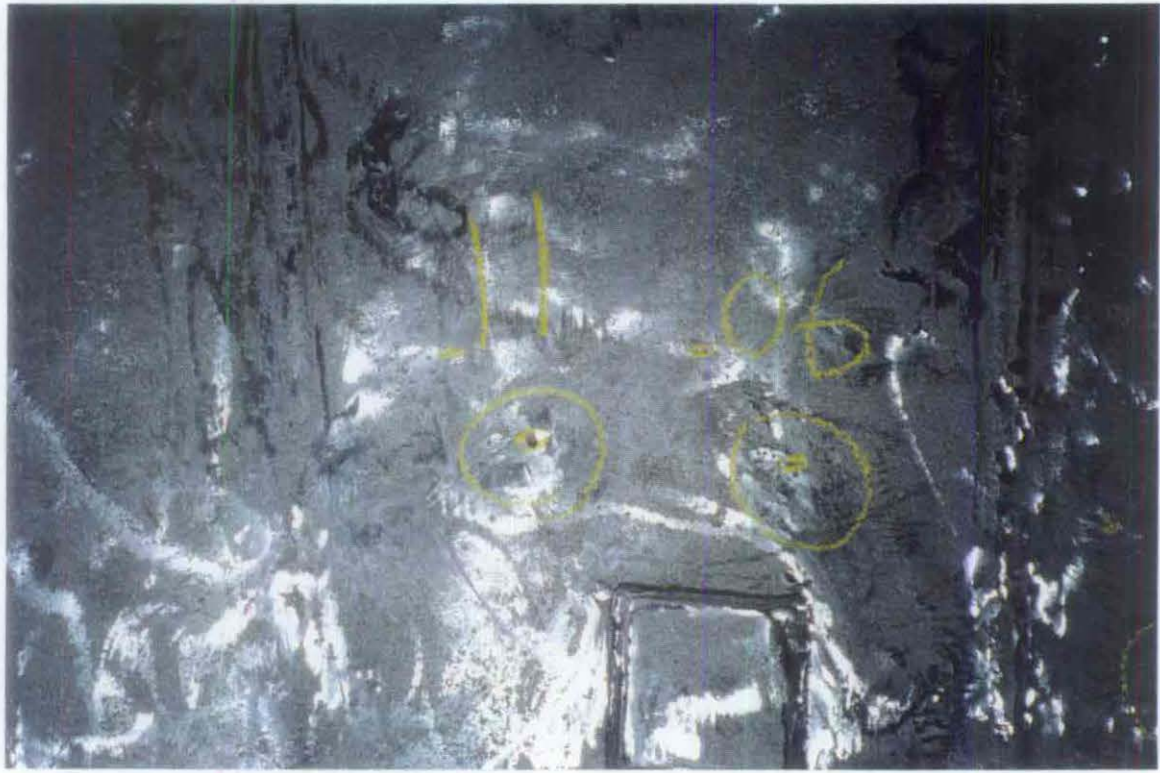
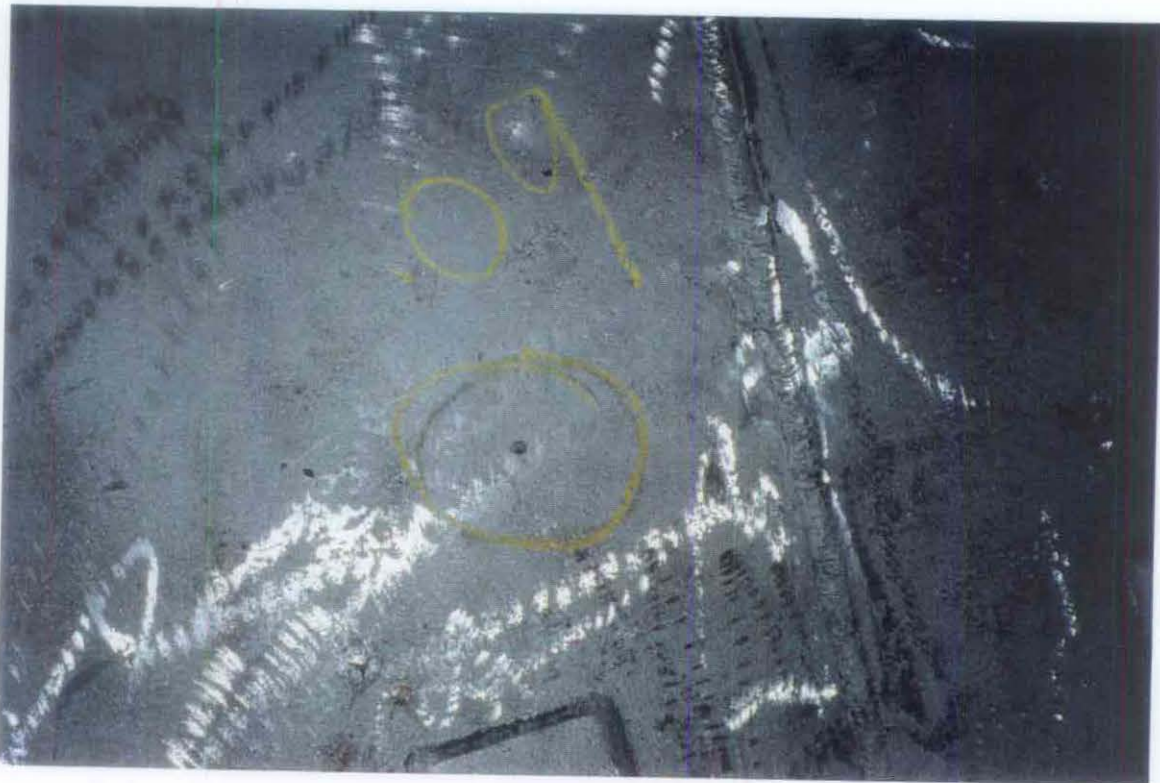
**PICTURE OF PITTING ON FIRST ASCENDING PLATES AT  
BOTTOM OF TANK #10**
