**Consolidated Construction Projects For FISC, Pearl Harbor, Hawaii  
Contract No. N62742-C-02-1402  
Clean And Repair Tanks 1 And 15, 6 And 16  
Weld Repair As Built Record**

**Tank 15**

**Quadrant A, B, D, Tank Floor, and Lower Dome  
Weld Repairs Completed June 2005  
Reference TESTEX Report Dated 2-18-2005  
And Government Provided Repair Procedure Spreadsheet**

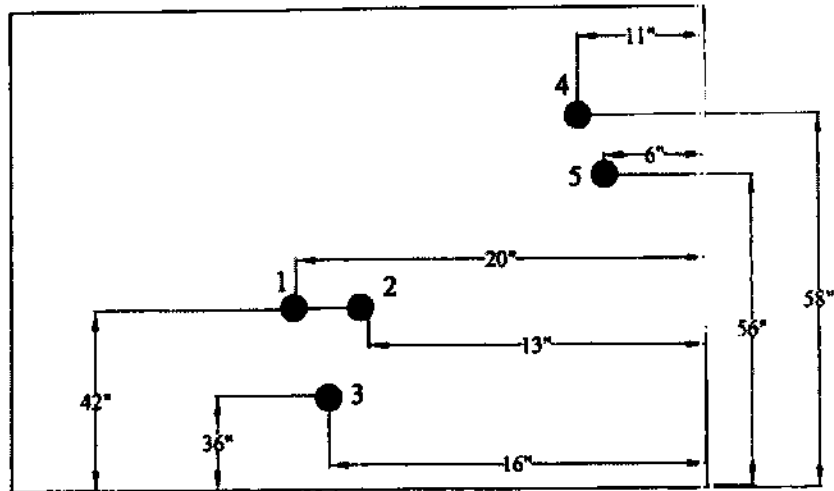
**Figure 6:**

- Thickness:**  
1 - 0.156"  
2 - 0.098"  
3 - 0.146"  
4 - Thru-hole  
5 - 0.119"

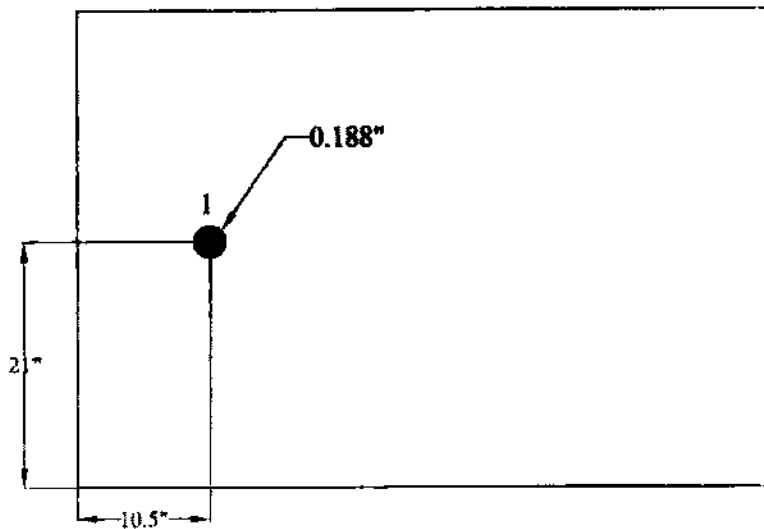
**Figure 7:**

- Thickness:**  
1 - 0.188"

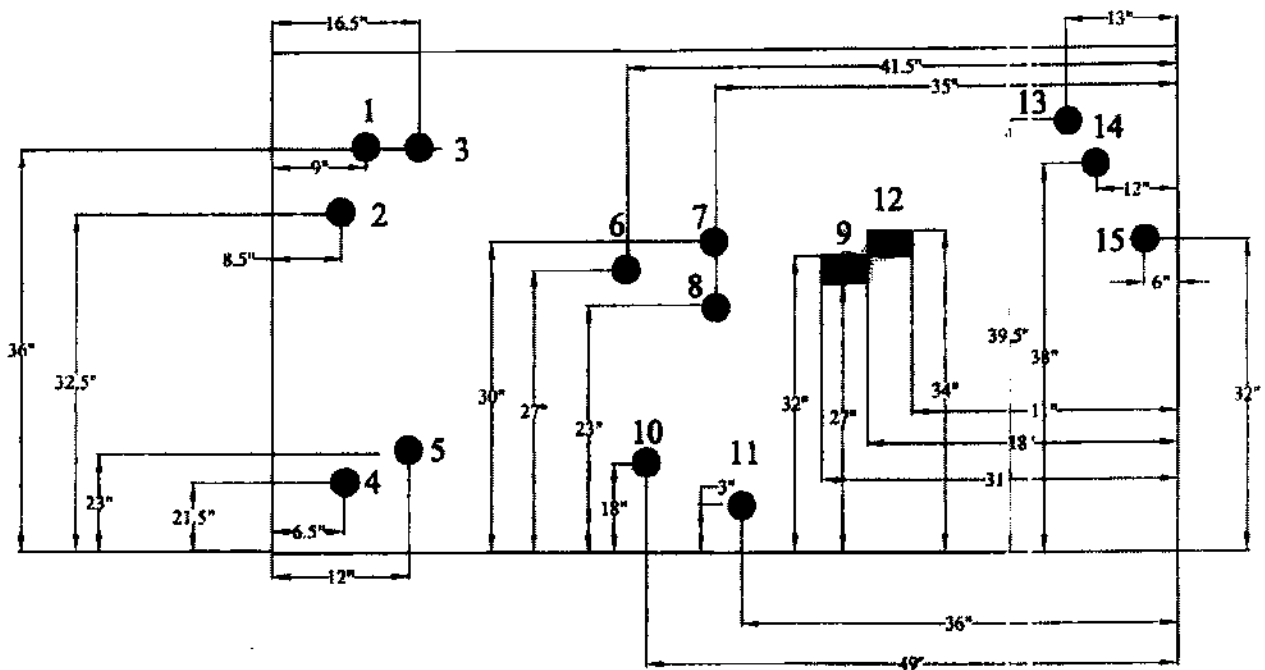
**Figure 8:**

1 - 0.178"	6 - 0.101"	11 - 0.175"
2 - 0.209"	7 - 0.154"	12 - 0.150"
3 - 0.177"	8 - 0.216"	13 - 0.191"
4 - 0.165"	9 - 0.140"	14 - 0.088"
5 - 0.155"	10 - 0.152"	15 - 0.188"

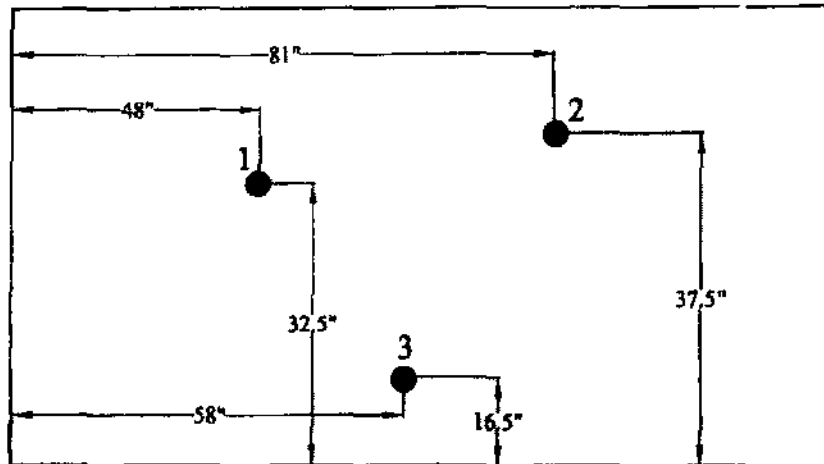
**Figure 9:**

**Thickness:**  
1 - 0.159"  
2 - Gouge  
3 - Dent &  
Gouge

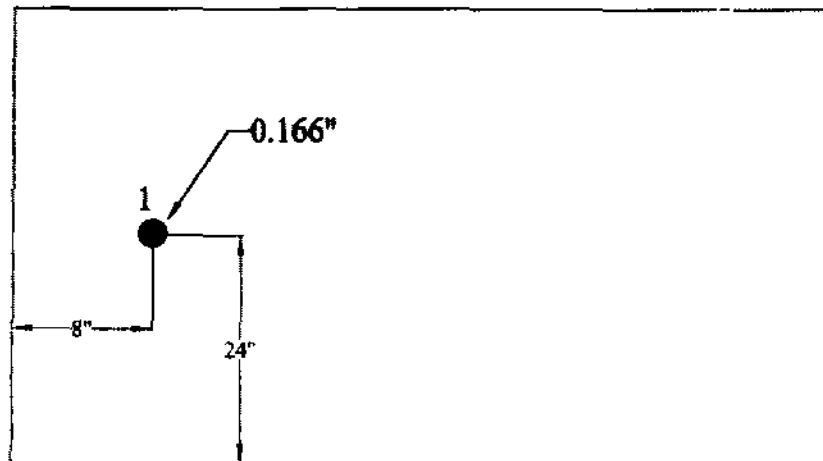
**Figure 10:**

**Thickness:**  
1 - 0.166"

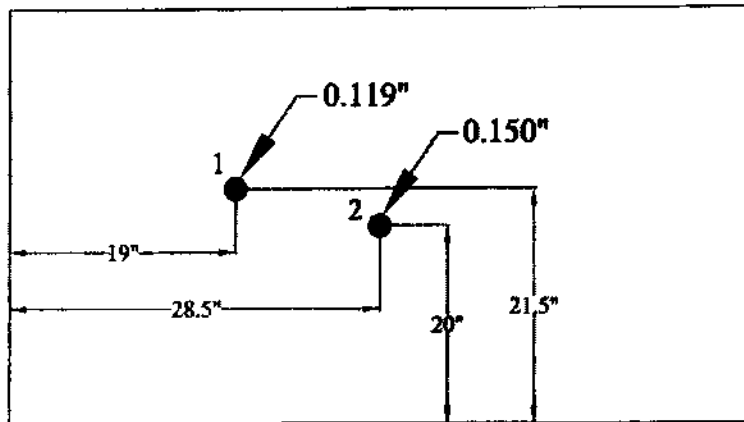
**Figure 11:**

**Thickness:**  
1 - 0.119"  
2 - 0.150"

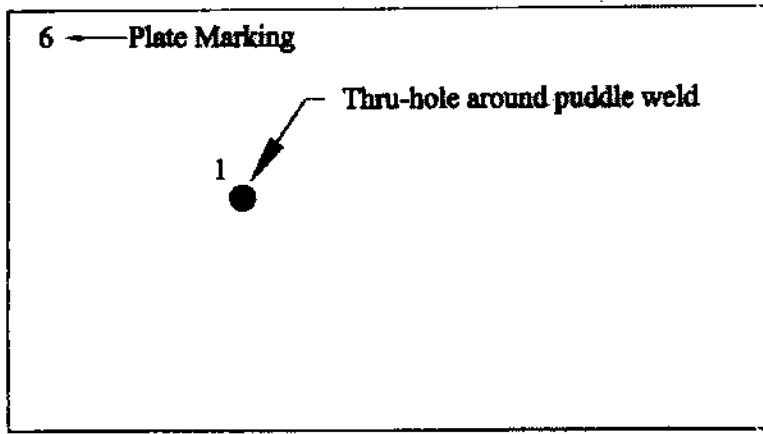
**Figure 12:**

**Thickness:  
1 - Thru-hole**

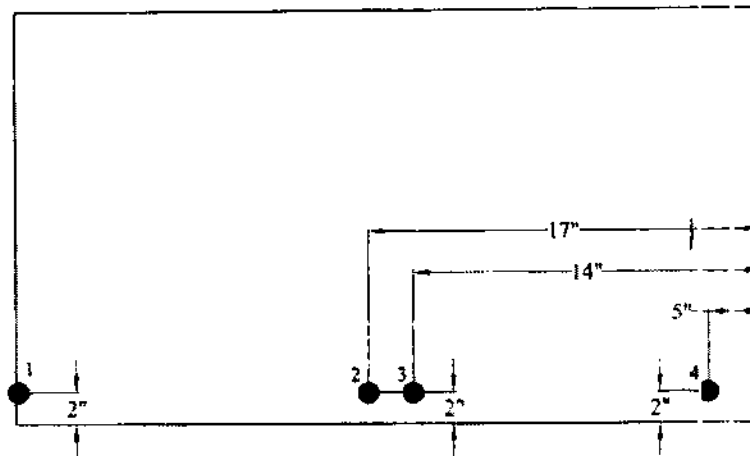
**Figure 14:**

**Thickness:**  
1 - 0.090"  
2 - Thru-hole  
3 - 0.196"  
4 - 0.183"

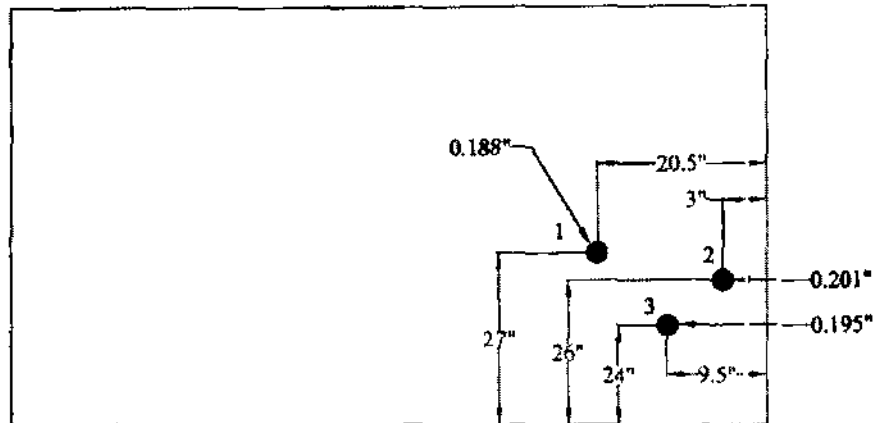
Figure 15:

1 - 0.188"

2 - 0.201"

3 - 0.195"

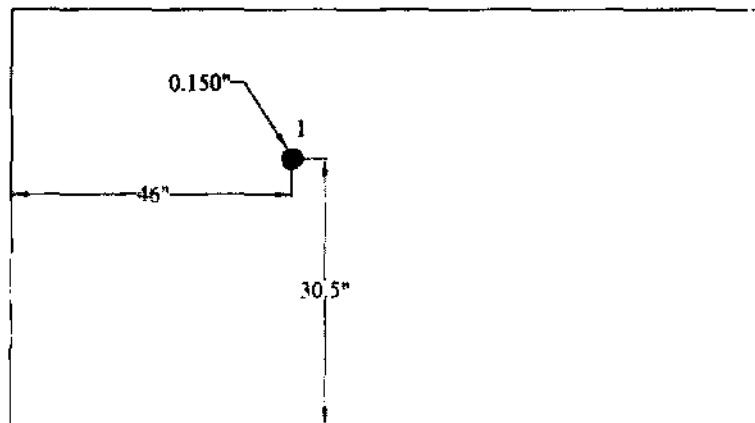
Figure 16:

1 - 0.150"

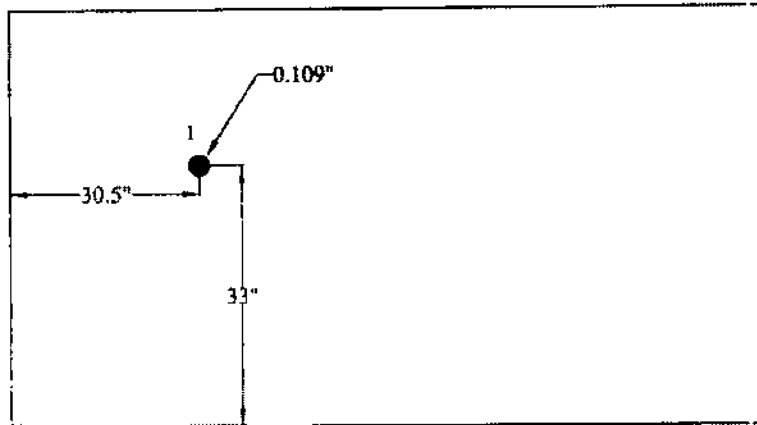
**Figure 17:**

**Thickness:  
1 - 0.109"**

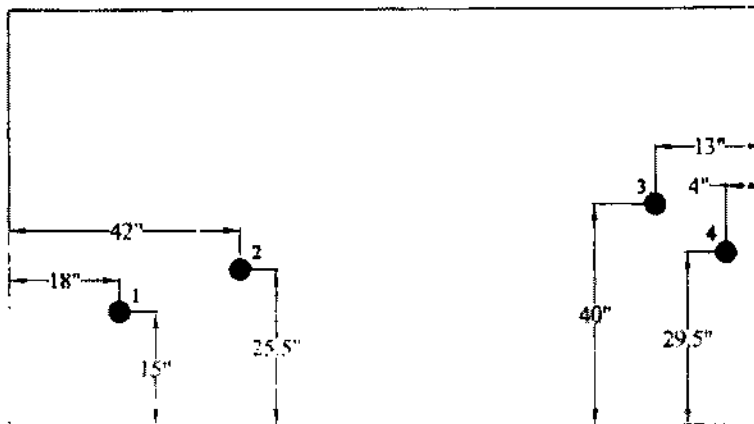
**Figure 18:**

**Thickness:  
1 - 0.199"  
2 - 0.175"  
3 - 0.186"  
4 - 0.177"**

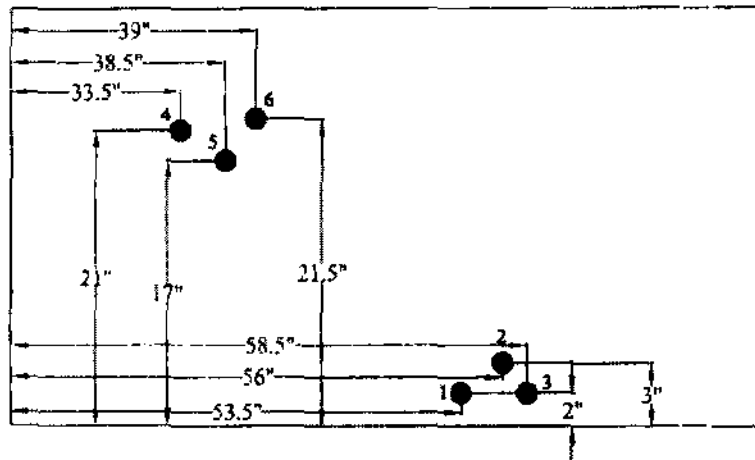
**Figure 21:**

- Thickness:**  
1 - 0.220"  
2 - Thru-hole  
3 - 0.230"  
4 - 0.108"  
5 - 0.133"  
6 - 0.157"

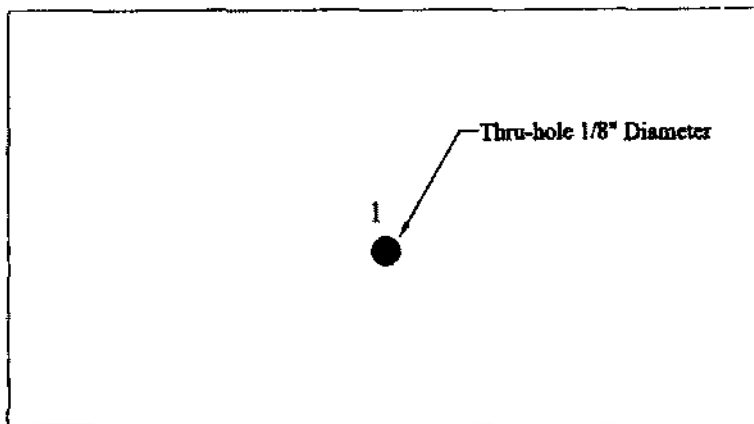
**Figure 24:**  
**Thickness:**  
**1 - Thru-hole**

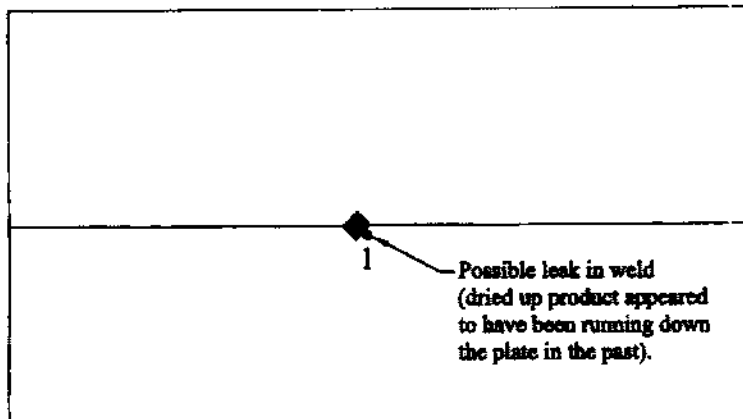
**Figure 27:**

**Thickness:  
1 - Possible  
Leak**

Quadrant D Upper Dome Repairs					
Plate No.	Testex Flaw No.	Repair Flaw No.	Wall / Plate Remaining	Approximate Corrosion Area (Total Affected Area)	Patch Plate Size/Thickness
In Vertical Scan #5	1	D-1	Possible leak in weld (dried up product apparent on plate)		4" x 1/4" Round Patch Plate
6	1	D-2	Thru-hole	1.250" X 0.625" Elliptical Area	4" x 1/4" Round Patch Plate

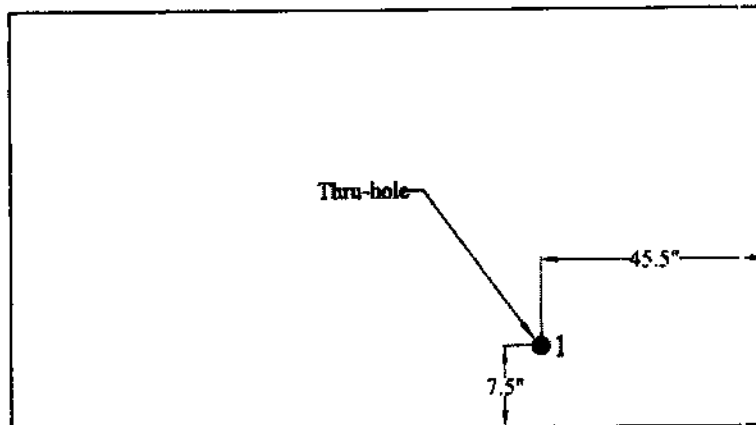
**Figure 28:**

**Thickness:  
1 - Thru-hole**
