Section 9

RECOMMENDED REPAIRS

MID ATLANTIC ENVIRONMENTAL	
EMERGENCY REPAIRS FOR RED HILL TANKS	
Tank #7 RECOMMENDED REPAIR DRAWINGS	
Repair No.: 001	File: 7r001
Upper Dome	Quadrant: D
Course: B	Plate: 19
Drawn by: Tom Kitchen	Date: 5/4/98

Dames & Moore
Emergency Repairs For Red Hill Tanks at the Fleet Industrial & Supply Center
Contract No. N62742-96-C-1356

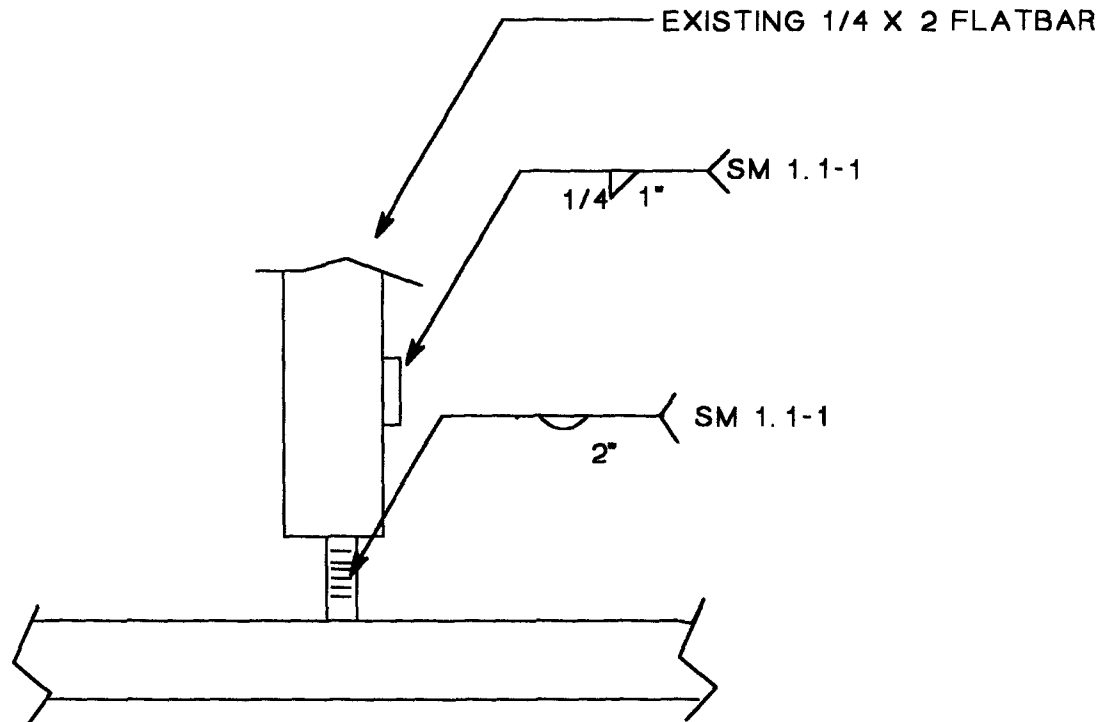
MID ATLANTIC ENVIRONMENTAL	
EMERGENCY REPAIRS FOR RED HILL TANKS	
Tank #7 AS BUILT DRAWINGS	
Repair No.: 003	File: 7R003
Upper Dome	Quadrant: D
Course: A	Plate: 22
Drawn by: Tom Kitchen	Date: 5/4/98

DEFECT INSPECTED 3/27/98 BY JF & TK

EXISTING 1/4 X 2 FLATBAR

TYPE 10 REPAIR

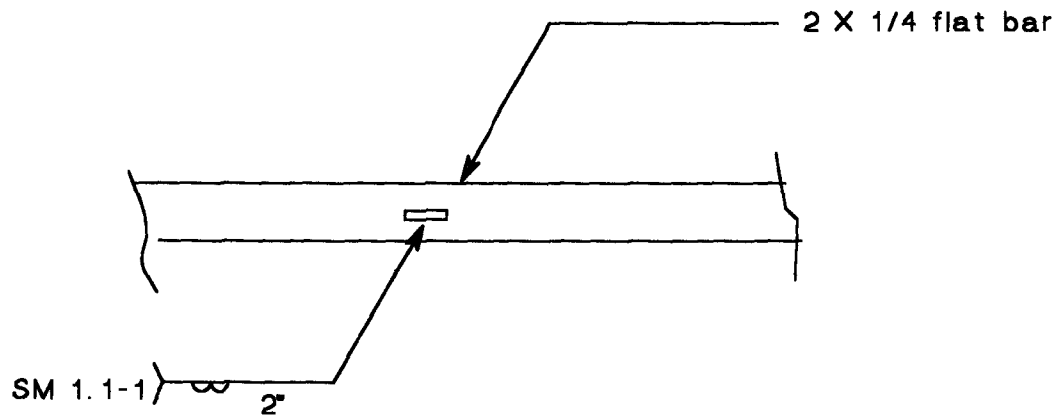
MID ATLANTIC ENVIRONMENTAL	
EMERGENCY REPAIRS FOR RED HILL TANKS	
Tank #7 REPAIR DRAWING	
Repair No. : 008	File: 7R008
Upper Dome	Quadrant: D
Course: EXTENSION	Plate: 22
Drawn by: Tom Kitchen	Date: 5/4/98

Inspected 3/27/98 by JF & TK

TYPE 10 REPAIR
