MID ATLANTIC ENVIRONMENTAL	
EMERGENCY REPAIRS FOR RED HILL TANKS	
Tank #7 RECOMMENDED REPAIR DRAWINGS	
Repair No. 046	File: 7r046
Upper Dome	Quadrant: B
Course: A	Plate: 10
Drawn by: Tom Kitchen	Date: 5/4/98

**Dames & Moore**  
Emergency Repairs For Red Hill Tanks at the Fleet Industrial & Supply Center  
Contract No. N62742-96-C-1356

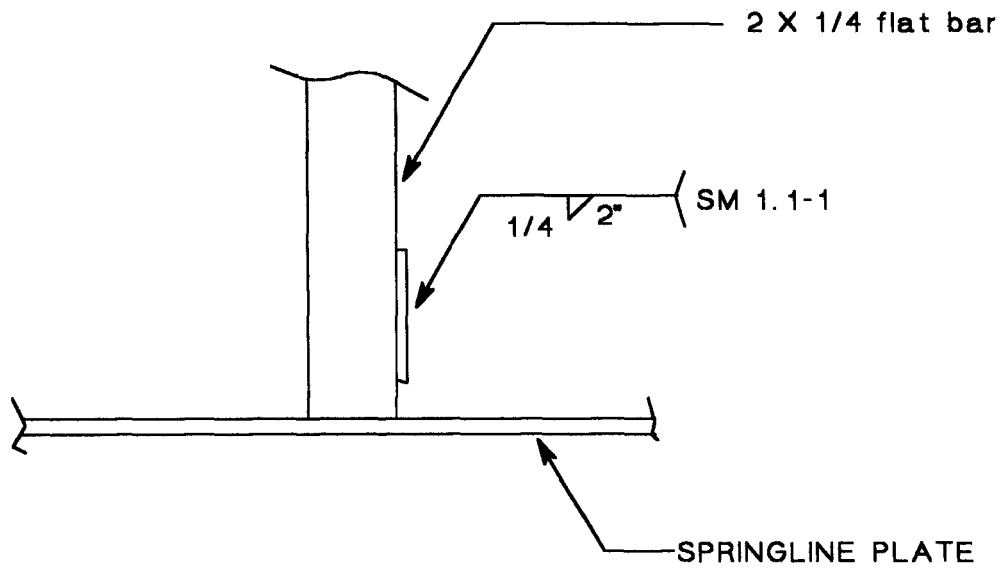
TYPE 10 REPAIR

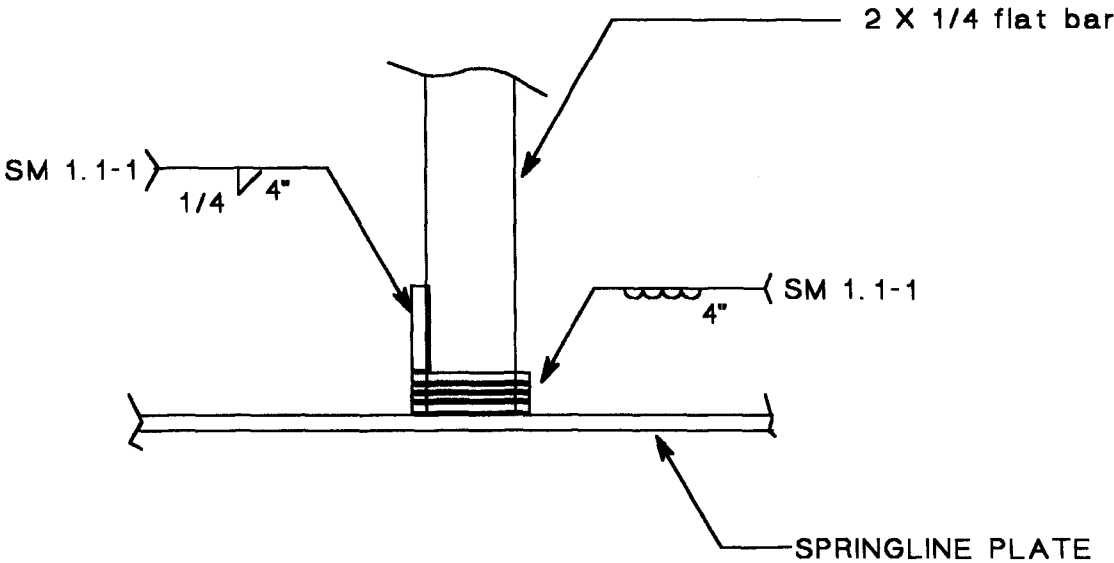
TYPE 10 REPAIR

MID ATLANTIC ENVIRONMENTAL	
EMERGENCY REPAIRS FOR RED HILL TANKS	
Tank #7 RECOMMENDED REPAIR DRAWINGS	
Repair No.: 047	File: 7r047
Upper Dome	Quadrant: B
Course: A	Plate: 11
Drawn by: Tom Kitchen	Date: 5/4/98

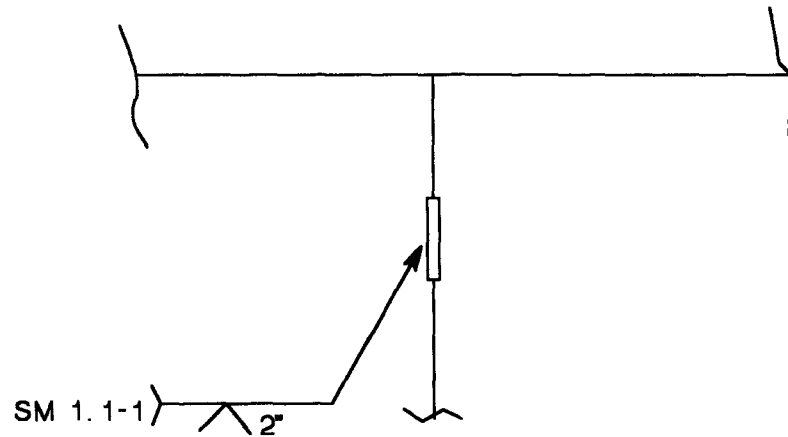
TYPE 9 REPAIR

MID ATLANTIC ENVIRONMENTAL	
EMERGENCY REPAIRS FOR RED HILL TANKS	
Tank #7 RECOMMENDED REPAIR DRAWING	
Repair No.: 048	File: 7R048
CYLINDER	Quadrant: B
Course: 18	Plate: 11
Drawn by: Tom Kitchen	Date: 5/4/98

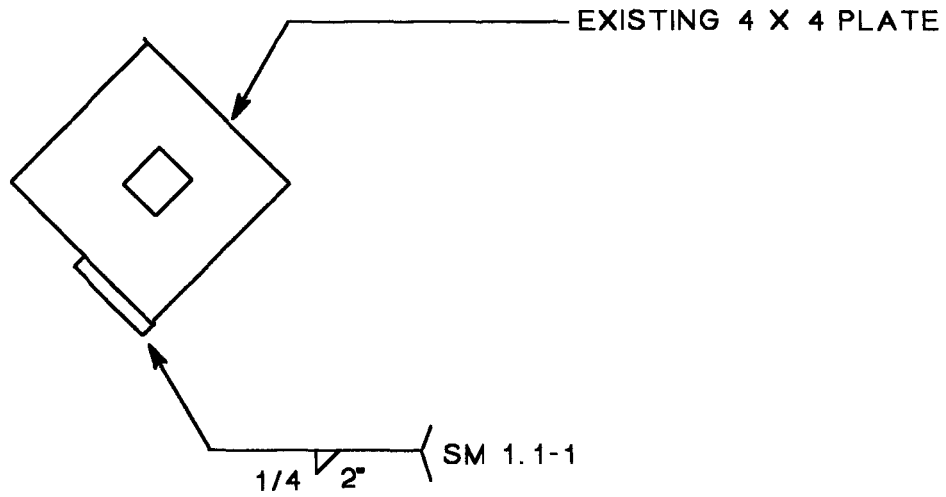
TYPE 10 REPAIR

MID ATLANTIC ENVIRONMENTAL	
EMERGENCY REPAIRS FOR RED HILL TANKS	
Tank #7 REPAIR DRAWING	
Repair No. : 049	File: 7R049
CYLINDER	Quadrant: B
Course: 15	Plate: 9
Drawn by: Tom Kitchen	Date: 5/4/98

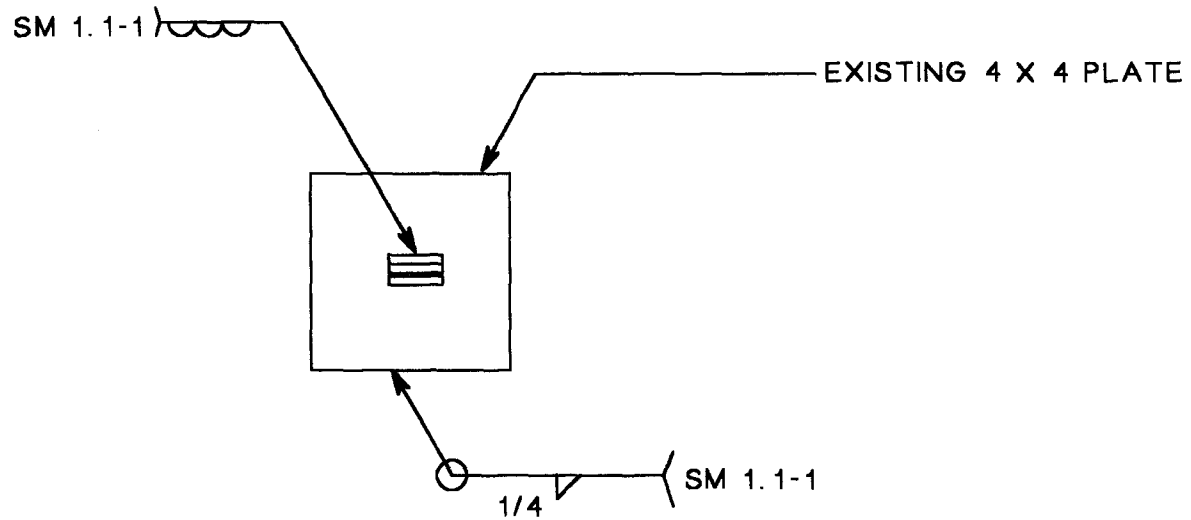
TYPE 10 REPAIR

MID ATLANTIC ENVIRONMENTAL	
EMERGENCY REPAIRS FOR RED HILL TANKS	
Tank #7 REPAIR DRAWING	
Repair No. : 050	File: 7R050
CYLINDER	Quadrant: B
Course: 28	Plate: 11
Drawn by: Tom Kitchen	Date: 5/4/98

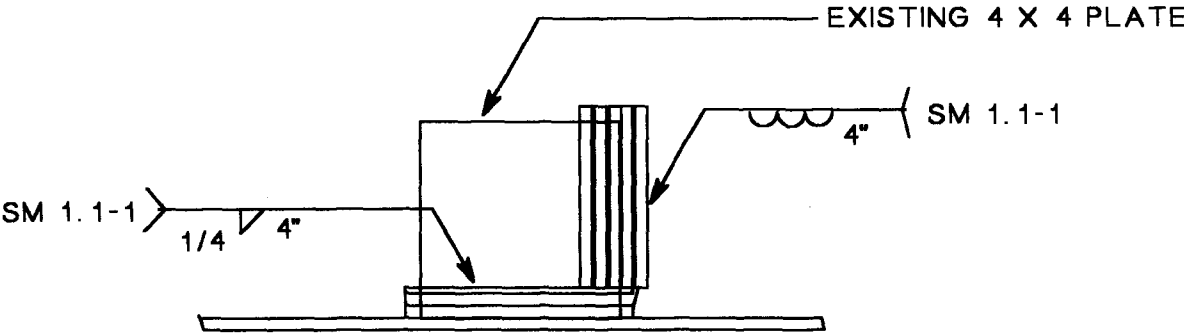
TYPE 10 REPAIR

MID ATLANTIC ENVIRONMENTAL	
EMERGENCY REPAIRS FOR RED HILL TANKS	
Tank #7 REPAIR DRAWING	
Repair No. 051	File 7R051
CYLINDER	Quadrant B
Course 28	Plate 8
Drawn by Tom Kitchen	Date 5/4/98

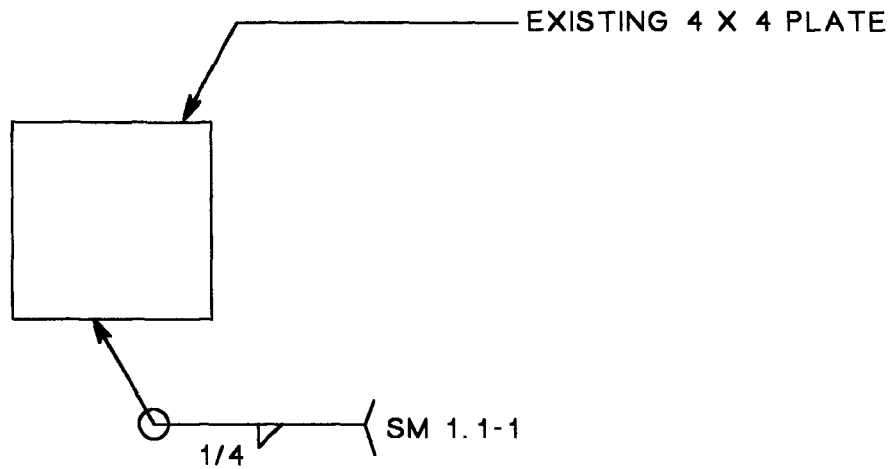
TYPE 10 REPAIR

MID ATLANTIC ENVIRONMENTAL	
EMERGENCY REPAIRS FOR RED HILL TANKS	
Tank #7 REPAIR DRAWING	
Repair No. 052	File: 7R052
CYLINDER	Quadrant: B
Course: 28	Plate: 7
Drawn by: Tom Kitchen	Date: 5/4/98

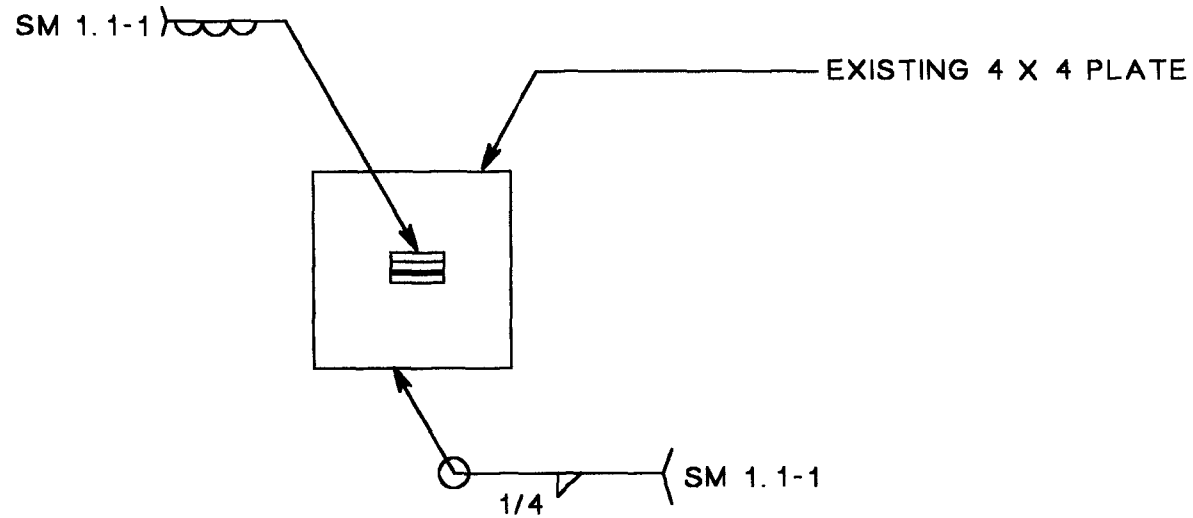
TYPE 10 REPAIR

MID ATLANTIC ENVIRONMENTAL	
EMERGENCY REPAIRS FOR RED HILL TANKS	
Tank #7 RECOMMENDED REPAIR DRAWING	
Repair No. 053	File 7R053
CYLINDER	Quadrant B
Course 28	Plate 6
Drawn by Tom Kitchen	Date 5/4/98

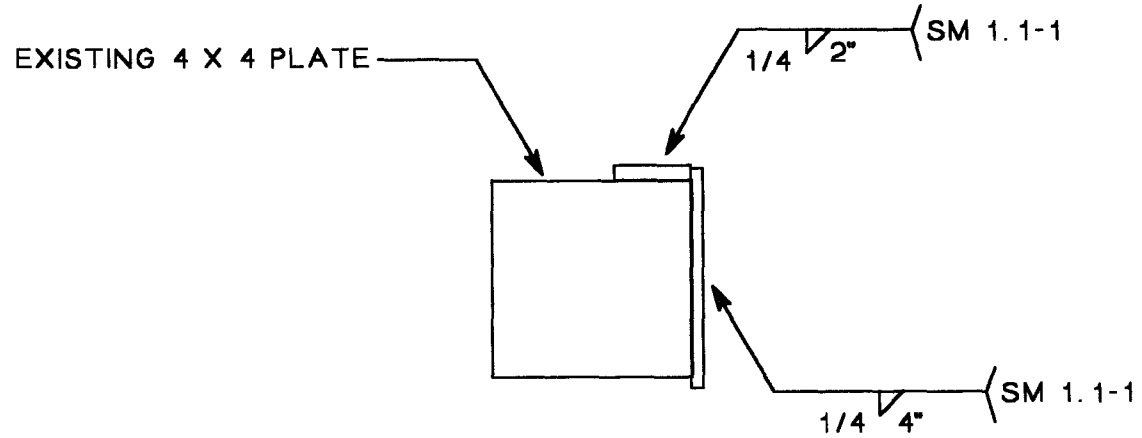
TYPE 10 REPAIR

MID ATLANTIC ENVIRONMENTAL	
EMERGENCY REPAIRS FOR RED HILL TANKS	
Tank #7 RECOMMENDED REPAIR DRAWING	
Repair No.: 054	File: 7R054
CYLINDER	Quadrant: B
Course: 28	Plate: 5
Drawn by: Tom Kitchen	Date: 5/4/98

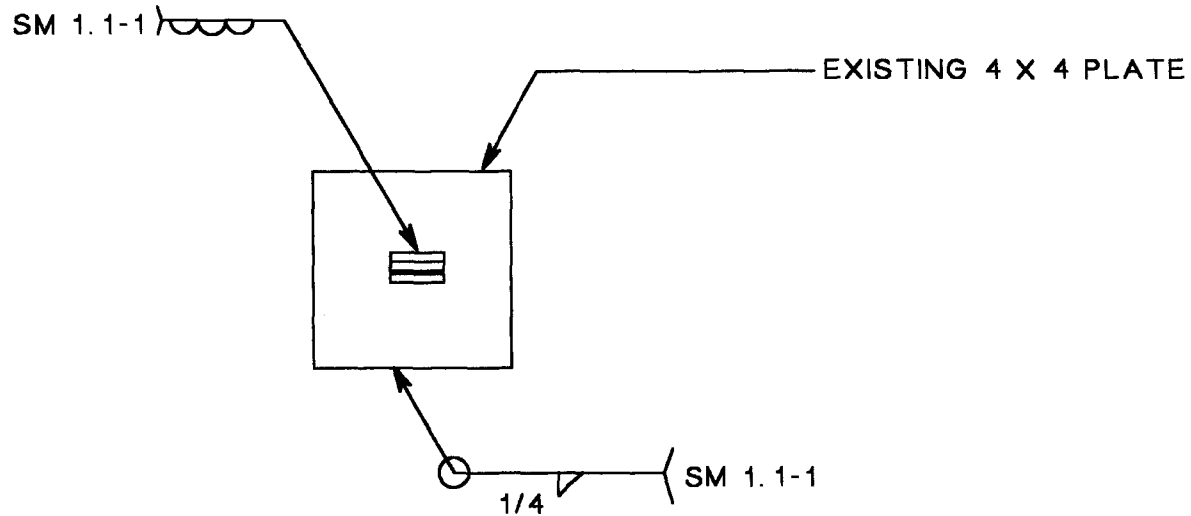
TYPE 10 REPAIR

MID ATLANTIC ENVIRONMENTAL	
EMERGENCY REPAIRS FOR RED HILL TANKS	
Tank #7 RECOMMENDED REPAIR DRAWING	
Repair No.: 055	File: 7R055
CYLINDER	Quadrant: A
Course: 28	Plate: 4
Drawn by: Tom Kitchen	Date: 5/4/98

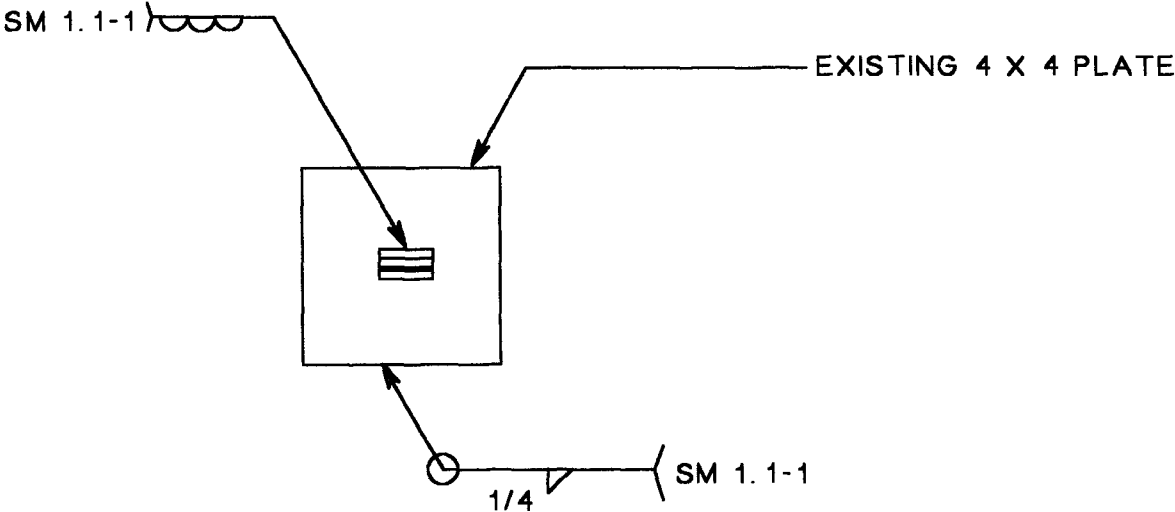
TYPE 10 REPAIR

MID ATLANTIC ENVIRONMENTAL	
EMERGENCY REPAIRS FOR RED HILL TANKS	
Tank #7 RECOMMENDED REPAIR DRAWING	
Repair No.: 056	File: 7R056
CYLINDER	Quadrant: A
Course: 28	Plate: 2
Drawn by: Tom Kitchen	Date: 5/4/98

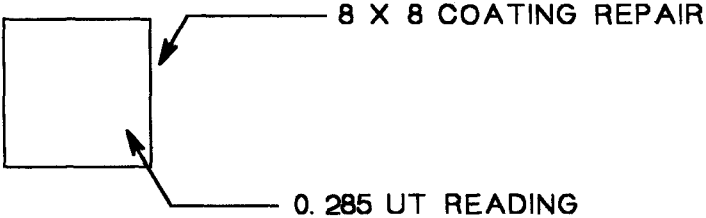
TYPE 8 REPAIR

MID ATLANTIC ENVIRONMENTAL	
EMERGENCY REPAIRS FOR RED HILL TANKS	
Tank #7 RECOMMENDED REPAIR DRAWING	
Repair No.: 057	File: 7R057
LOWER DOME	Quadrant: B
Course: 3	Plate: 11
Drawn by: Tom Kitchen	Date: 5/4/98

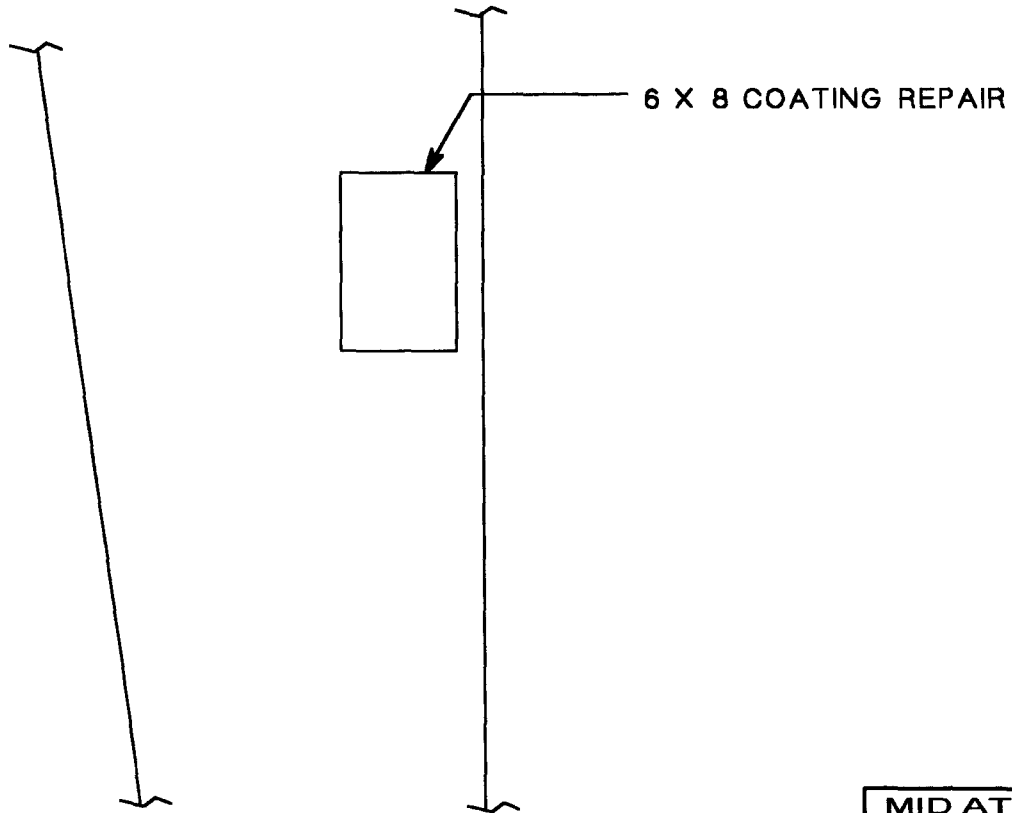
TYPE 8 REPAIR

MID ATLANTIC ENVIRONMENTAL	
EMERGENCY REPAIRS FOR RED HILL TANKS	
Tank #7 RECOMMENDED REPAIR DRAWING	
Repair No.: 058	File: 7R058
Lower Dome	Quadrant: B
Course: 3	Plate: 11
Drawn by: Tom Kitchen	Date: 5/4/98

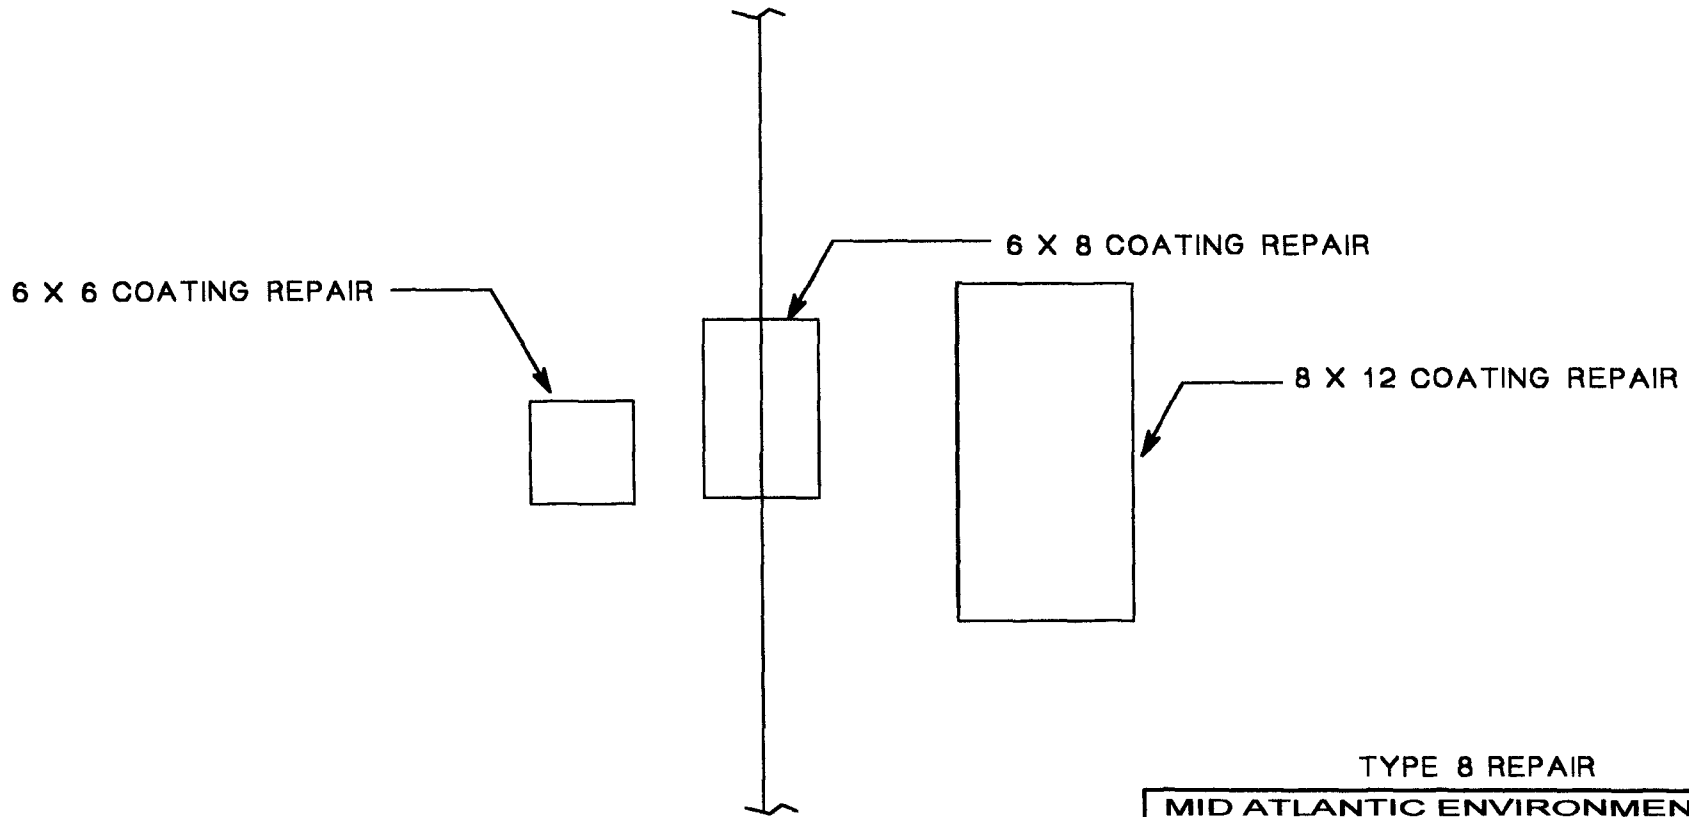
TYPE 8 REPAIR

MID ATLANTIC ENVIRONMENTAL	
EMERGENCY REPAIRS FOR RED HILL TANKS	
Tank #7 RECOMMENDED REPAIR DRAWING	
Repair No.: 059	File: 7R059
Lower Dome	Quadrant: A
Course: 3	Plate: 3
Drawn by: Tom Kitchen	Date: 5/4/98

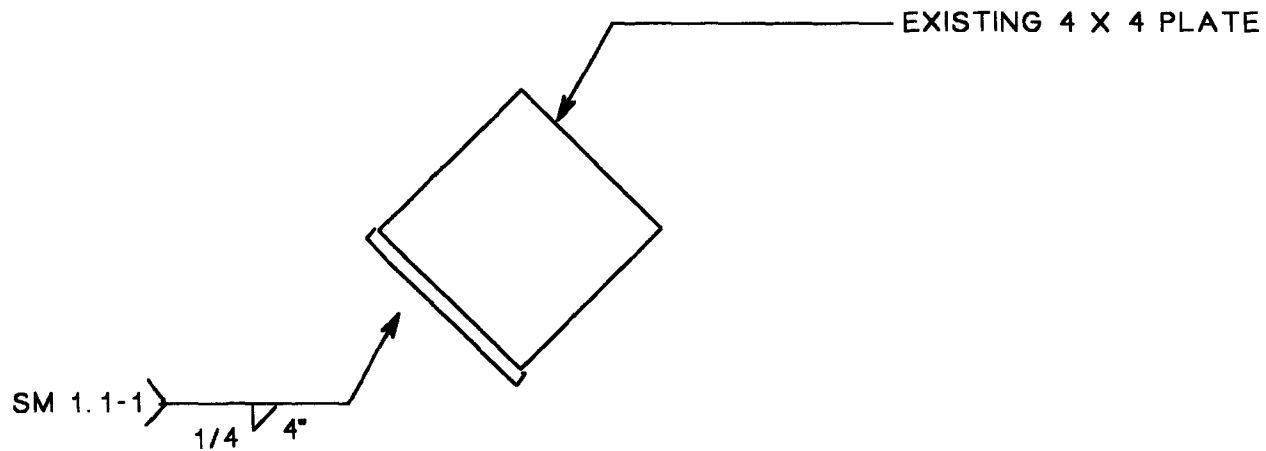
TYPE 10 REPAIR

MID ATLANTIC ENVIRONMENTAL	
EMERGENCY REPAIRS FOR RED HILL TANKS	
Tank #7 RECOMMENDED REPAIR DRAWING	
Repair No.: 060	File: 7R060
CYLINDER	Quadrant: A
Course: 17	Plate: 1
Drawn by: Tom Kitchen	Date: 5/4/98
