2.1 Mid Atlantic Environmental, Inc. conducted an inspection on Tank #8 at the Red Hill Underground Storage Facility, Pearl Harbor, Hawaii. This inspection was conducted in accordance with the scope of work identified by Contract Number N00604-97-R-0013, PRL 96-21, titled "Emergency Repair for Red Hill Tanks."

RED HILL TANK NO. 8
PRODUCT: DFM

OI		TK	
LTR	DESCRIPTION	BY	DATE
REVISIONS			
MID ATLANTIC ENVIRONMENTAL			
EMERGENCY REPAIRS FOR RED HILL TANKS			
Tank #8			
Floor Layout		File: 8fillo	
Tank bottom			
Drawn By: T. Kitchen		Date: 7/20/98

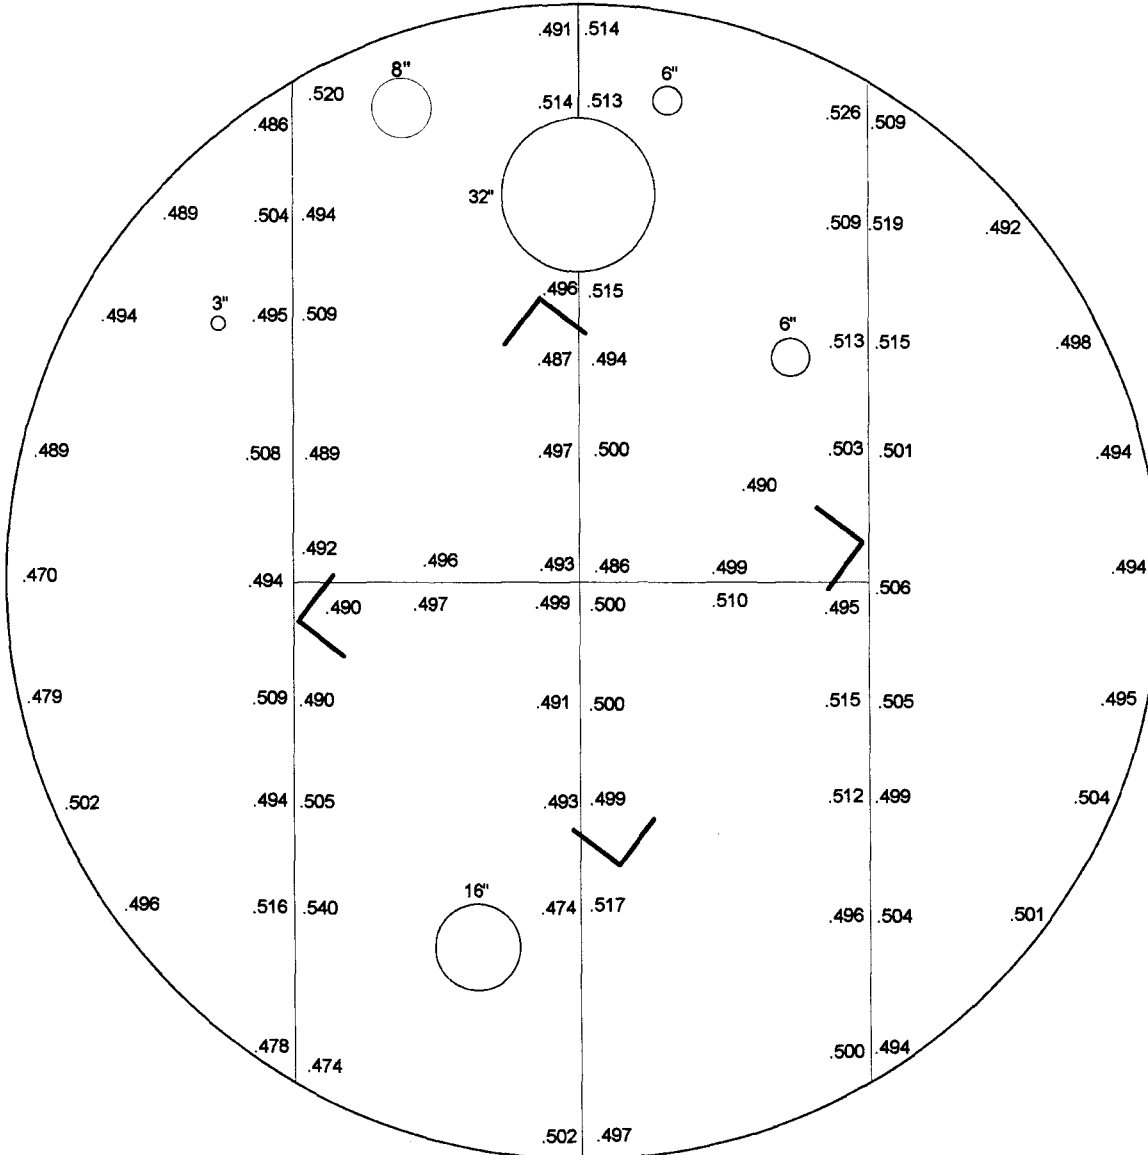
Drawing Title:
Bottom Layout & Thickness Measurements

7.2.1 The original bottom thickness was determined to be 0.500 inches and the first ascending plate to be 0.250 inches. The ultrasonic thickness measurements taken determined that backside corrosion in this area is not a problem. Pitting on the bottom plates is widespread and the enclosed drawing shows that many patch plates had been added in the past. Although pitting is widespread it is not a problem since the remaining metal thickness is well within the 0.10 inches of metal required by API Standard 653 by the next inspection. Also the coating to be applied to the tank bottom should prevent any increase in pit depth. Although pitting is not a problem with regard to structural integrity, it did present a problem regarding the coating to be applied. Pictures of this pitting are included with this report. The surface contamination test results yielded 0% ferrous salts, 32 ppm NaCl and a pH level of 7. These results are within the limits set forth in the KTA SCAN Kit technical data and the NACE technical committee report on Surface Preparation of Contaminated Steel Surfaces. The Caustic Soda test of the tank bottom indicated that all Flame Sprayed Aluminum had been removed. By visual inspection, scattered pitting was observed on the tank bottom and first ascending plates. The deeper pits were measured and recorded on the Bottom Layout With Pit Indications drawing.
