MID ATLANTIC ENVIRONMENTAL	
EMERGENCY REPAIRS FOR RED HILL TANKS	
Tank #8 RECOMMENDED REPAIR DRAWING	
Repair No.: 014	File: 8r014
LOWER DOME	Quadrant: B
Course: 3	PLATE: 10
Drawn by: Tom Kitchen	Date: 5/4/98

Dames & Moore
Emergency Repairs For Red Hill Tanks at the Fleet Industrial & Supply Center
Contract No. N62742-96-C-1356

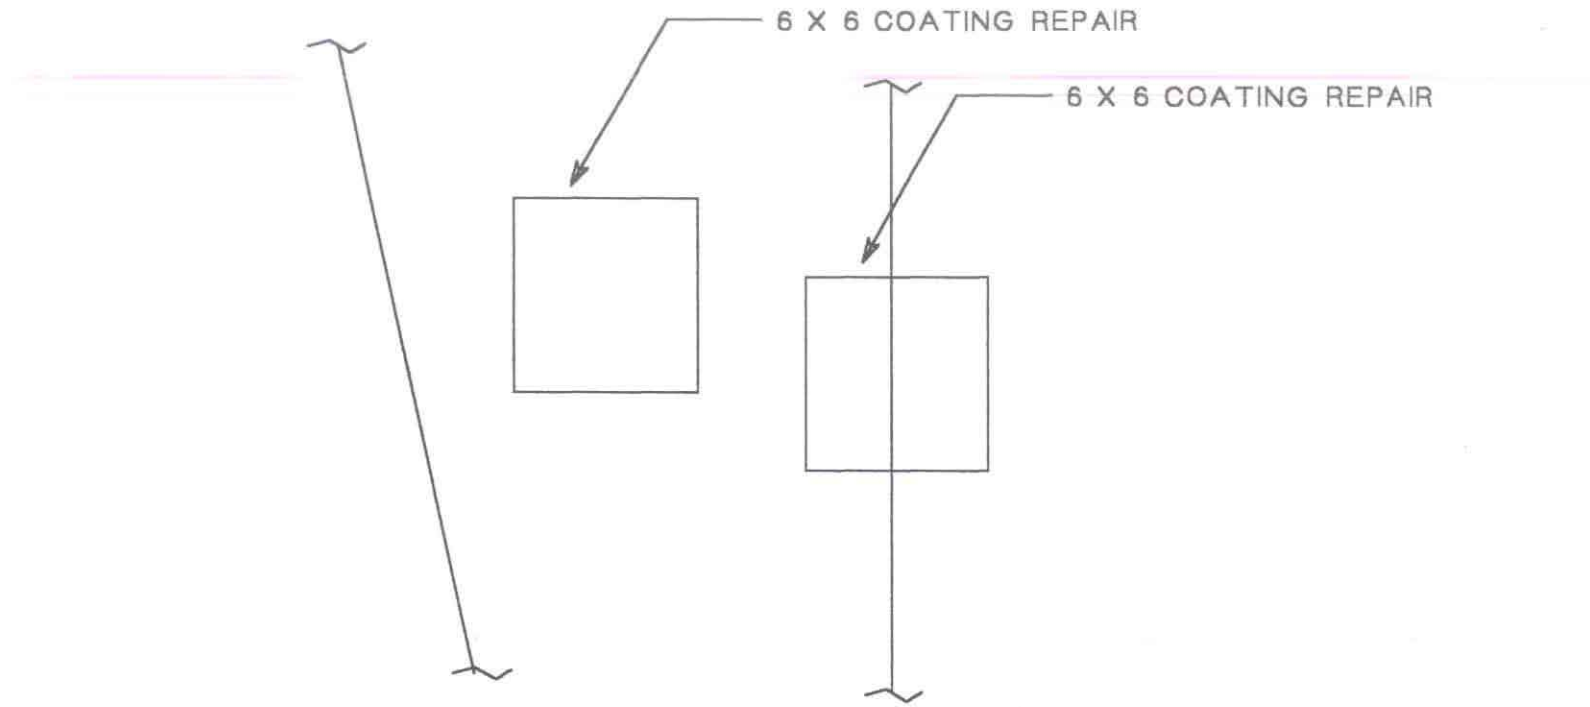
TYPE 9 REPAIR

DEFECT INSPECTED BY TK & JF 3/16/98

Repair Acceptable: John Zedwell Date Accepted: 4-13-98

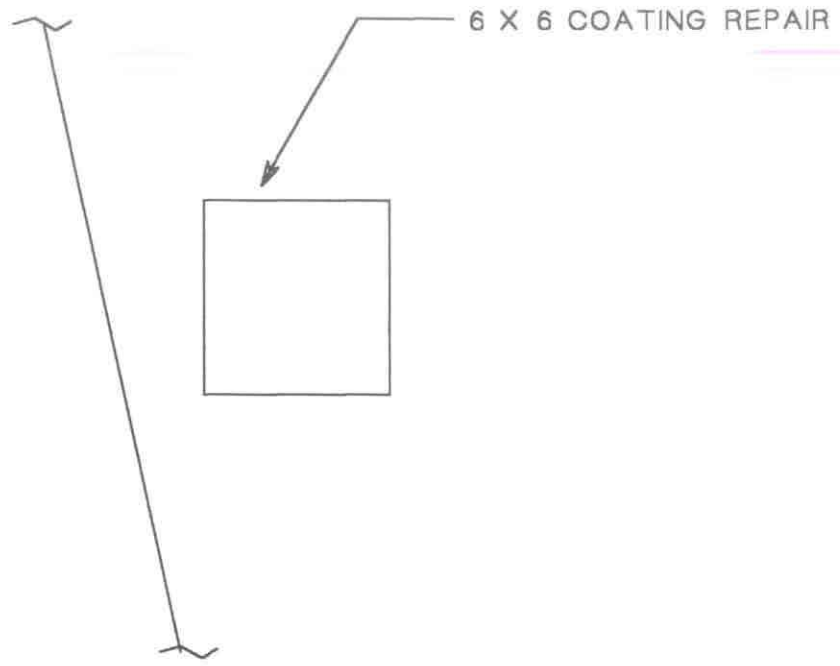
TYPE 8 REPAIR

6 X 8 COATING REPAIR

Repair Acceptable: John Zehrell Date Accepted: 4-13-98

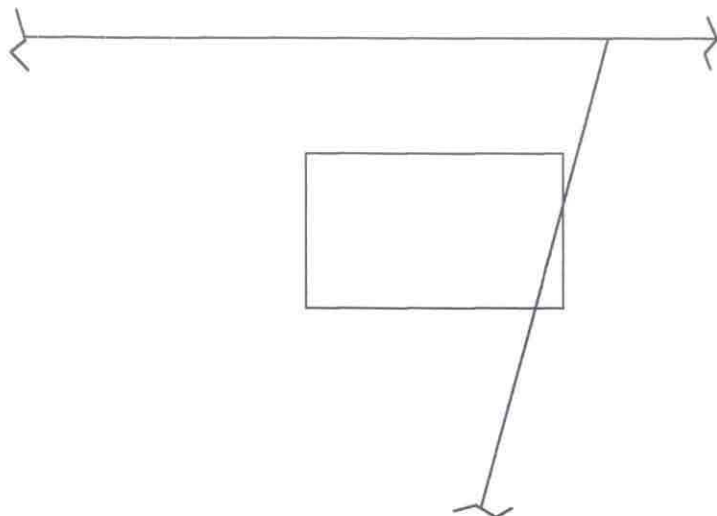
TYPE 8 REPAIR

DEFECT INSPECTED BY TK & JF 3/16/98

Repair Acceptable: John Zicknell Date Accepted: 4-13-98

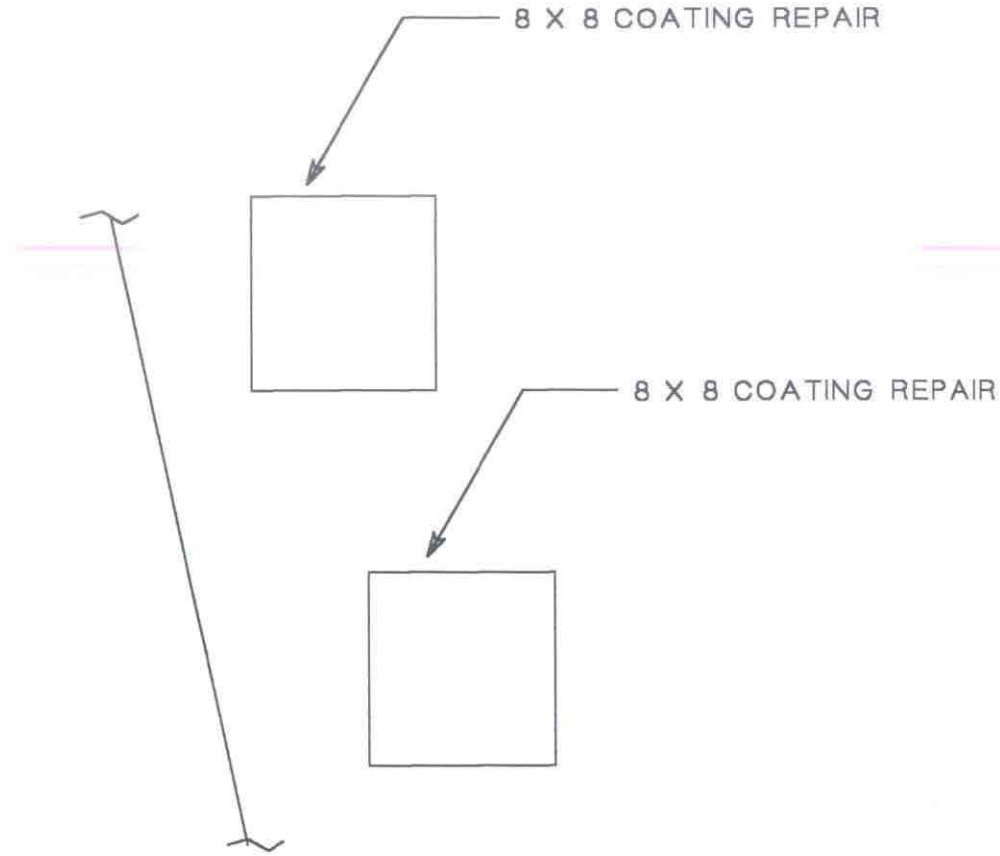
TYPE 8 REPAIR

DEFECT INSPECTED BY TK & JF 7/1/98

Repair Acceptable: John Zickell Date Accepted: 4-13-98
