FINAL 2011 BIENNIAL INTEGRITY TESTING REPORT OF BULK FIELD CONSTRUCTED UNDERGROUND STORAGE TANK 15

JOINT BASE PEARL HARBOR – HICKAM / RED HILL, HAWAII

Date:
8 APRIL 2011

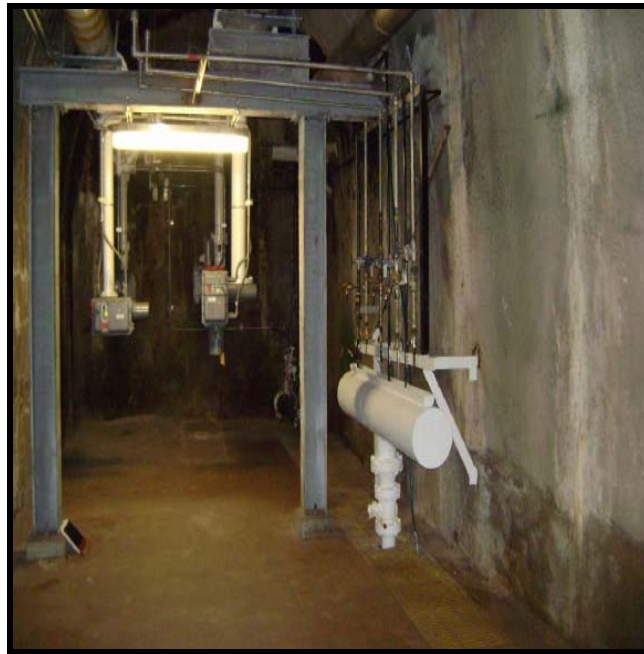
Figure 1-2: Typical Tank Bottom Access

BFCUST 15 is 100 feet in diameter, 250 feet in height and has a capacity of 12,600,000 gallons of F-76. The BFCUSTs at Red Hill are constructed within Red Hill and are accessible through an underground tunnel system. The top tunnel is located approximately 60 feet below the top section of the tank. The bottom tunnel is located at the same elevation as the tank's base. The issue / receipt and water drain pipelines are adjacent to the tank and immediately accessible from within the lower tunnel.

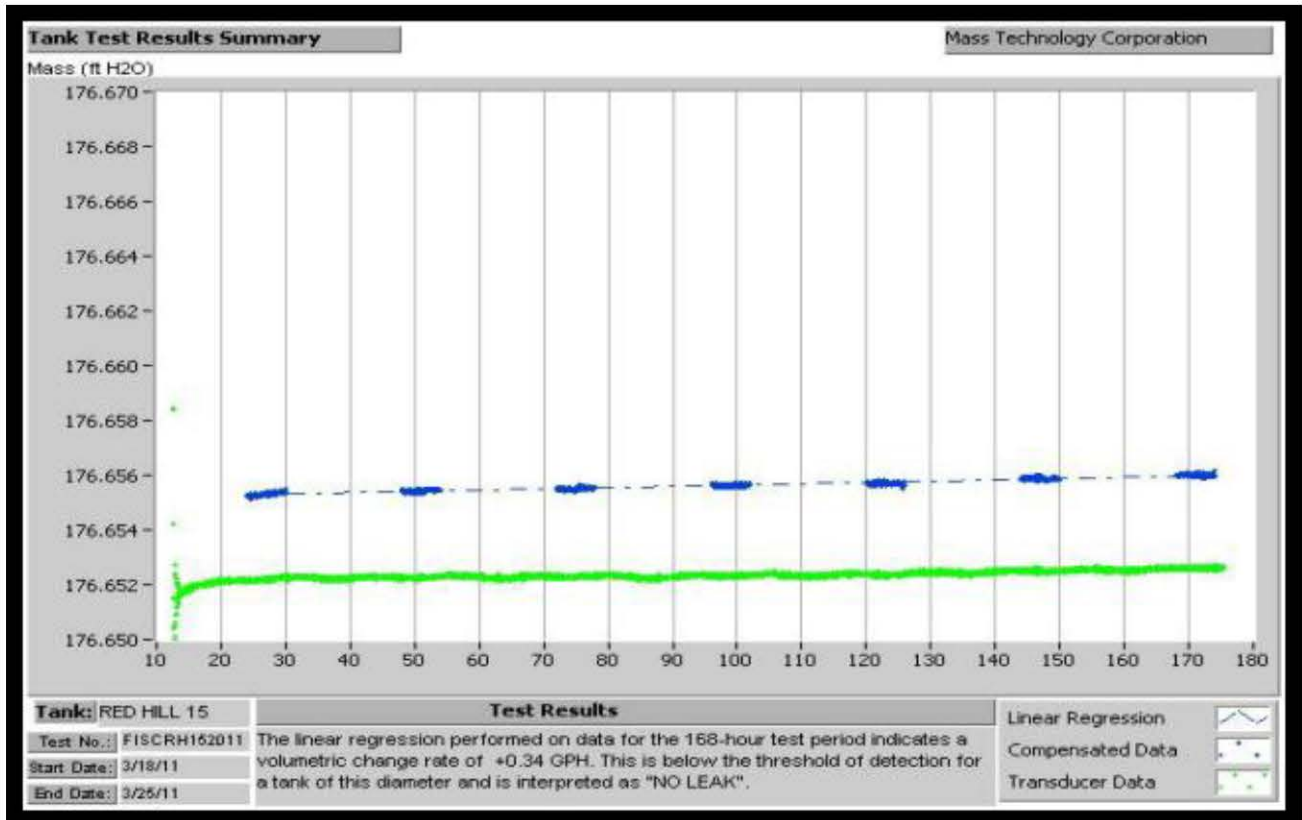
The fluid mass data was recorded over a 168-hour period. A linear regression of the recorded fluid mass data resulted in a leak rate detected below the minimum detection level of 0.7 gallons per hour. All tank valves were adequately secured such that any fluid loss was isolated to leakage. Therefore, the containment integrity of the tank was not compromised and the test is considered conclusive.

Tank # 15 is certified to be tight.
