# FINAL- 2009 - BIENNIAL TANK INTEGRITY TESTING REPORT (CDRL A001) – BFCUST #13

## FISC RED HILL / PEARL HARBOR, HI

**FINAL 2009 BIENNIAL INTEGRITY TESTING REPORT**  
**(CDRL A001)**  
**OF**  
**BFCUST #13**

**FISC RED HILL – PEARL HARBOR, HI**

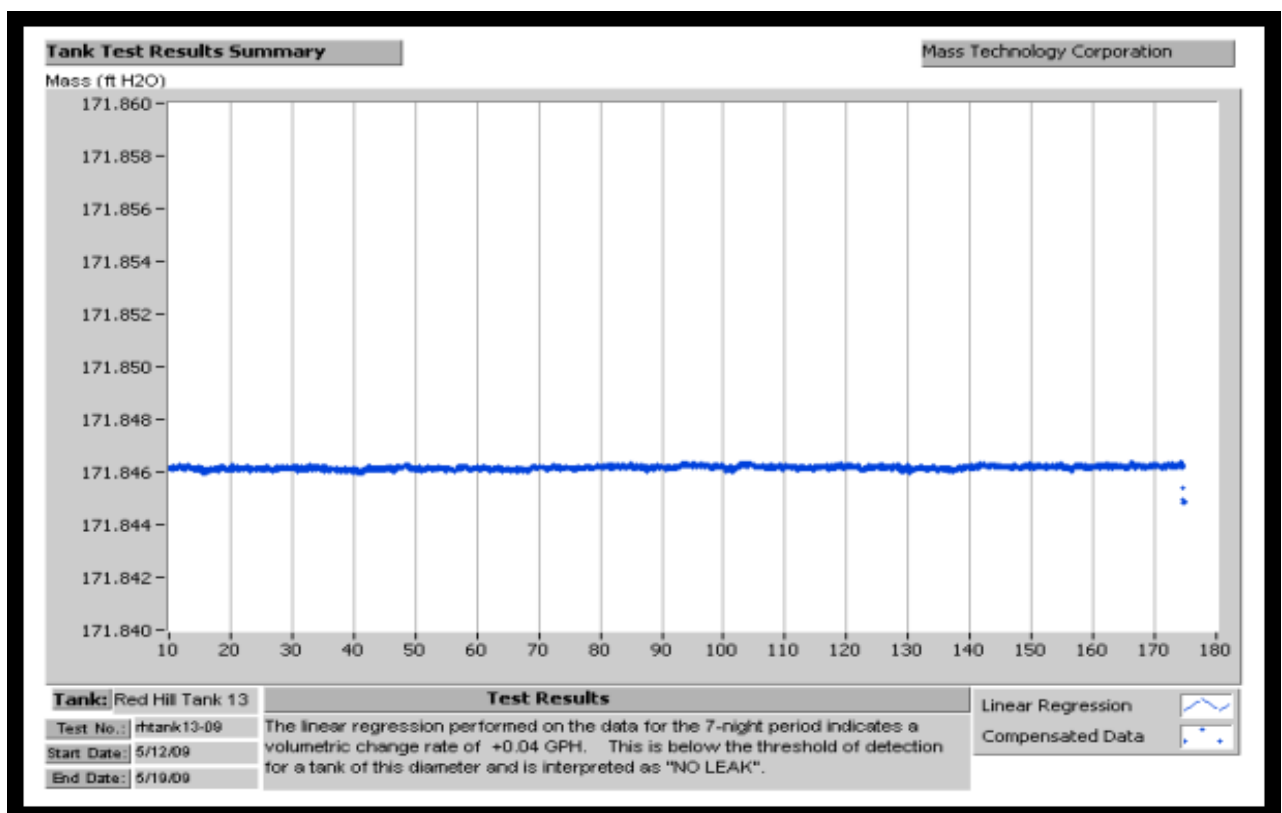
The fluid mass data was recorded over a 168-hour period. A linear regression of the recorded fluid mass data resulted in a leak rate detected below the minimum detection level of 0.7 gallons per hour. All tank valves were adequately secured such that any fluid loss was isolated to leakage. Therefore, the containment integrity of the tank was not compromised and the test is considered conclusive.

Tank # 13 is certified to be tight.
