**Consolidated Construction Projects For FISC, Pearl Harbor, Hawaii  
Contract No. N62742-C-02-1402  
Clean And Repair Tanks 1 And 15, 6 And 16  
Weld Repair As Built Record**

**Tank 15**

**Quadrant A, B, D, Tank Floor, and Lower Dome  
Weld Repairs Completed June 2005  
Reference TESTEX Report Dated 2-18-2005  
And Government Provided Repair Procedure Spreadsheet**

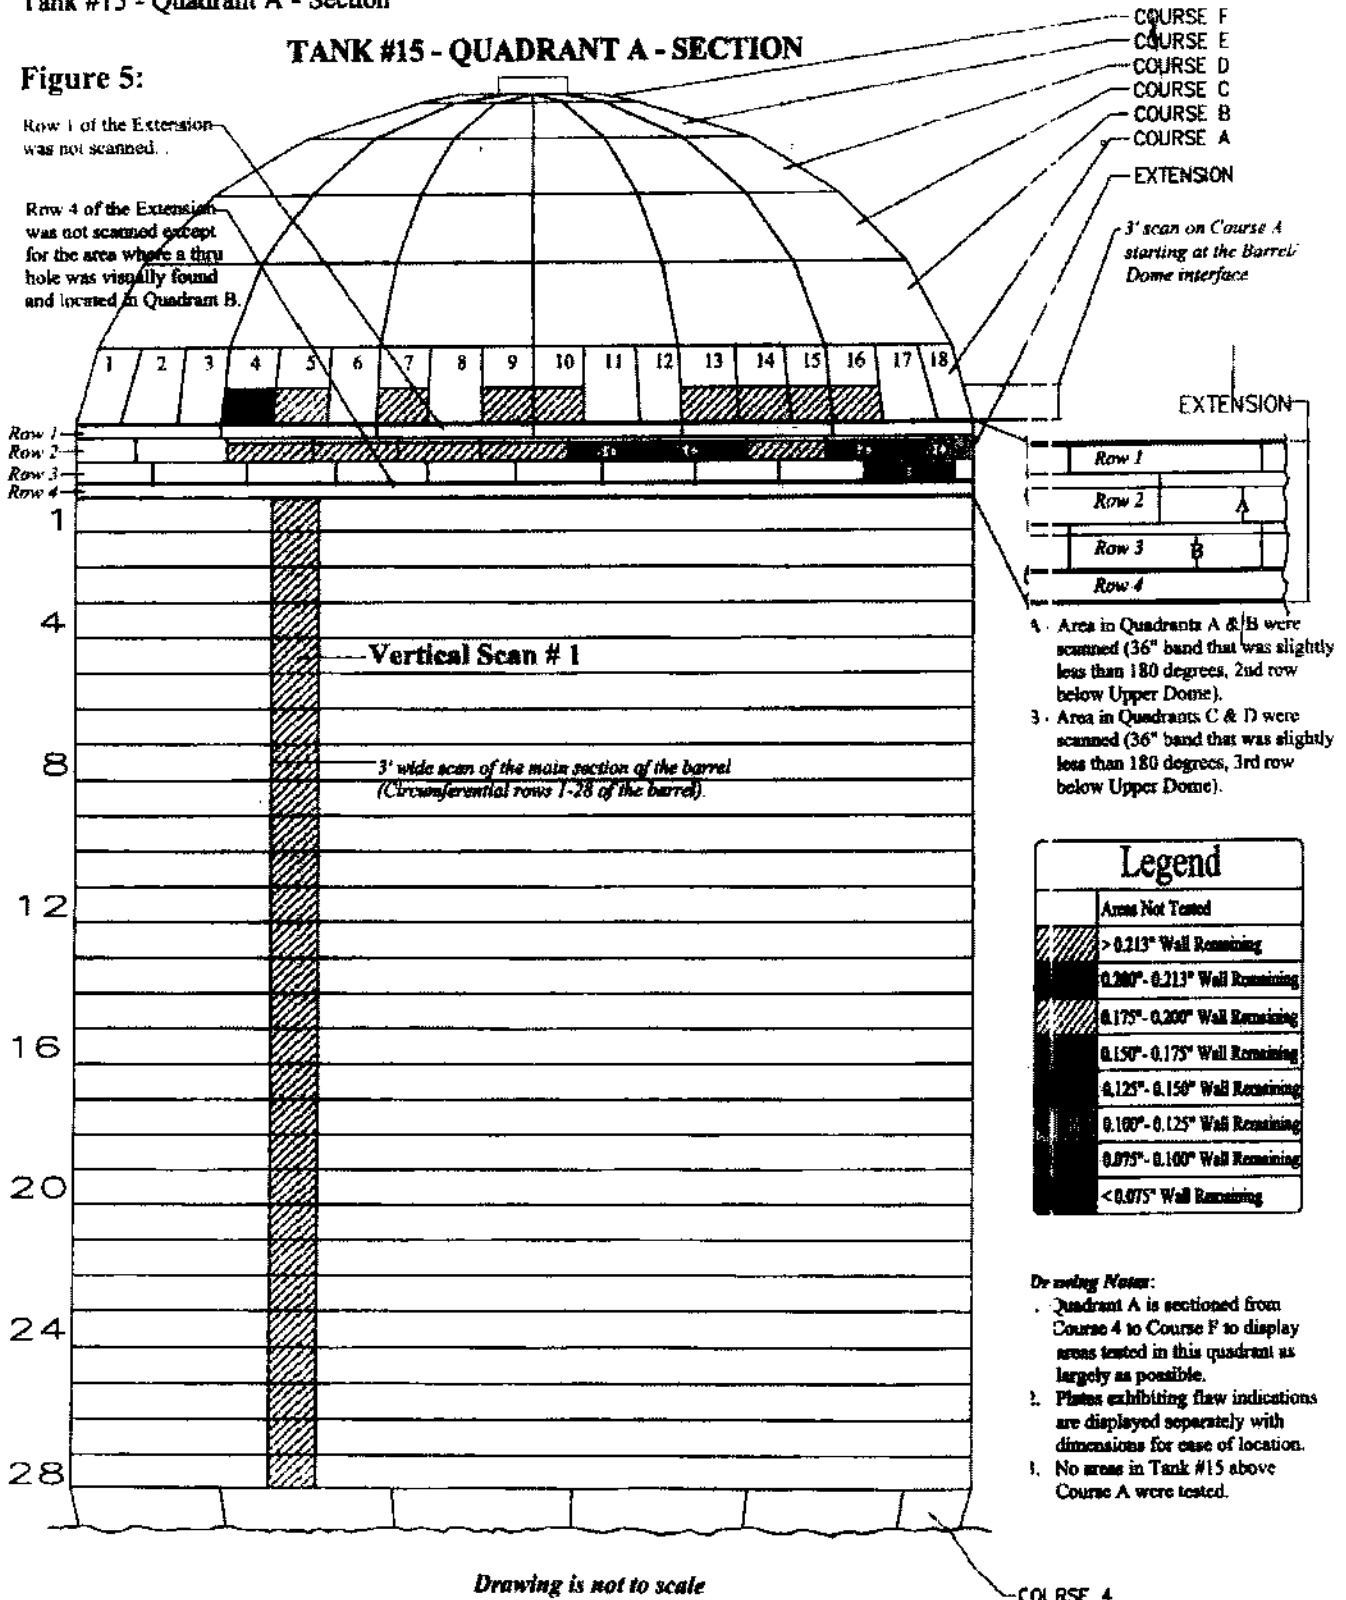
Figure 5:

TANK #15 - QUADRANT A - SECTION

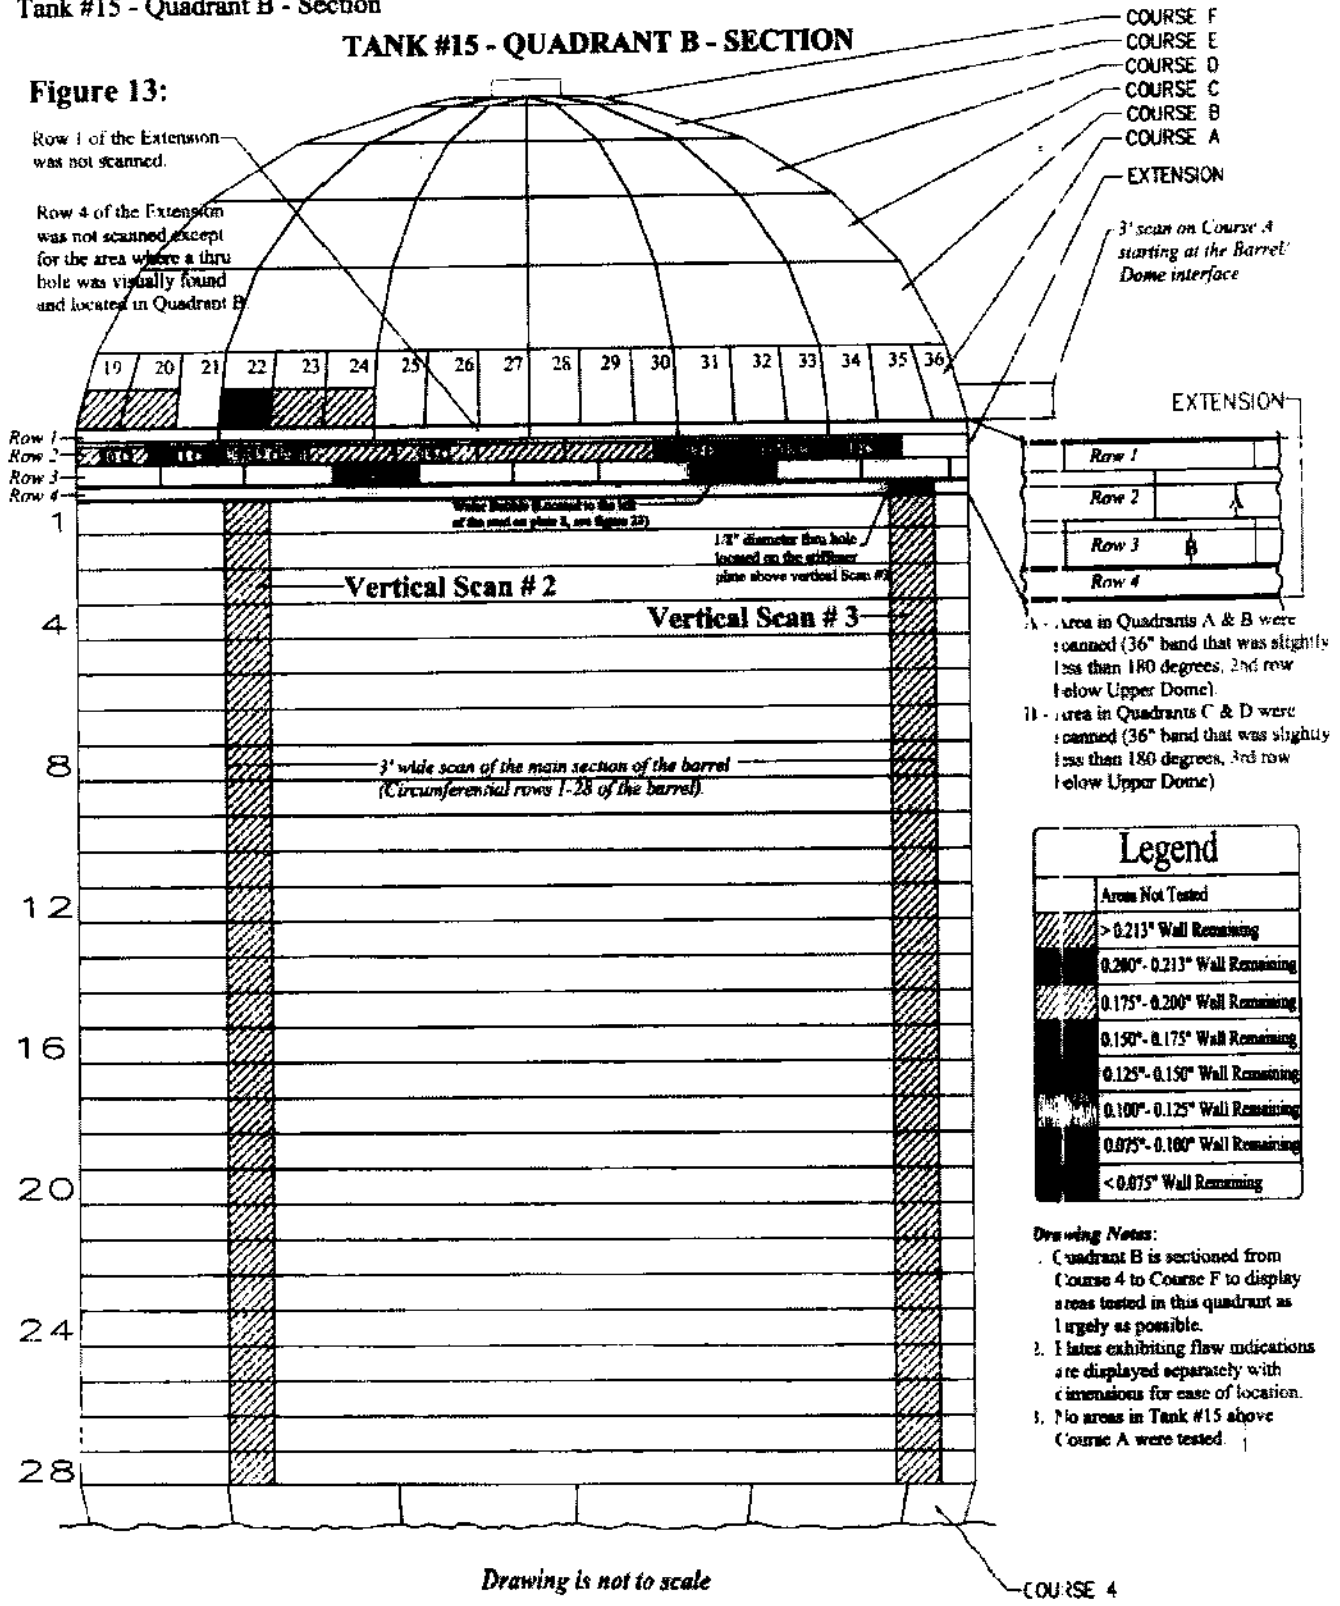
**Figure 13:**

**TANK #15 - QUADRANT B - SECTION**

Row 1 of the Extension was not scanned.

Row 4 of the Extension was not scanned except for the area where a thru hole was visually found and located in Quadrant B.

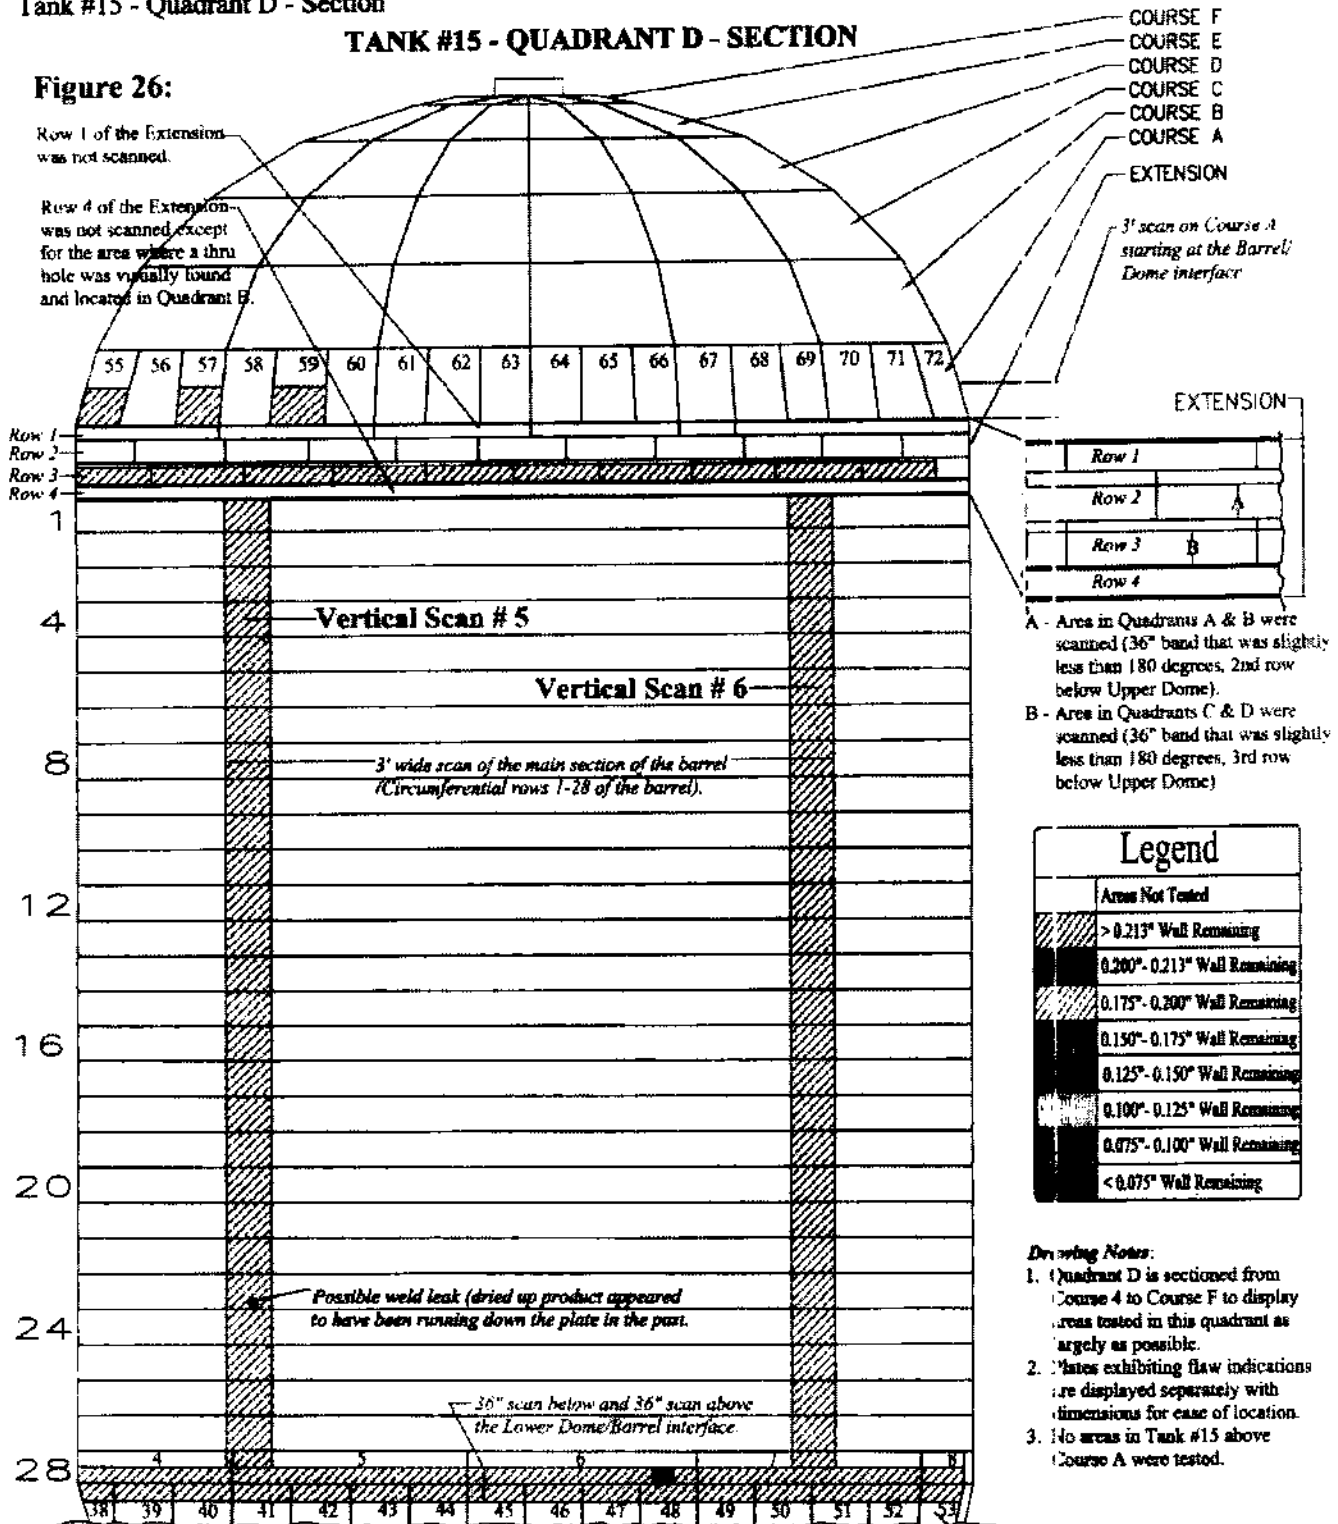
**Figure 26:**

**TANK #15 - QUADRANT D - SECTION**

A - Area in Quadrants A & B were scanned (36° band that was slightly less than 180 degrees, 2nd row below Upper Dome).  
 B - Area in Quadrants C & D were scanned (36° band that was slightly less than 180 degrees, 3rd row below Upper Dome)

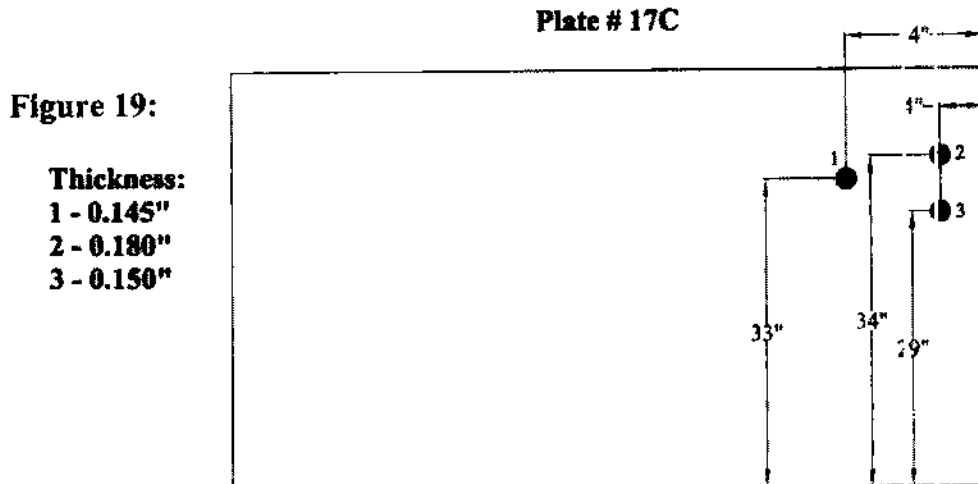
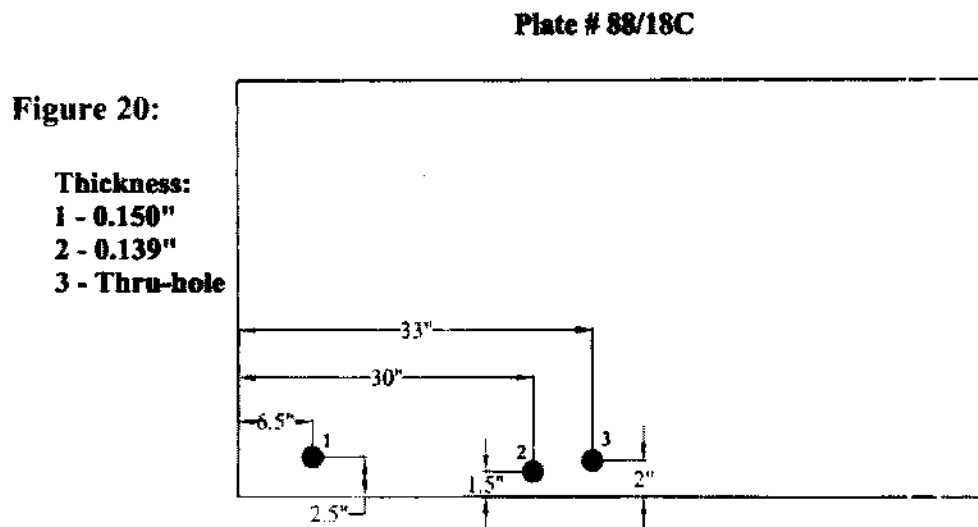
**TANK #15 - QUADRANT B FLAWS 14-19**

Upper Barrel between Dome & Stiffening Ring (Row 2 below Upper dome on Barrel)

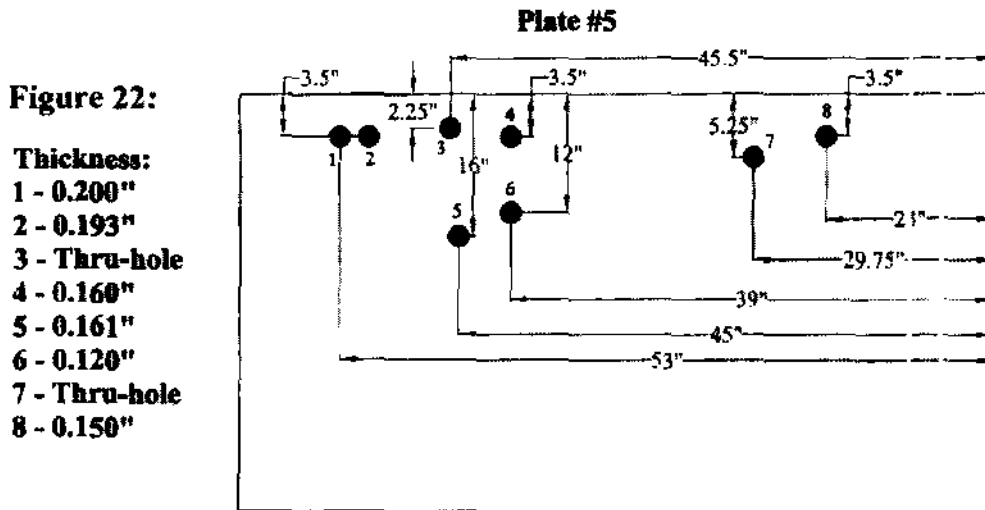
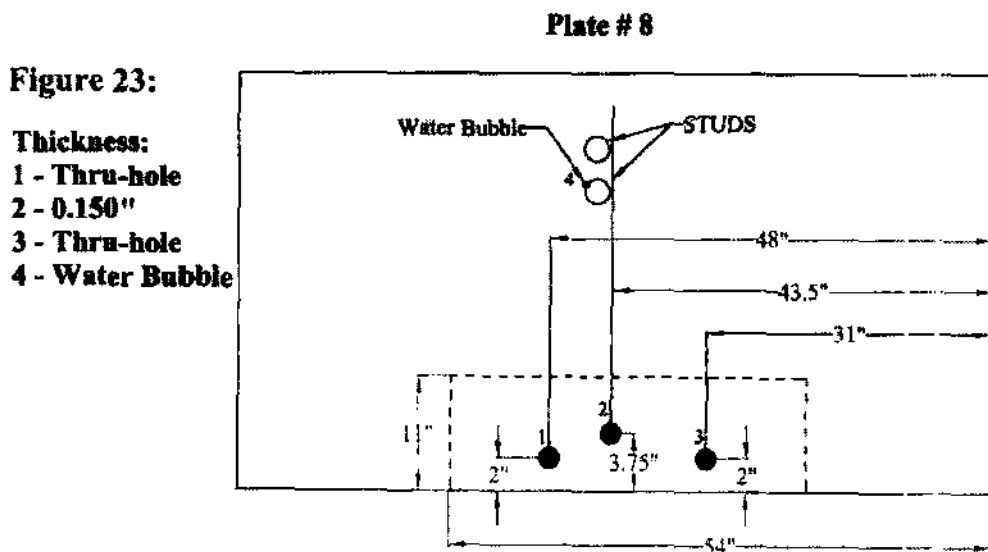
**TANK #15 - QUADRANT B FLAWS 26-37**

Upper Barrel between Dome & Stiffening Ring (Row 3 below Upper dome on Barrel)

Tank 15  
Quadrant B  
Extension Course Row 3  
Plate 5  
Reference TESTEX Report 2-18-2005 Page 20 Figure 22  
Repair # 15-042 to 15-046, Flaw No. B26-B33

Tank 15  
Quadrant B  
Extension Course Row 3  
Plate 8  
Reference TESTEX Report 2-18-2005 Page 20 Figure 23  
Repair # 15-047 to 15-049, Flaw No. B34-B37
