2.1 Mid Atlantic Environmental, Inc. conducted an inspection on Tank #8 at the Red Hill Underground Storage Facility, Pearl Harbor, Hawaii. This inspection was conducted in accordance with the scope of work identified by Contract Number N00604-97-R-0013, PRL 96-21, titled "Emergency Repair for Red Hill Tanks."

RED HILL TANK NO. 8
PRODUCT: DFM

OI		TK	
LTR	DESCRIPTION	BY	DATE
REVISIONS			
MID ATLANTIC ENVIRONMENTAL			
EMERGENCY REPAIRS FOR RED HILL TANKS			
Tank #8			
Floor Layout		File: 8fillo	
Tank bottom			
Drawn By: T. Kitchen		Date: 7/20/98

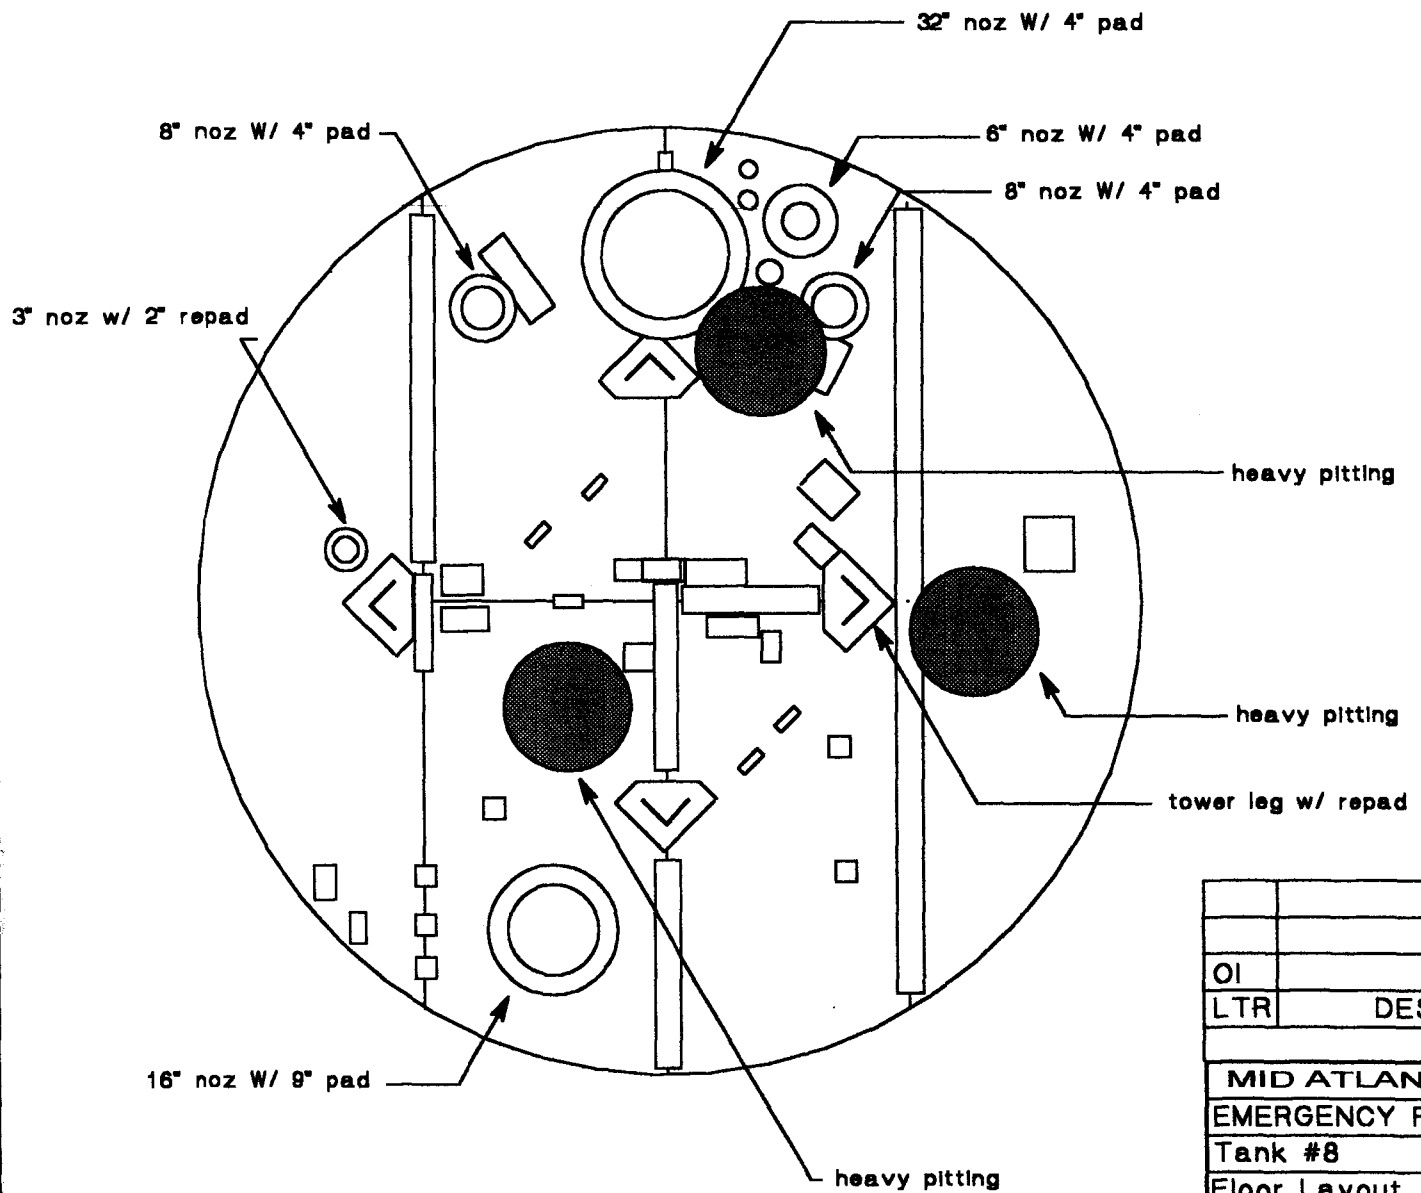
Drawing Title:
Bottom Layout & Thickness Measurements

7.2.1 The original bottom thickness was determined to be 0.500 inches and the first ascending plate to be 0.250 inches. The ultrasonic thickness measurements taken determined that backside corrosion in this area is not a problem. Pitting on the bottom plates is widespread and the enclosed drawing shows that many patch plates had been added in the past. Although pitting is widespread it is not a problem since the remaining metal thickness is well within the 0.10 inches of metal required by API Standard 653 by the next inspection. Also the coating to be applied to the tank bottom should prevent any increase in pit depth. Although pitting is not a problem with regard to structural integrity, it did present a problem regarding the coating to be applied. Pictures of this pitting are included with this report. The surface contamination test results yielded 0% ferrous salts, 32 ppm NaCl and a pH level of 7. These results are within the limits set forth in the KTA SCAN Kit technical data and the NACE technical committee report on Surface Preparation of Contaminated Steel Surfaces. The Caustic Soda test of the tank bottom indicated that all Flame Sprayed Aluminum had been removed. By visual inspection, scattered pitting was observed on the tank bottom and first ascending plates. The deeper pits were measured and recorded on the Bottom Layout With Pit Indications drawing.

Remarks/Legend: Pitting was general over 30% of bottom
