MID ATLANTIC ENVIRONMENTAL	
EMERGENCY REPAIRS FOR RED HILL TANKS	
Tank #8 RECOMMENDED REPAIR DRAWING	
Repair No.: 014	File: 8r014
LOWER DOME	Quadrant: B
Course: 3	PLATE: 10
Drawn by: Tom Kitchen	Date: 5/4/98

Dames & Moore
Emergency Repairs For Red Hill Tanks at the Fleet Industrial & Supply Center
Contract No. N62742-96-C-1356

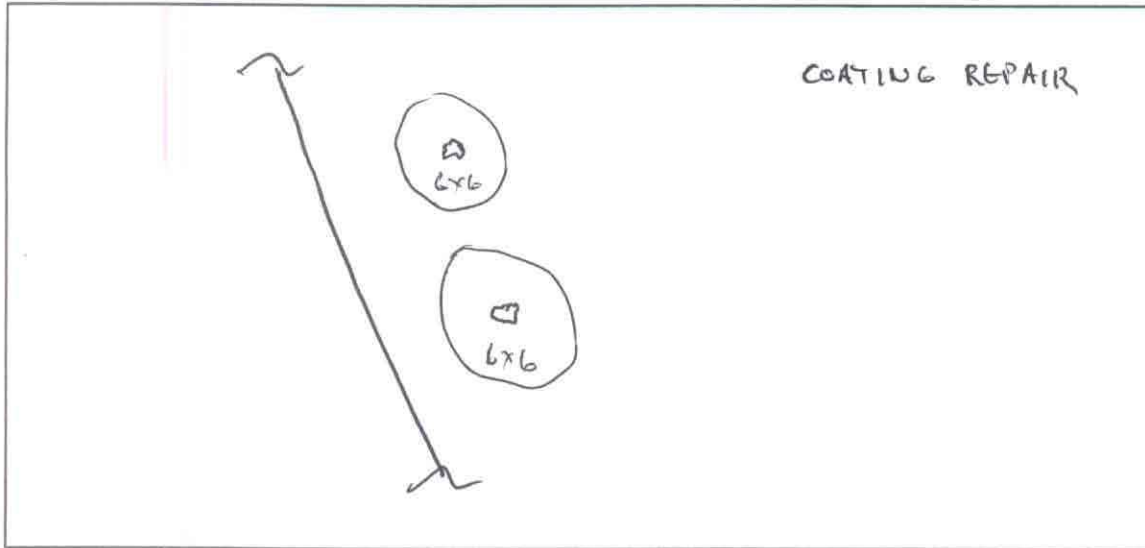
Tank No.: 8 Repair No.: ADD 015 Type: 8 Location: B10-3

TYPE 8 REPAIR

DEFECT INSPECTED BY TK & JF 3/16/98

Repair Acceptable: John Zebell Date Accepted: 4-13-98

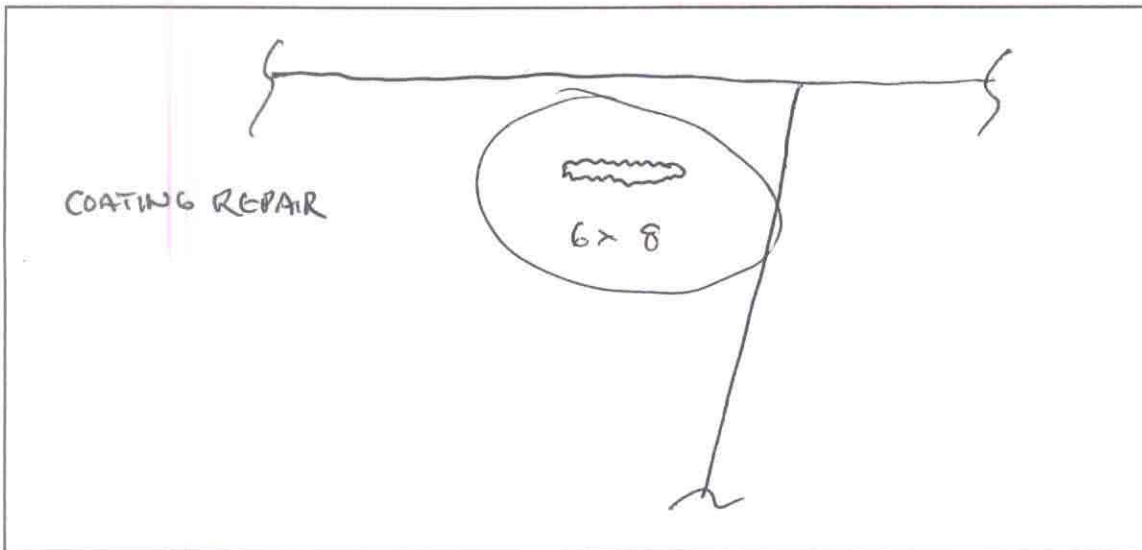
Tank No.: 8 Repair No.: ADD 017 Type: 8 Location: 88-3

TYPE 8 REPAIR

DEFECT INSPECTED BY TK & JF 3/16/98

Repair Acceptable: John Zicknell Date Accepted: 4-13-98

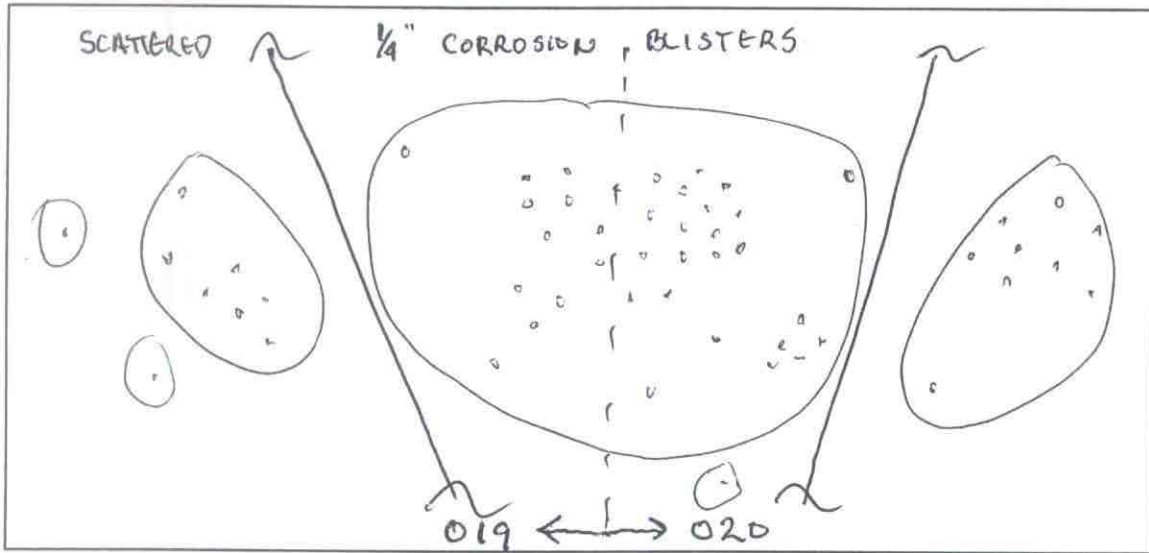
Tank No.: 8 Repair No.: ADD 019 Type: 8 Location: B11-2
~~019~~

TYPE 8 REPAIR

Repair Acceptable: John Zahrell Date Accepted: 4-13-98

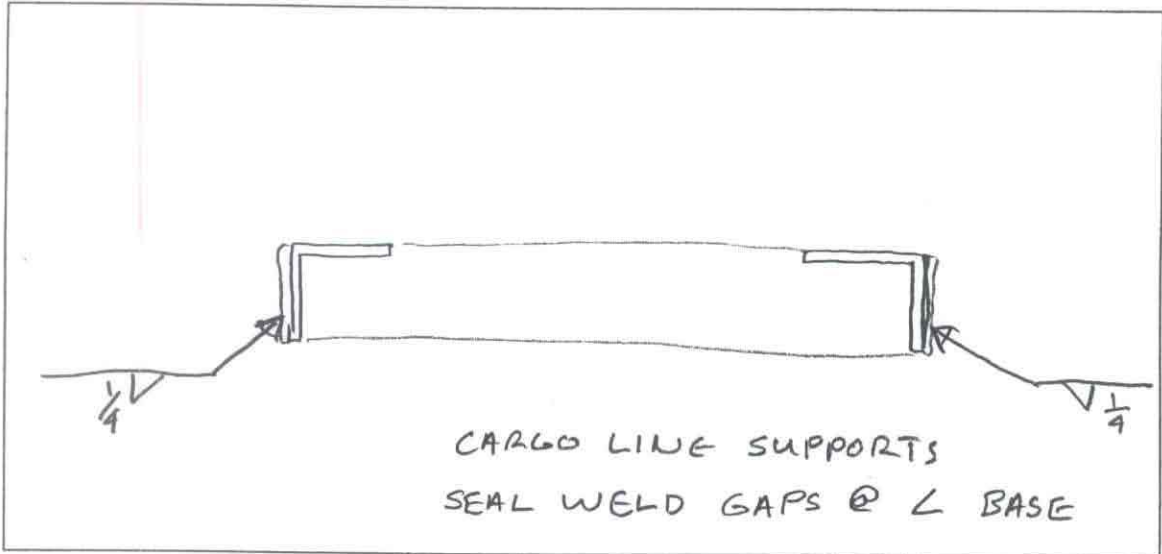
Tank No.: 8 Repair No.: 022 Type: 10 Location: B-12-1

TYPE 10 REPAIR

Repair Acceptable: John Barkell
