FINAL 2013 BIENNIAL LEAK DETECTION TESTING REPORT OF BULK FIELD-CONSTRUCTED UNDERGROUND STORAGE TANK 4, RED HILL UNDERGROUND FUEL STORAGE FACILITY

JOINT BASE PEARL HARBOR- HICKAM, HAWAII

**FINAL 2013 BIENNIAL LEAK DETECTION TESTING REPORT
OF BULK FIELD-CONSTRUCTED UNDERGROUND STORAGE TANK 4,
RED HILL UNDERGROUND FUEL STORAGE FACILITY**

Michael Baker Jr., Inc.
TEST REPORT
JB PEARL HARBOR-HICKAM / RED HILL, HAWAII

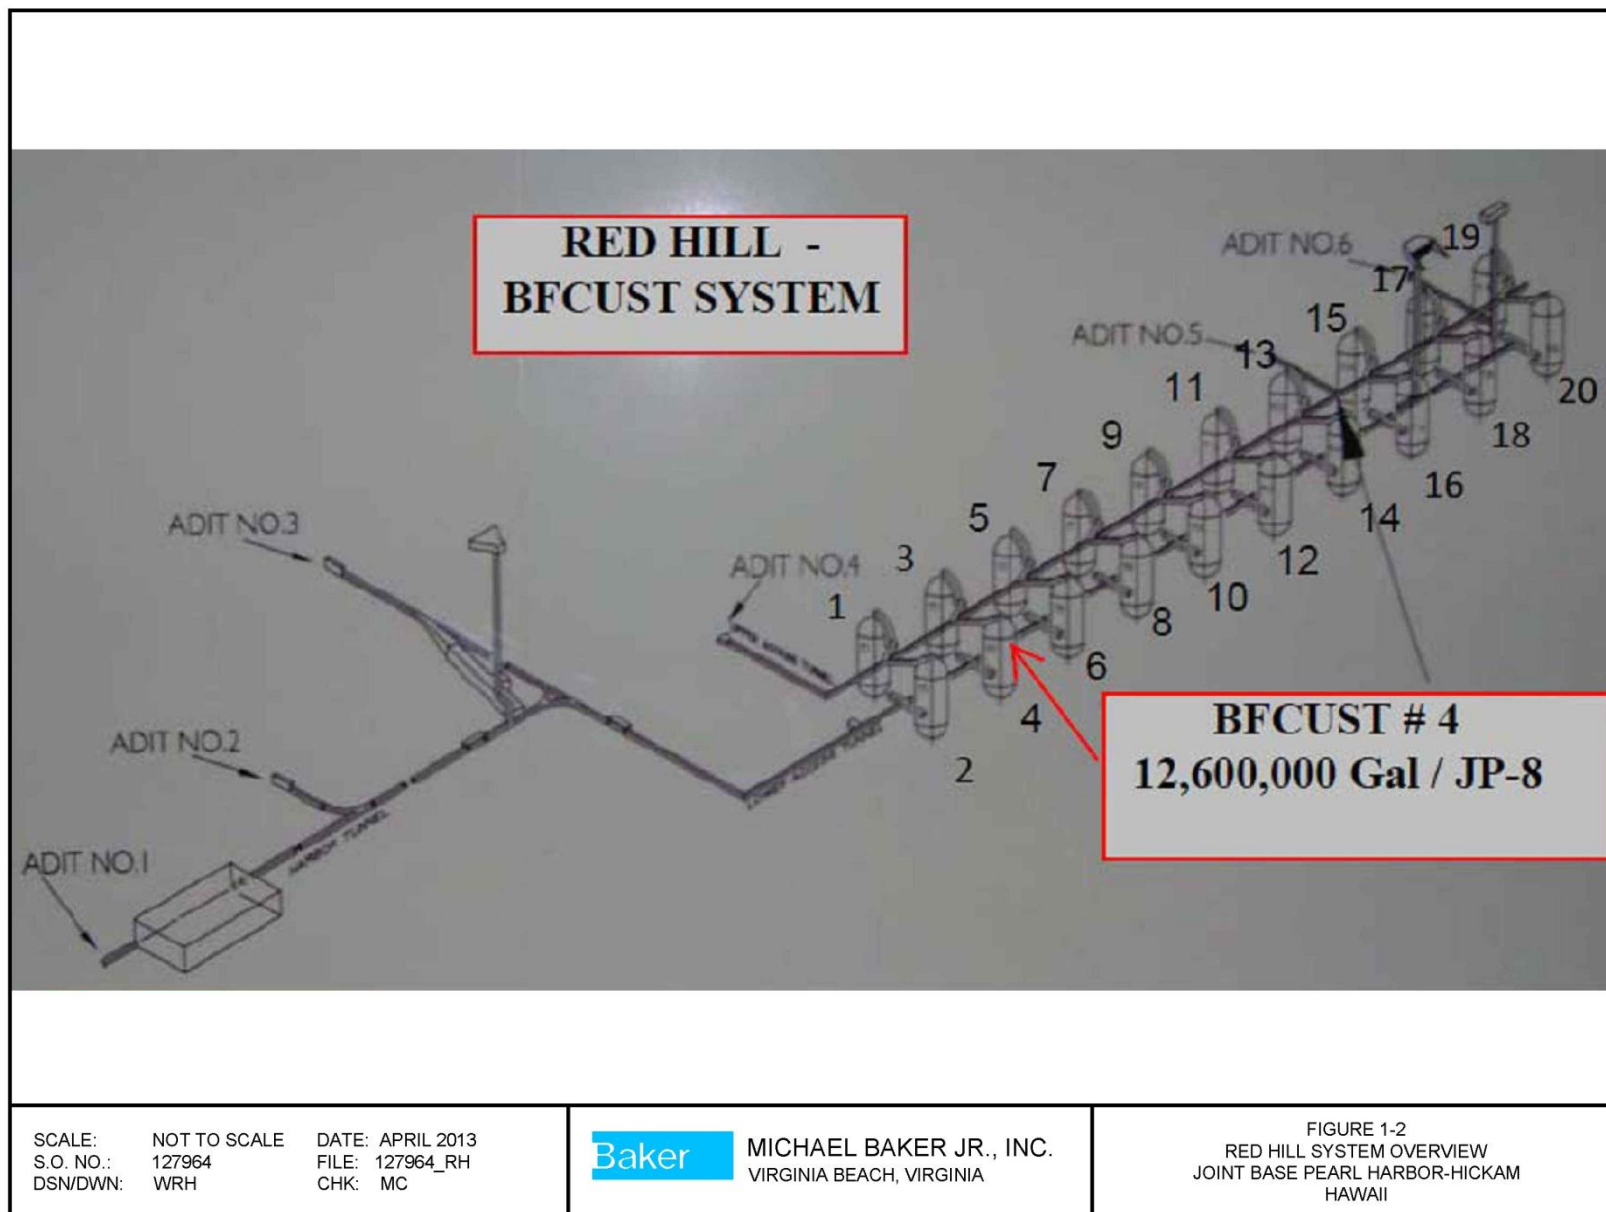
Figure 1-2: Red Hill System Layout

A MTC leak detection test on BFCUST 4 was performed from 29 March through 5 April 2013. Table 1-1 provides a description of the systems tested. Figure 1-1 provides a base overview map. Figure 1-2 provides a layout of the Red Hill system.

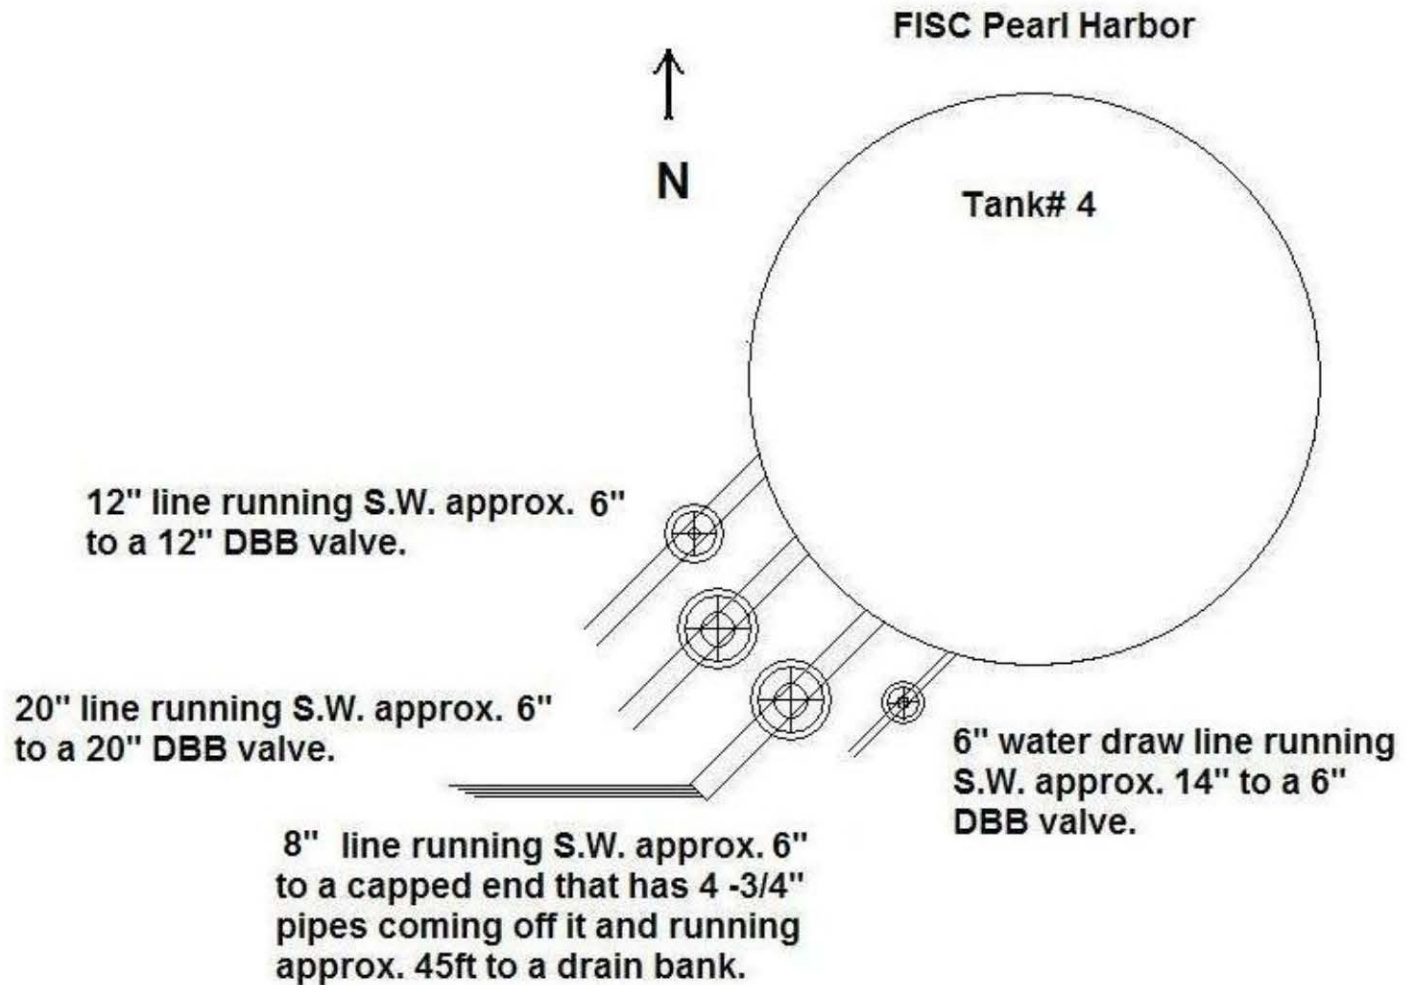
Tank Data Tank # 4

Diameter: 100 ft.
Tank Type: Vertical UST
Specific Gravity: 0.80

Height: 250 ft.
Contents: JP-8
Product Level: 211.08 ft.

All dimensions, line locations, sizes and valve descriptions have been furnished by the facility operator.

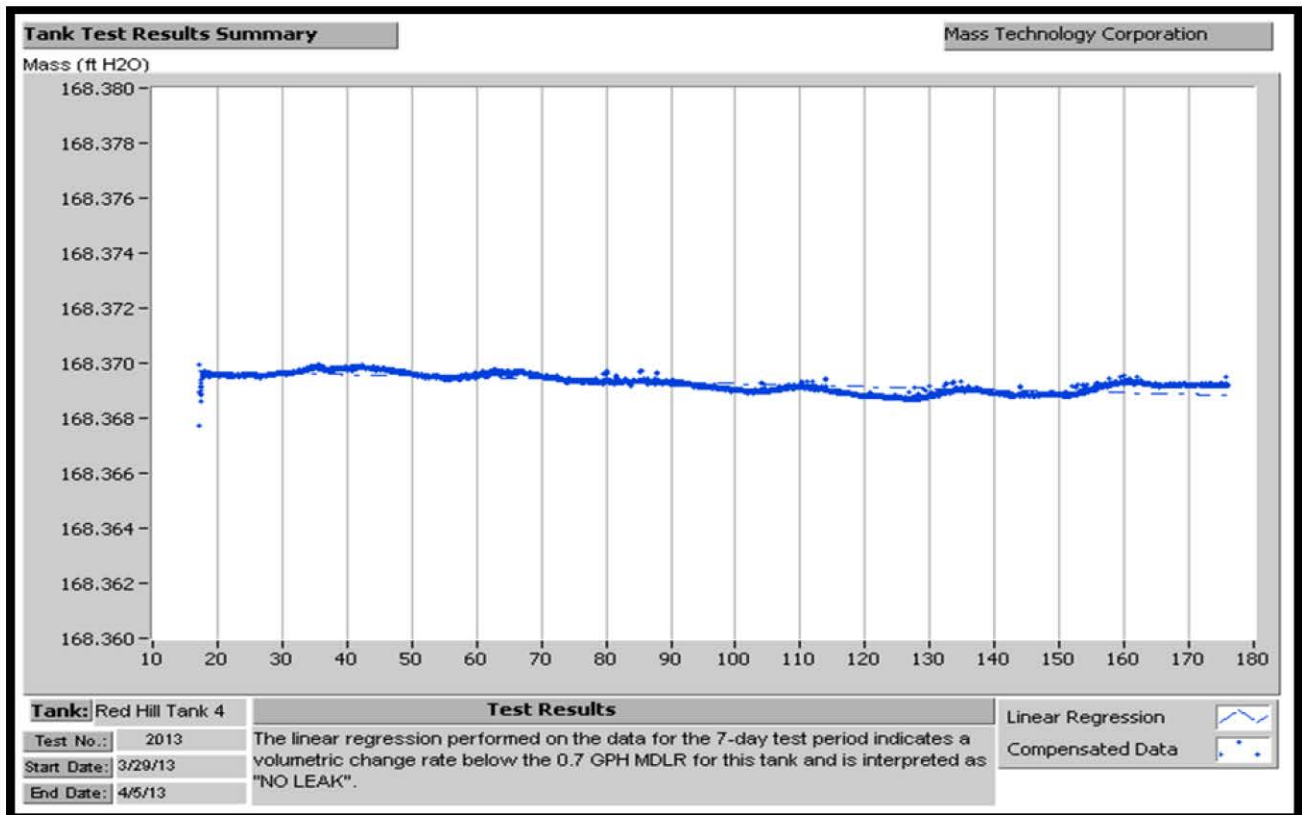
The fluid mass data was recorded over a 168-hour period. A linear regression of the recorded fluid mass data resulted in a leak rate detected below the minimum detection level of 0.7 gallons per hour. All tank valves were adequately secured such that any fluid loss was isolated to leakage. Therefore, the containment integrity of the tank was not compromised and the test is considered conclusive.

Tank # 4 is certified to be tight.
