FINAL 2013 BIENNIAL LEAK DETECTION TESTING REPORT OF BULK FIELD-CONSTRUCTED UNDERGROUND STORAGE TANK 7

JOINT BASE PEARL HARBOR- HICKAM / RED HILL, HAWAII

Date:
13 MARCH 2013

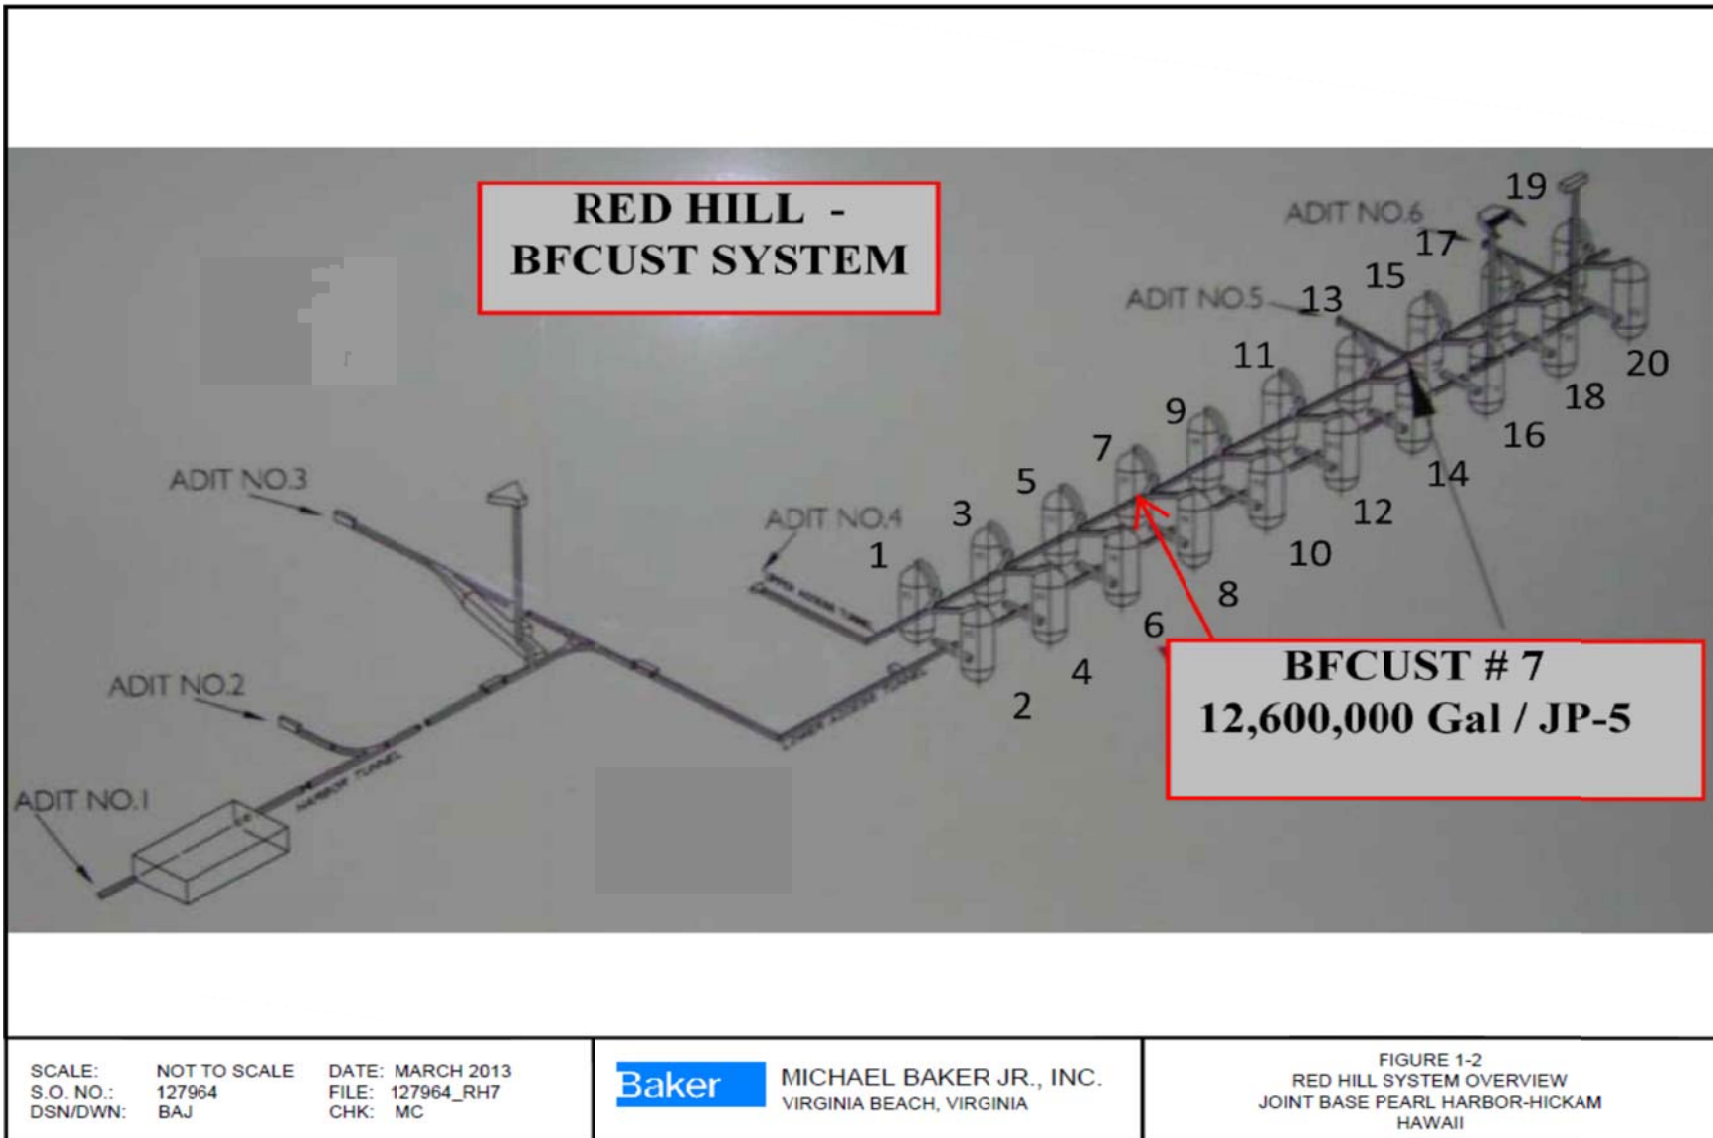
FIGURE 1-2
 RED HILL SYSTEM OVERVIEW
 JOINT BASE PEARL HARBOR-HICKAM
 HAWAII

The Red Hill underground fuel storage facility consists of 20 BFCUSTs located hundreds of feet below ground and was constructed between 1940 and 1943 to replace vulnerable aboveground fuel storage tanks that were located around Pearl Harbor. The BFCUSTs at Red Hill are accessible through a tunnel system. The top tunnel runs approximately 60 feet below the top section of the tanks and the bottom tunnel runs equal to the bottom level of the tanks. The issue/receipt and water drain pipelines are accessible and have isolation valves immediately adjacent to each tank within the lower tunnel. BFCUST 7 is 100 feet in diameter, 250 feet in height, and has a capacity of 12,600,000 gallons of JP-5.

Figure 1-2: Red Hill System Layout
 (Source: Baker, 2009)

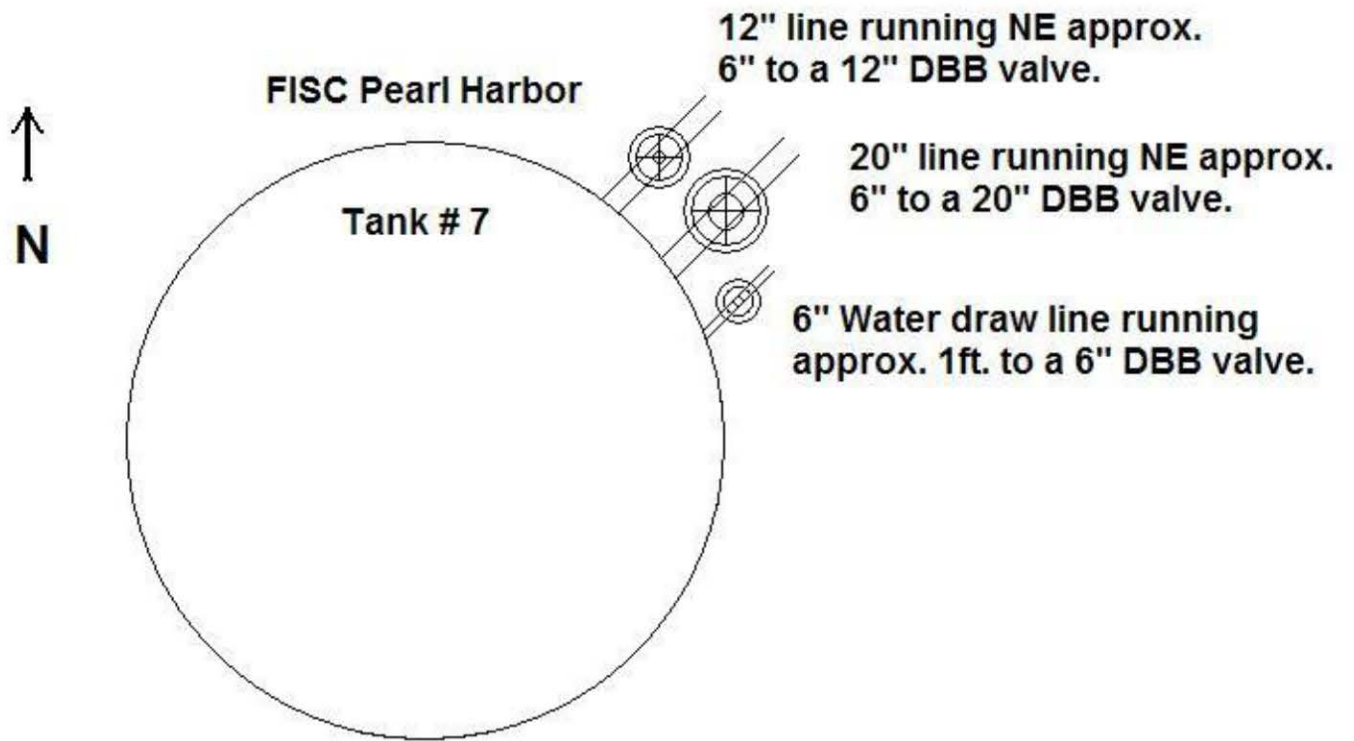
Diameter: 100 ft.
Tank Type: Vertical UST
Specific Gravity: 0.82

Height: 250 ft.
Contents: JP-5
Product Level: 211.8 ft.

All dimensions, line locations, sizes and valve descriptions have been furnished by the facility operator.

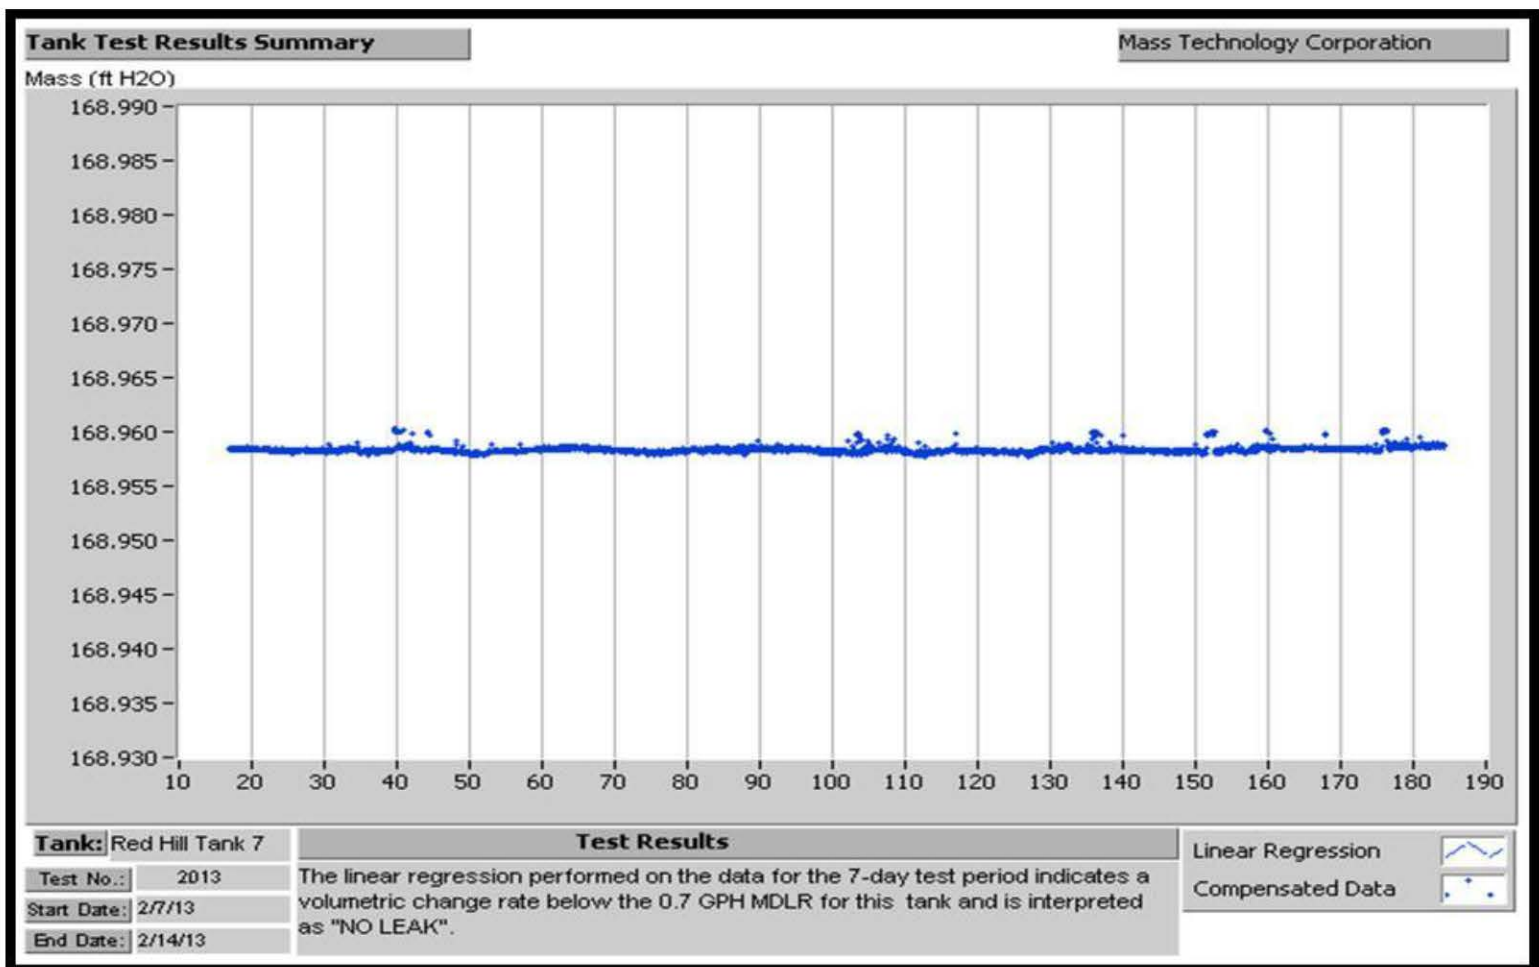
The fluid mass data was recorded over a 168-hour period. A linear regression of the recorded fluid mass data resulted in a leak rate detected below the minimum detection level of 0.7 gallons per hour. All tank valves were adequately secured such that any fluid loss was isolated to leakage. Therefore, the containment integrity of the tank was not compromised and the test is considered conclusive.

Tank # 7 is certified to be tight.
