FINAL 2013 BIENNIAL LEAK DETECTION TESTING REPORT OF BULK FIELD-CONSTRUCTED UNDERGROUND STORAGE TANK 8

JOINT BASE PEARL HARBOR- HICKAM / RED HILL, HAWAII

Date:
13 MARCH 2013

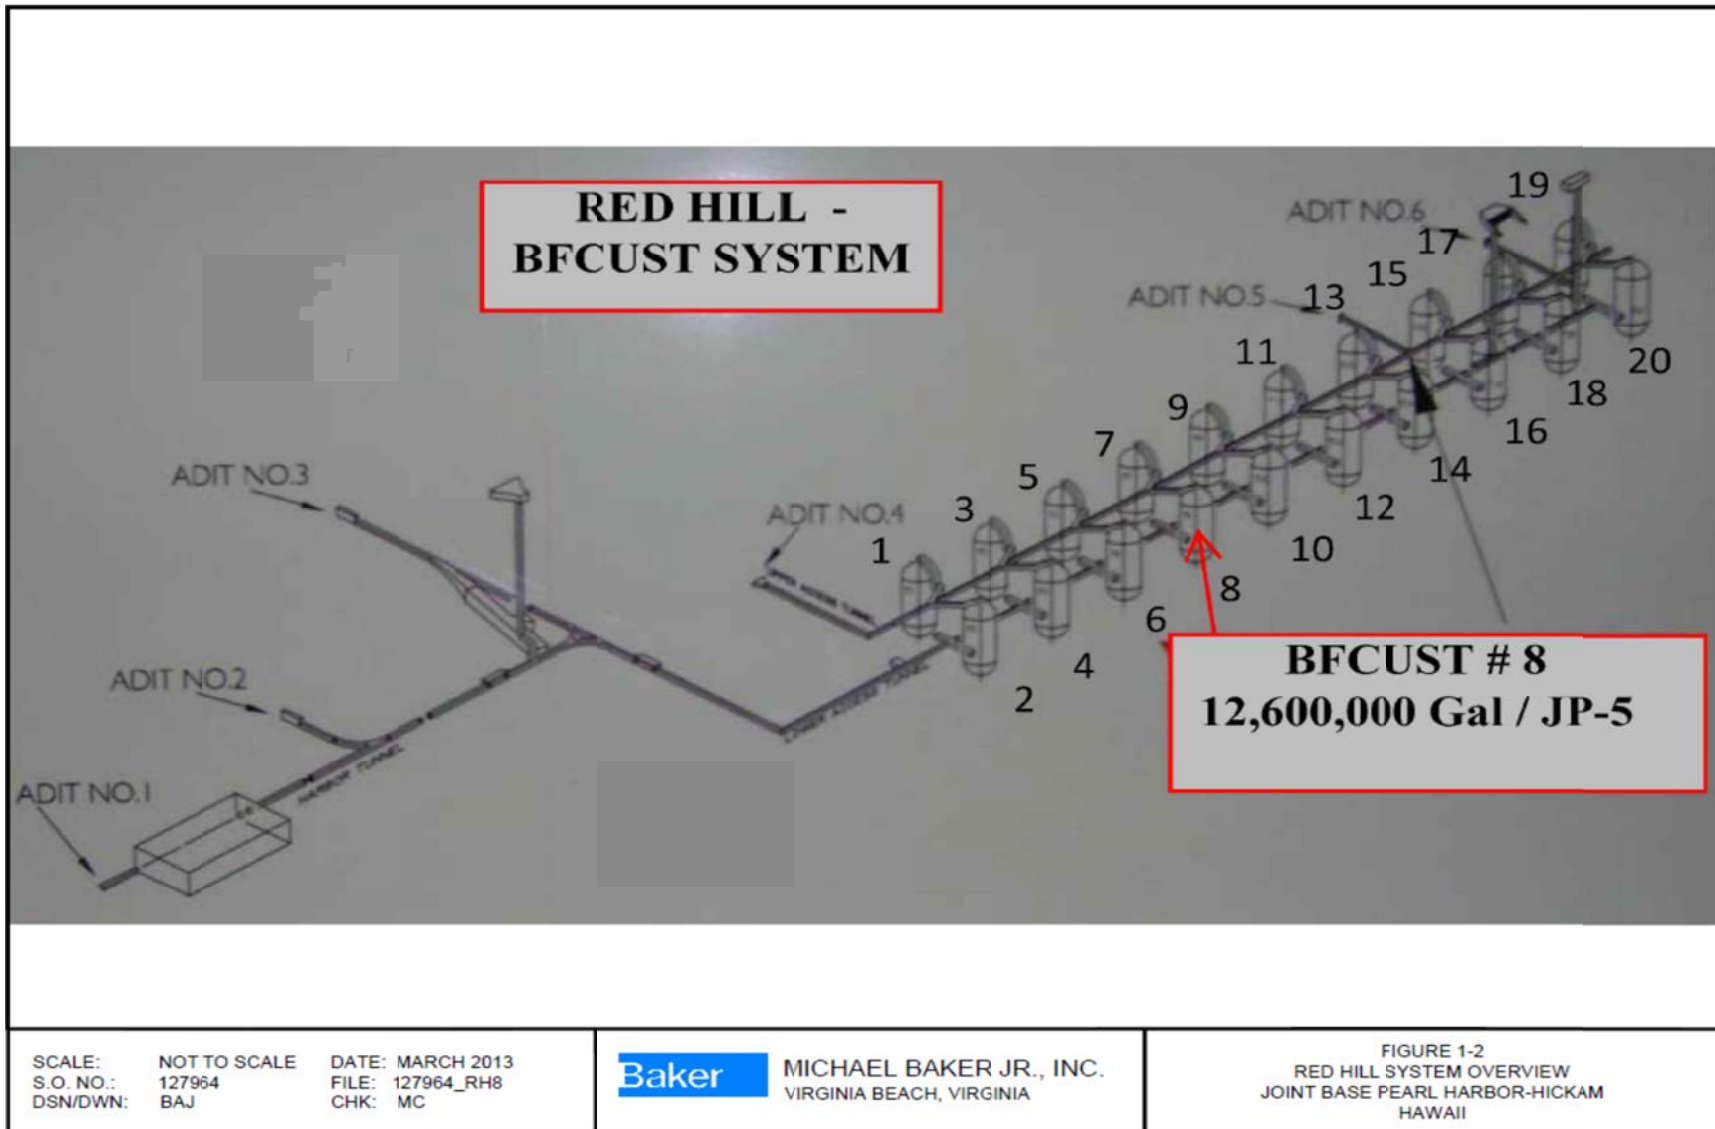
Figure 1-2: Red Hill System Layout
 (Source: Baker, 2009)

A MTC leak detection test on BFCUST 8 was performed from 6 February through 13 February 2013. Table 1-1 provides a description of the system tested. Figure 1-1 provides a base overview map. Figure 1-2 provides a layout of the Red Hill system.

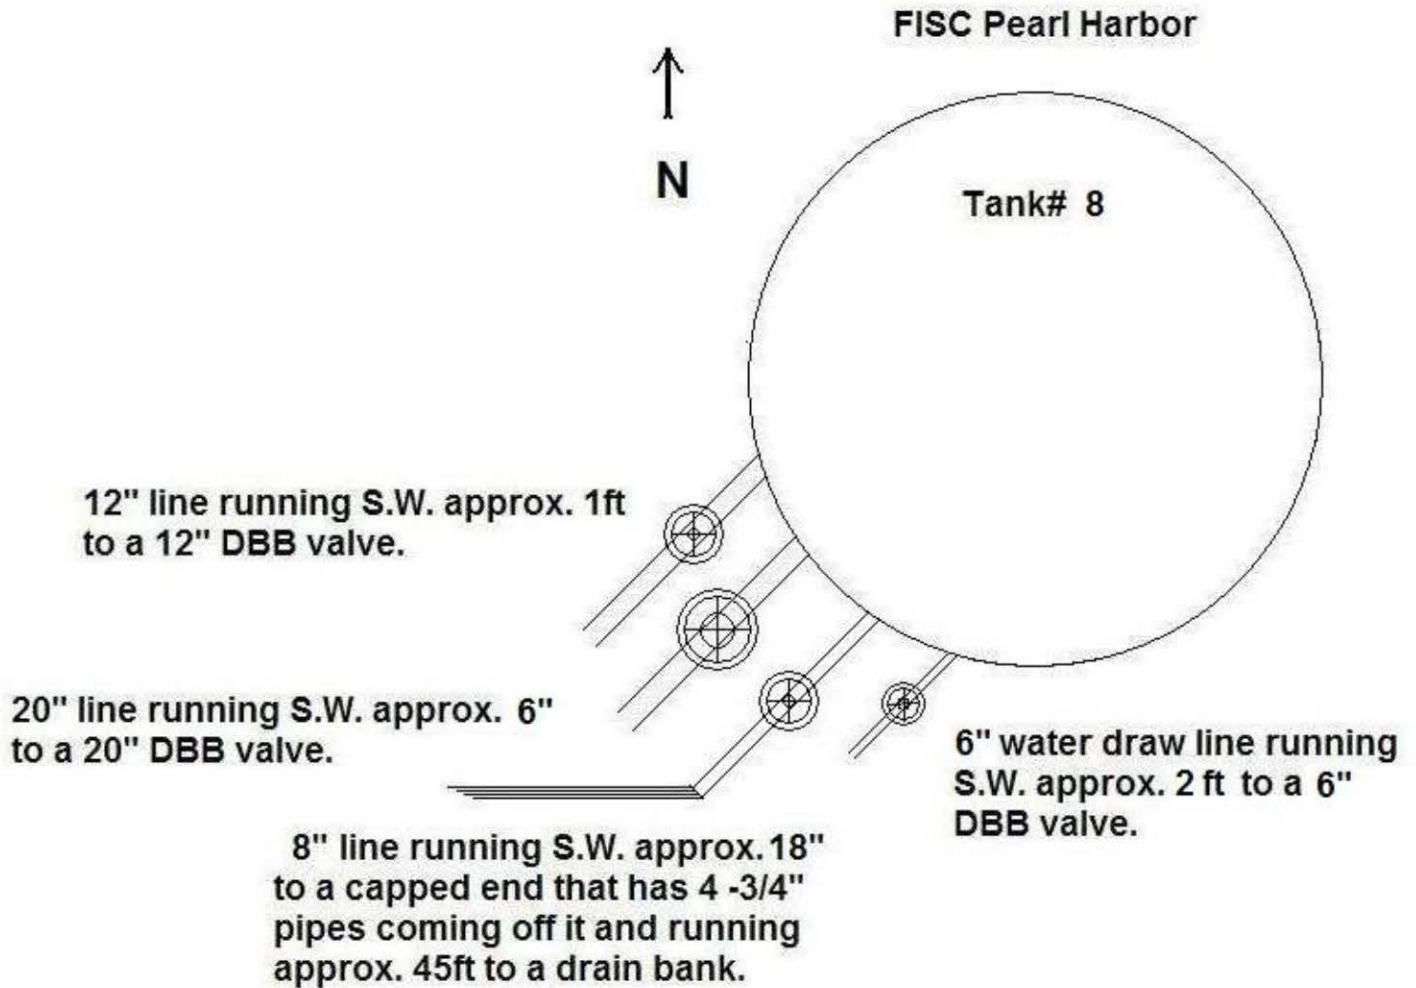
All dimensions, line locations, sizes and valve descriptions have been furnished by the facility operator.

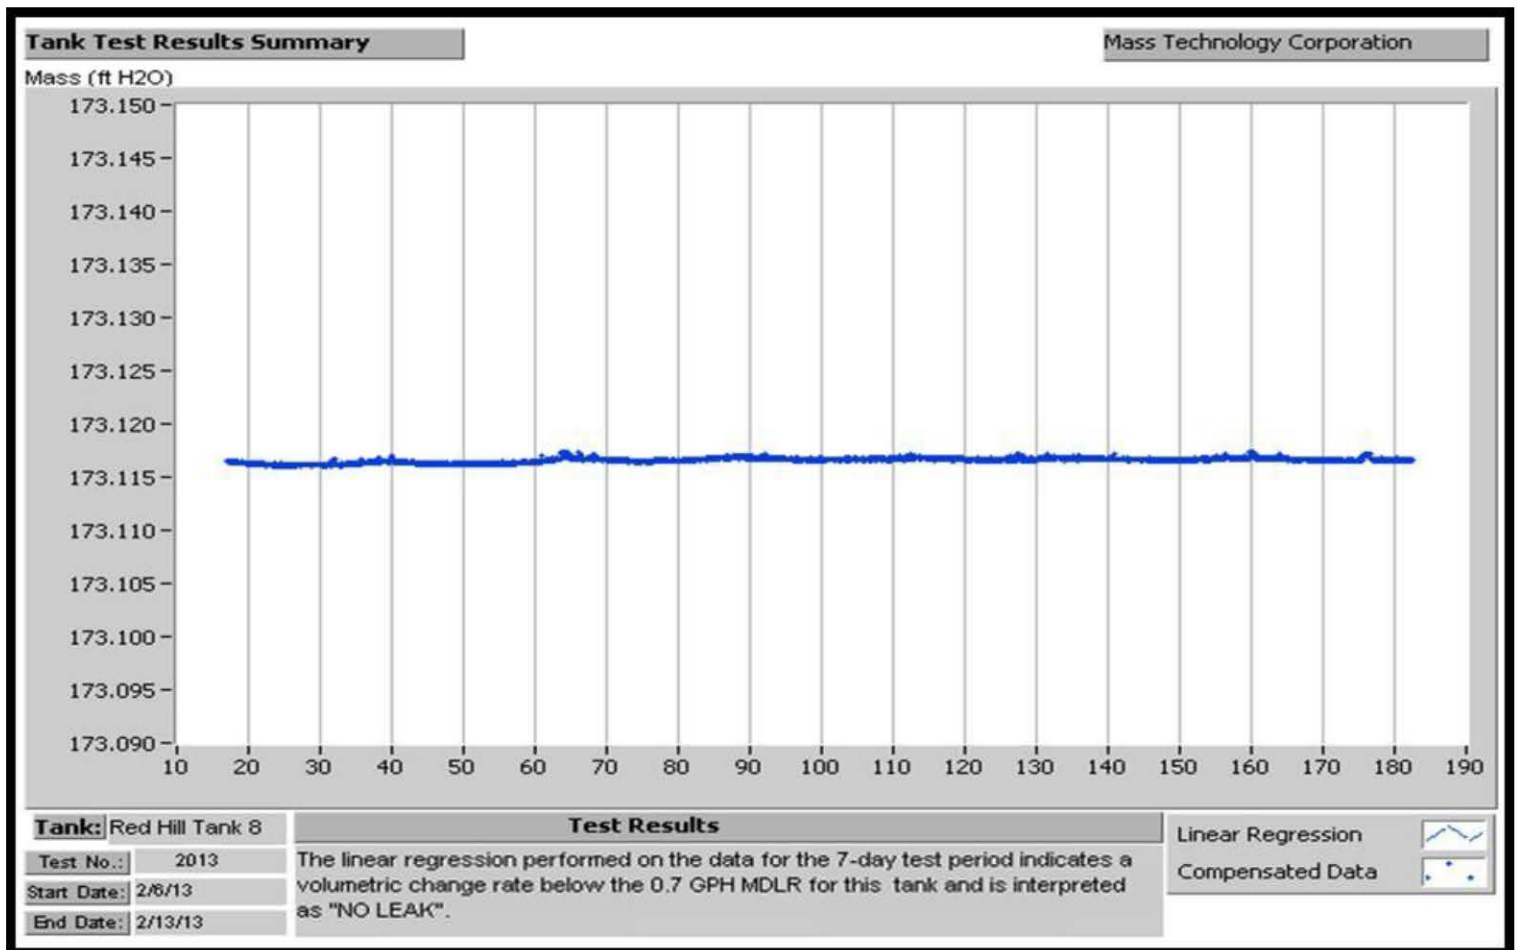
The fluid mass data was recorded over a 168-hour period. A linear regression of the recorded fluid mass data resulted in a leak rate detected below the minimum detection level of 0.7 gallons per hour. All tank valves were adequately secured such that any fluid loss was isolated to leakage. Therefore, the containment integrity of the tank was not compromised and the test is considered conclusive.

Tank # 8 is certified to be tight.
