FINAL 2013 BIENNIAL LEAK DETECTION TESTING REPORT OF BULK FIELD-CONSTRUCTED UNDERGROUND STORAGE TANK 15

JOINT BASE PEARL HARBOR- HICKAM / RED HILL, HAWAII

Testing of Tank # 15 a 12,600,000 gal underground storage tank located at FISC Red Hill, Pearl Harbor, Hawaii commenced February 14, 2013 and was completed February 22, 2013. The tank contained F-76 and a precision leak test was conducted. The result of that testing is that the tank system is determined to be tight to isolation. All tank valves were adequately secured such that no unusual readings were noted. Testing was performed using the Mass Technology Corporation protocols set out in the third party evaluations. All tank valves were adequately secured such that any fluid loss was isolated to leakage. Therefore, the containment integrity of the tank was not compromised and the test is considered conclusive.

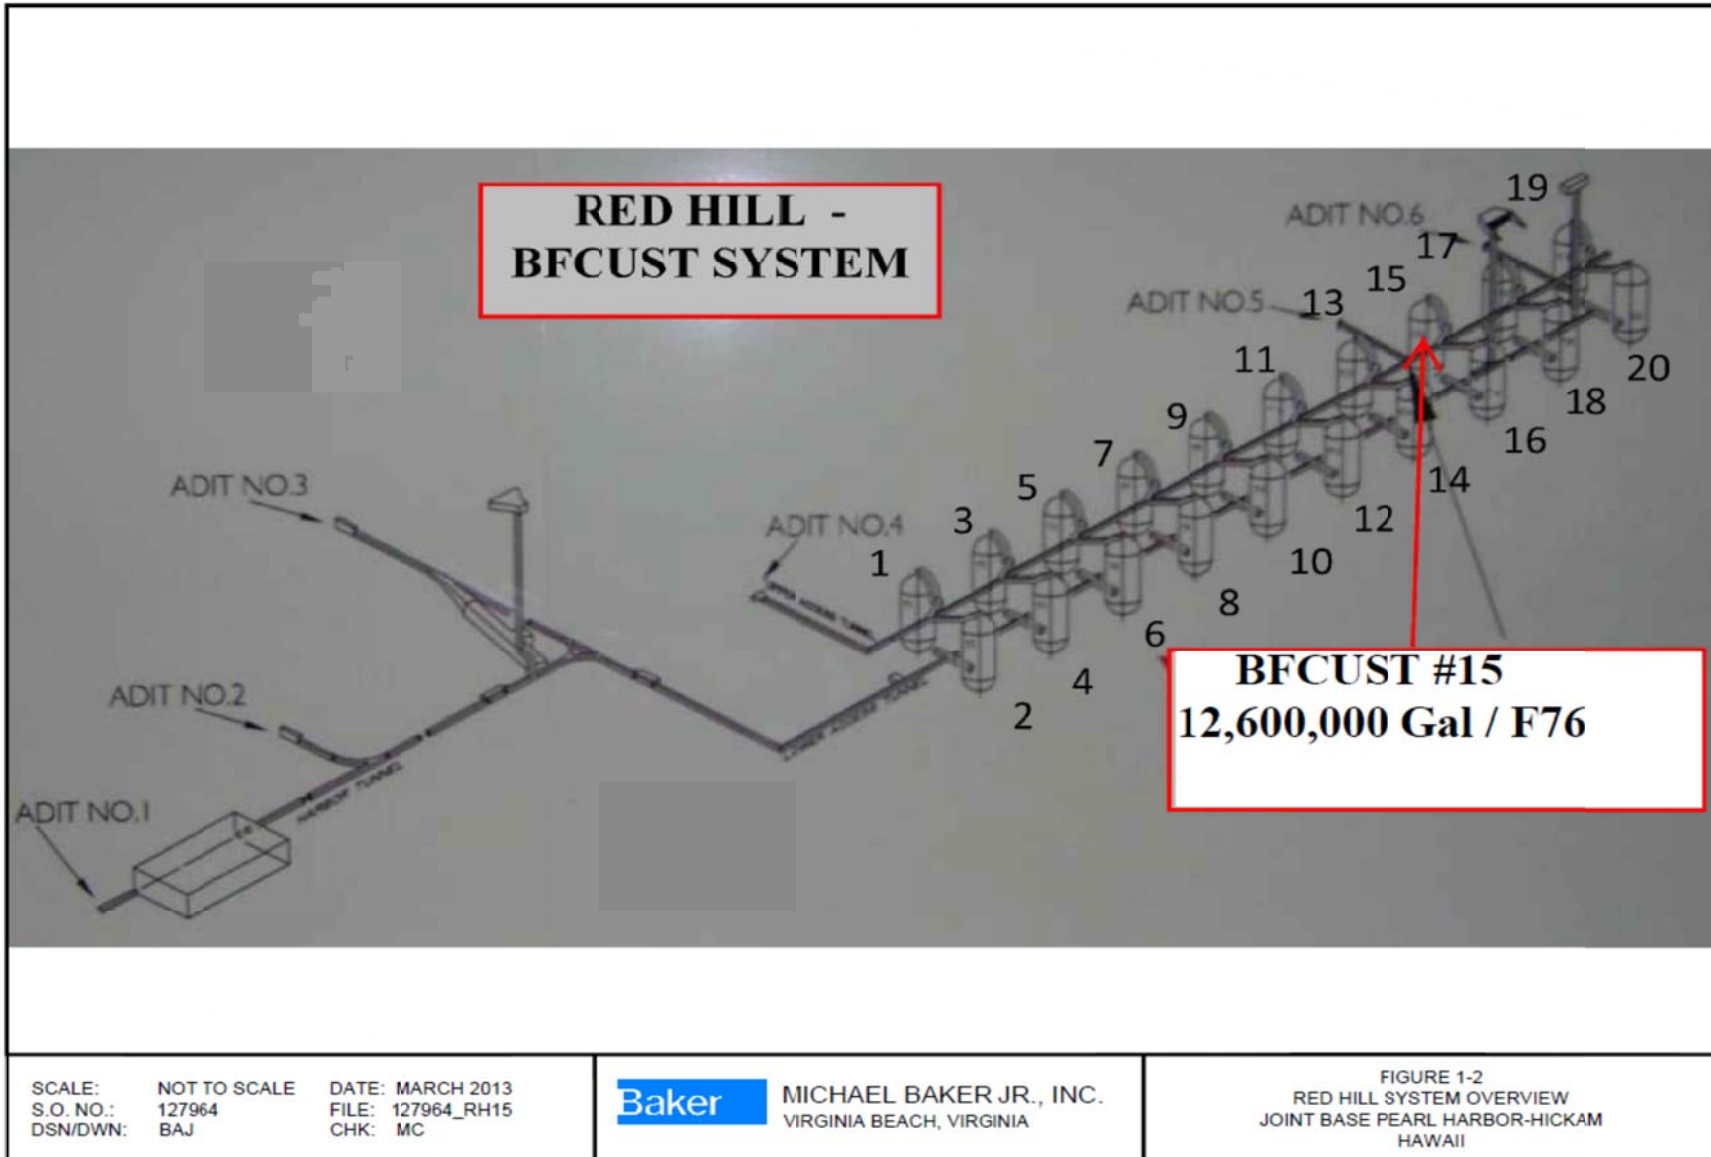
Figure 1-2: Red Hill System Layout
 (Source: Baker, 2009)

The Red Hill underground fuel storage facility consists of 20 BFCUSTs located hundreds of feet below ground and was constructed between 1940 and 1943 to replace vulnerable aboveground fuel storage tanks that were located around Pearl Harbor. The BFCUSTs at Red Hill are accessible through a tunnel system. The top tunnel runs approximately 60 feet below the top section of the tanks and the bottom tunnel runs equal to the bottom level of the tanks. The issue/receipt and water drain pipelines are accessible and have isolation valves immediately adjacent to each tank within the lower tunnel. BFCUST 15 is 100 feet in diameter, 250 feet in height, and has a capacity of 12,600,000 gallons of F-76.

FIGURE 1-2
 RED HILL SYSTEM OVERVIEW
 JOINT BASE PEARL HARBOR-HICKAM
 HAWAII

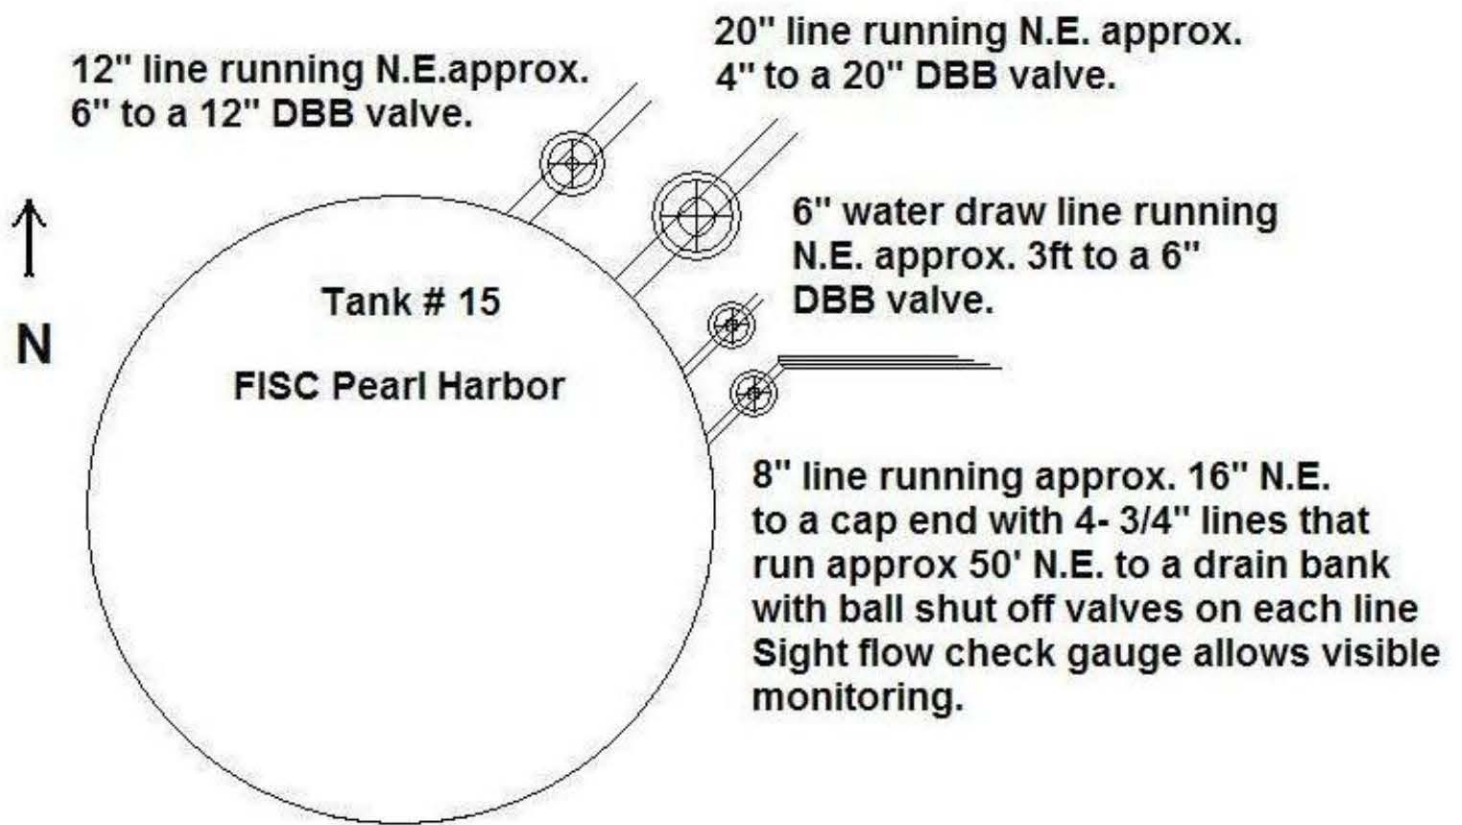
All dimensions, line locations, sizes and valve descriptions have been furnished by the facility operator.

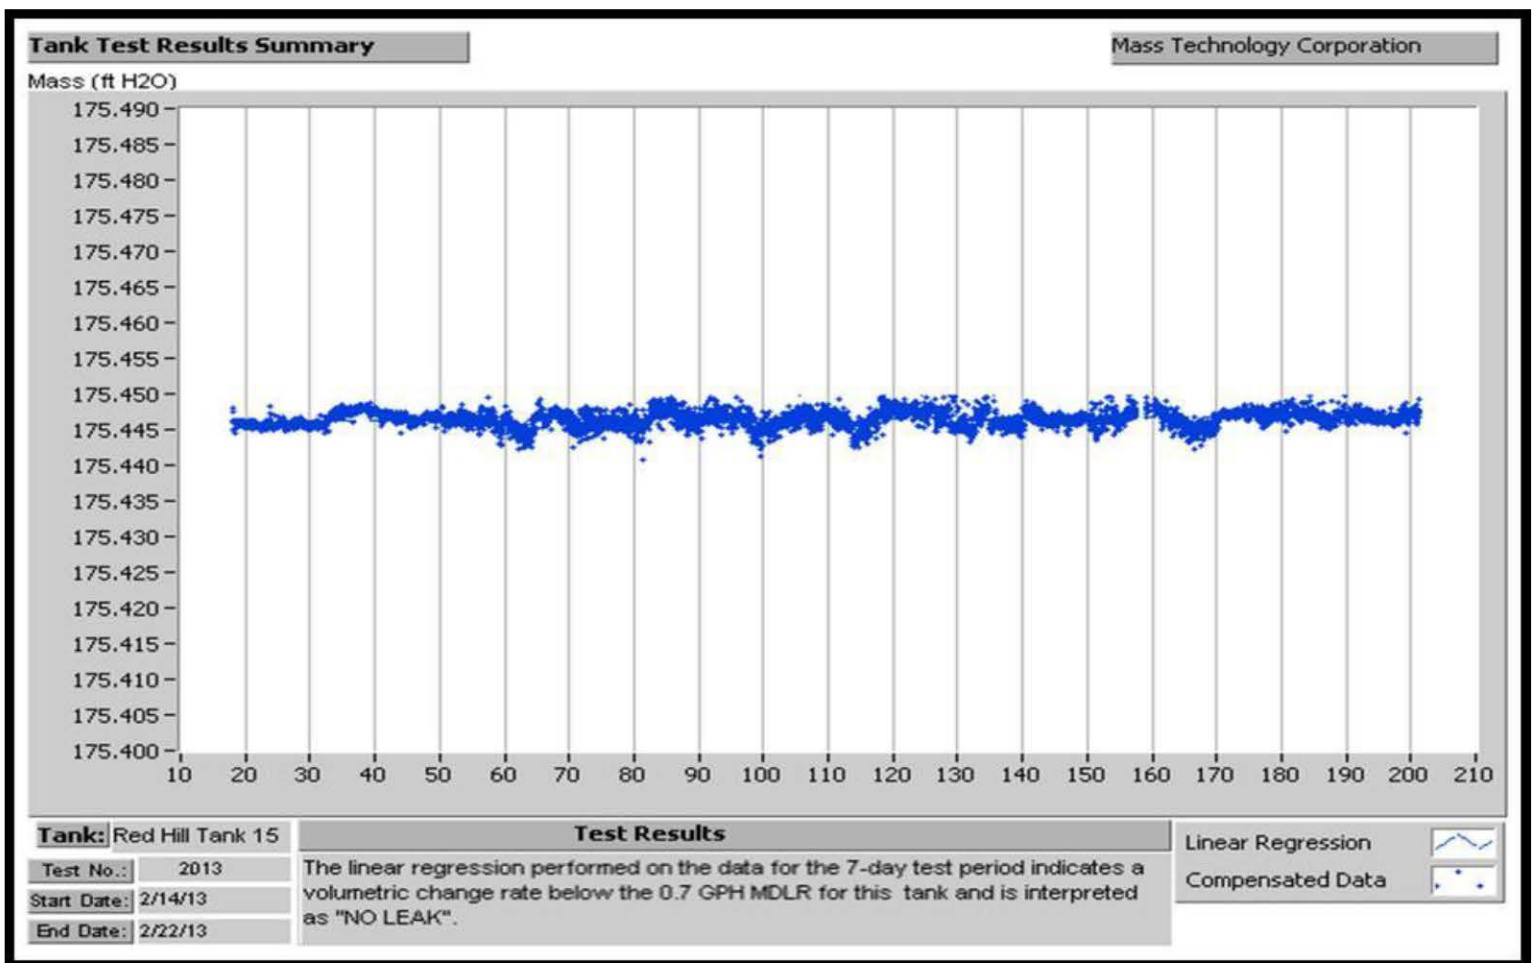
The fluid mass data was recorded over a 168-hour period. A linear regression of the recorded fluid mass data resulted in a leak rate detected below the minimum detection level of 0.7 gallons per hour. All tank valves were adequately secured such that any fluid loss was isolated to leakage. Therefore, the containment integrity of the tank was not compromised and the test is considered conclusive.

Tank # 15 is certified to be tight.
