# FINAL 2013 BIENNIAL LEAK DETECTION TESTING REPORT OF BULK FIELD-CONSTRUCTED UNDERGROUND STORAGE TANK 18

## JOINT BASE PEARL HARBOR- HICKAM / RED HILL, HAWAII

*Date:*  
**19 FEBRUARY 2013**

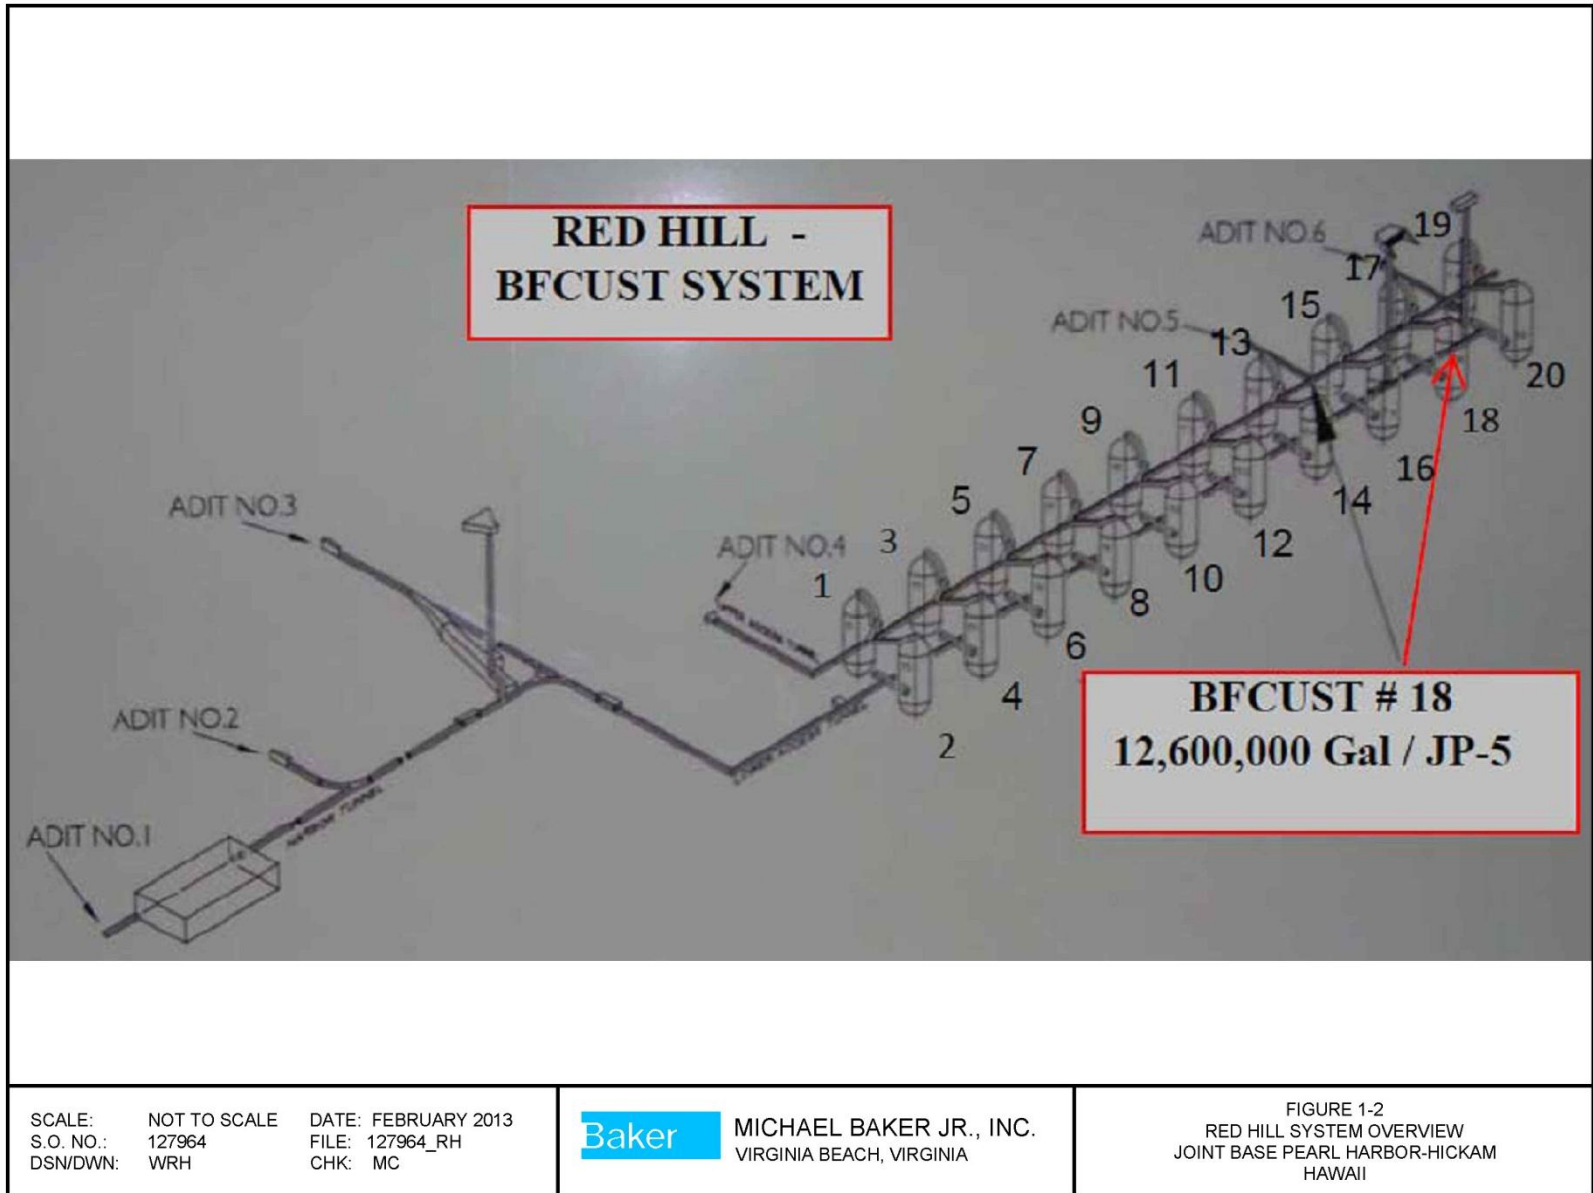
Figure 1-2: Red Hill System Layout  
 (Source: Baker, 2009)

FIGURE 1-2  
 RED HILL SYSTEM OVERVIEW  
 JOINT BASE PEARL HARBOR-HICKAM  
 HAWAII

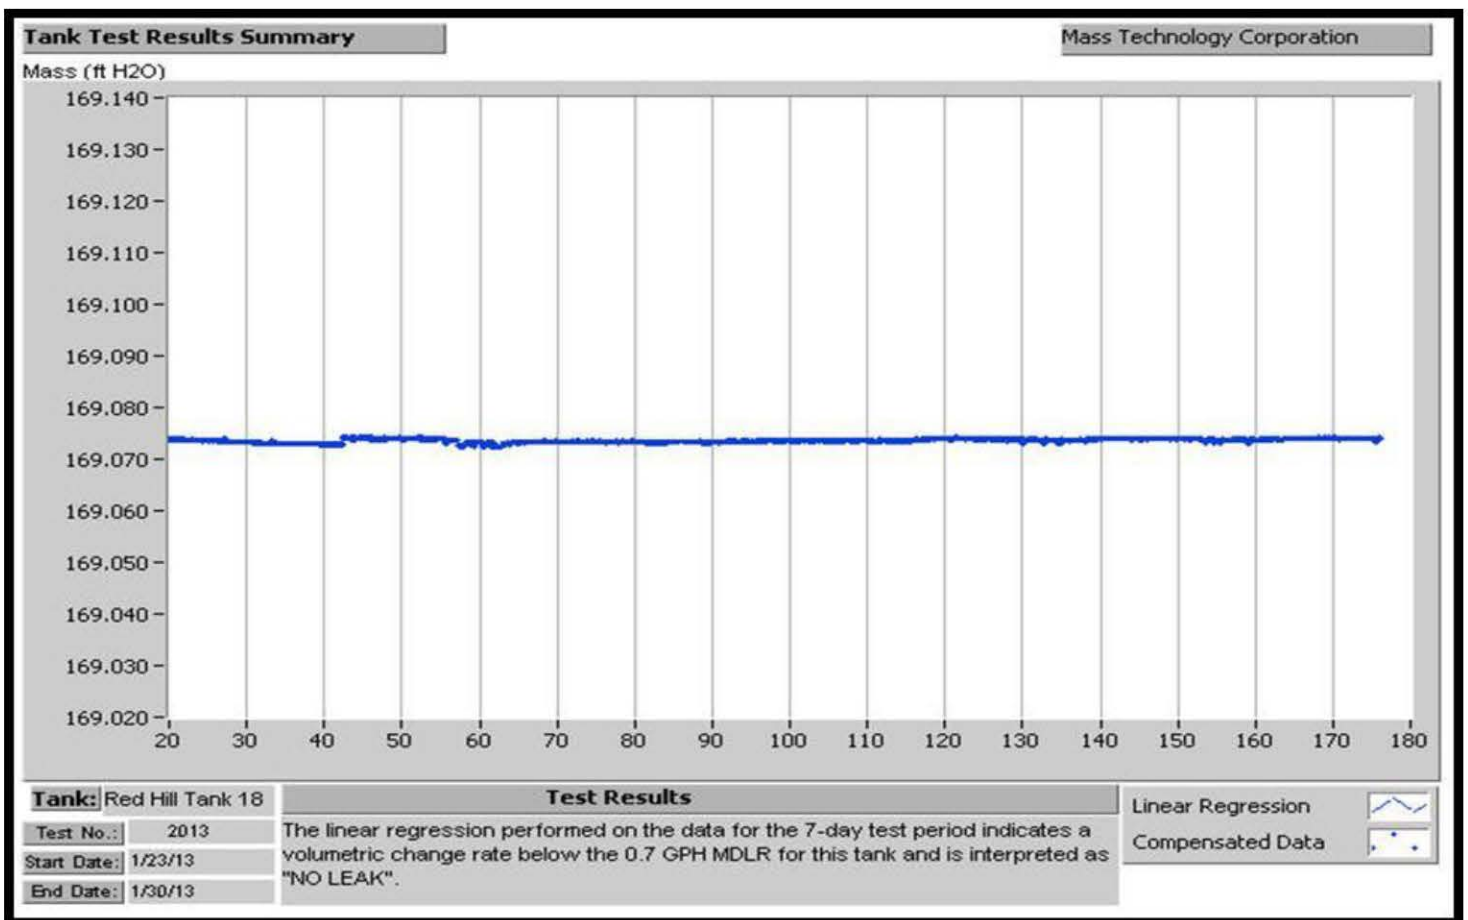
The fluid mass data was recorded over a 168-hour period. A linear regression of the recorded fluid mass data resulted in a leak rate detected below the minimum detection level of 0.7 gallons per hour. All tank valves were adequately secured such that any fluid loss was isolated to leakage. Therefore, the containment integrity of the tank was not compromised and the test is considered conclusive.

Tank # 18 is certified to be tight.
