FINAL 2013 BIENNIAL LEAK DETECTION TESTING REPORT OF BULK FIELD-CONSTRUCTED UNDERGROUND STORAGE TANK 2

JOINT BASE PEARL HARBOR- HICKAM / RED HILL, HAWAII

Date:
13 MARCH 2013

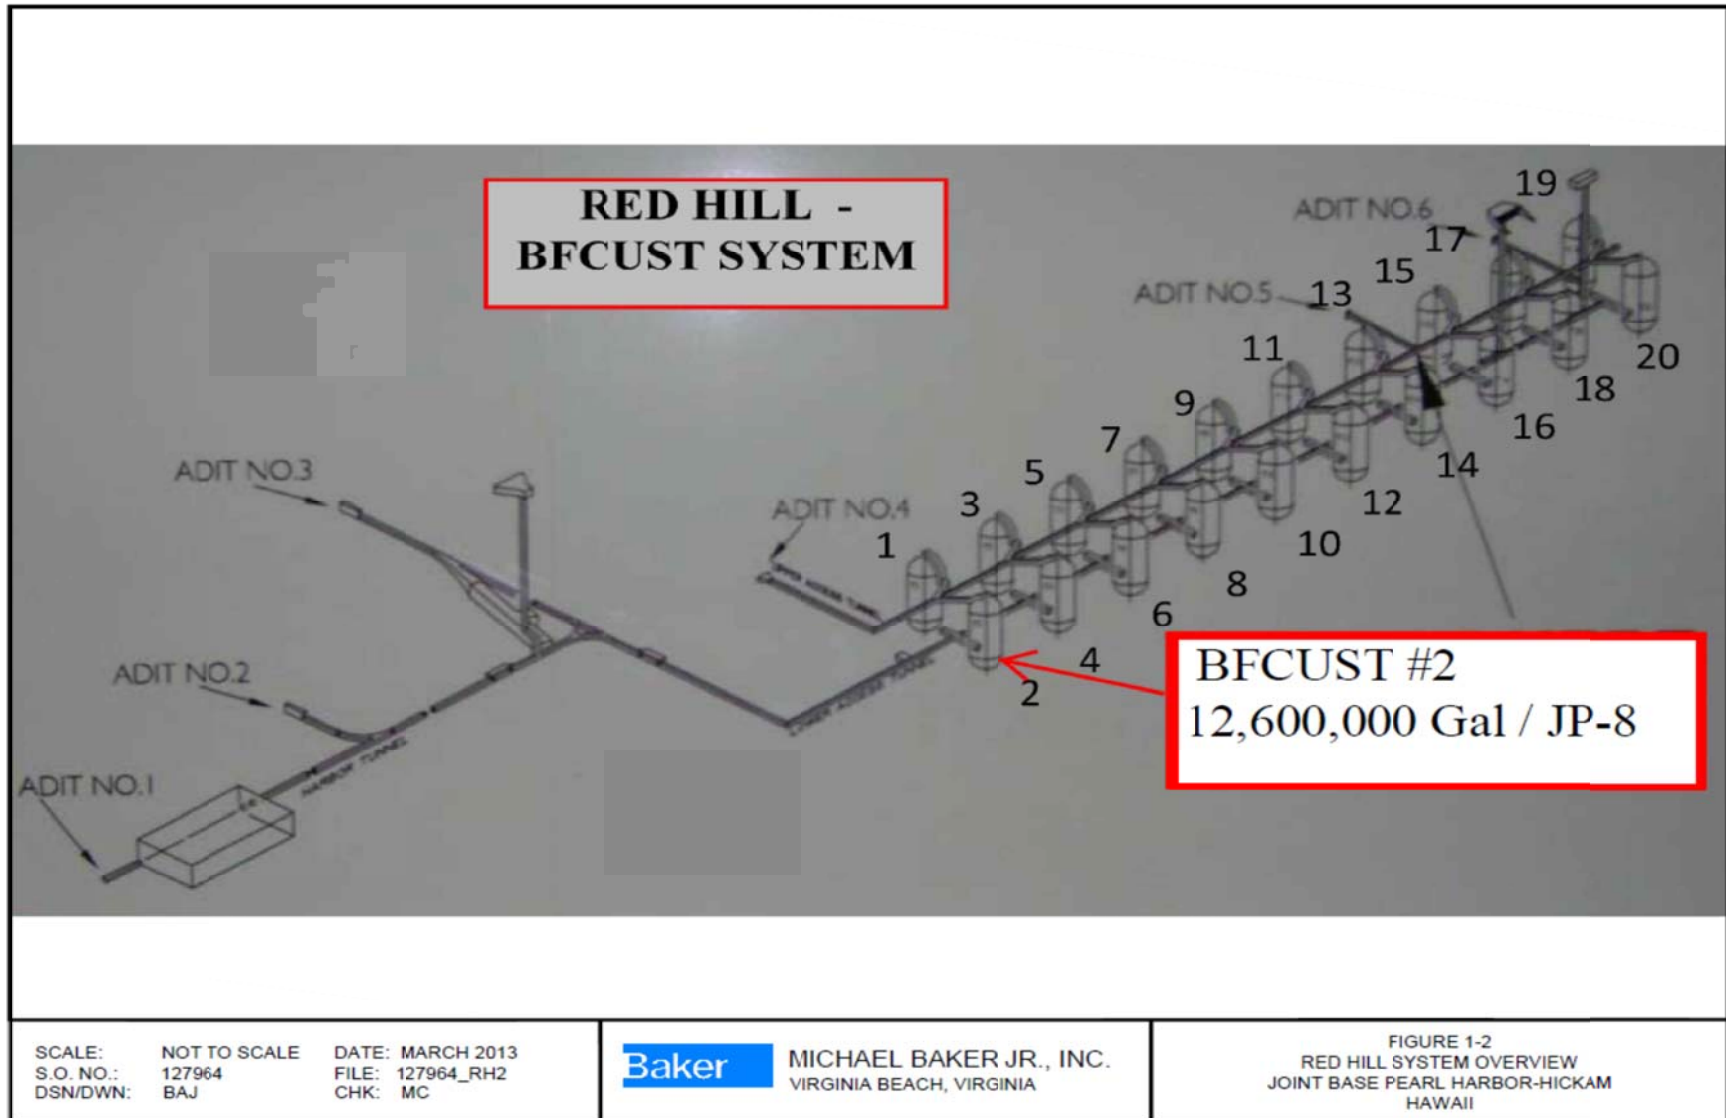
FIGURE 1-2
 RED HILL SYSTEM OVERVIEW
 JOINT BASE PEARL HARBOR-HICKAM
 HAWAII

Figure 1-2: Red Hill System Layout
 (Source: Baker, 2009)

A MTC leak detection test on BFCUST 2 was performed from 13 February through 20 February 2013. Table 1-1 provides a description of the system tested. Figure 1-1 provides a base overview map. Figure 1-2 provides a layout of the Red Hill system.

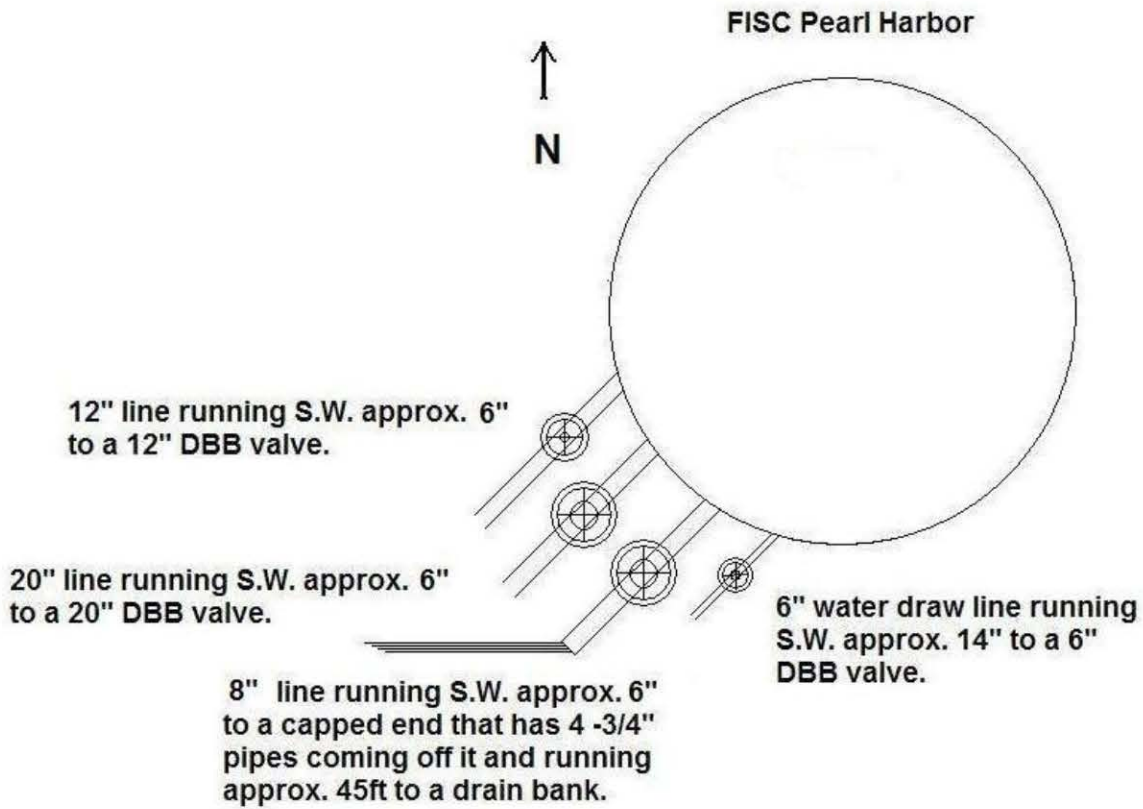
Tank Data Tank # 2

Diameter: 100 ft.
Tank Type: Vertical UST
Specific Gravity: 0.80

Height: 238 ft.
Contents: JP-8
Product Level: 200.28 ft.

All dimensions, line locations, sizes and valve descriptions have been furnished by the facility operator.

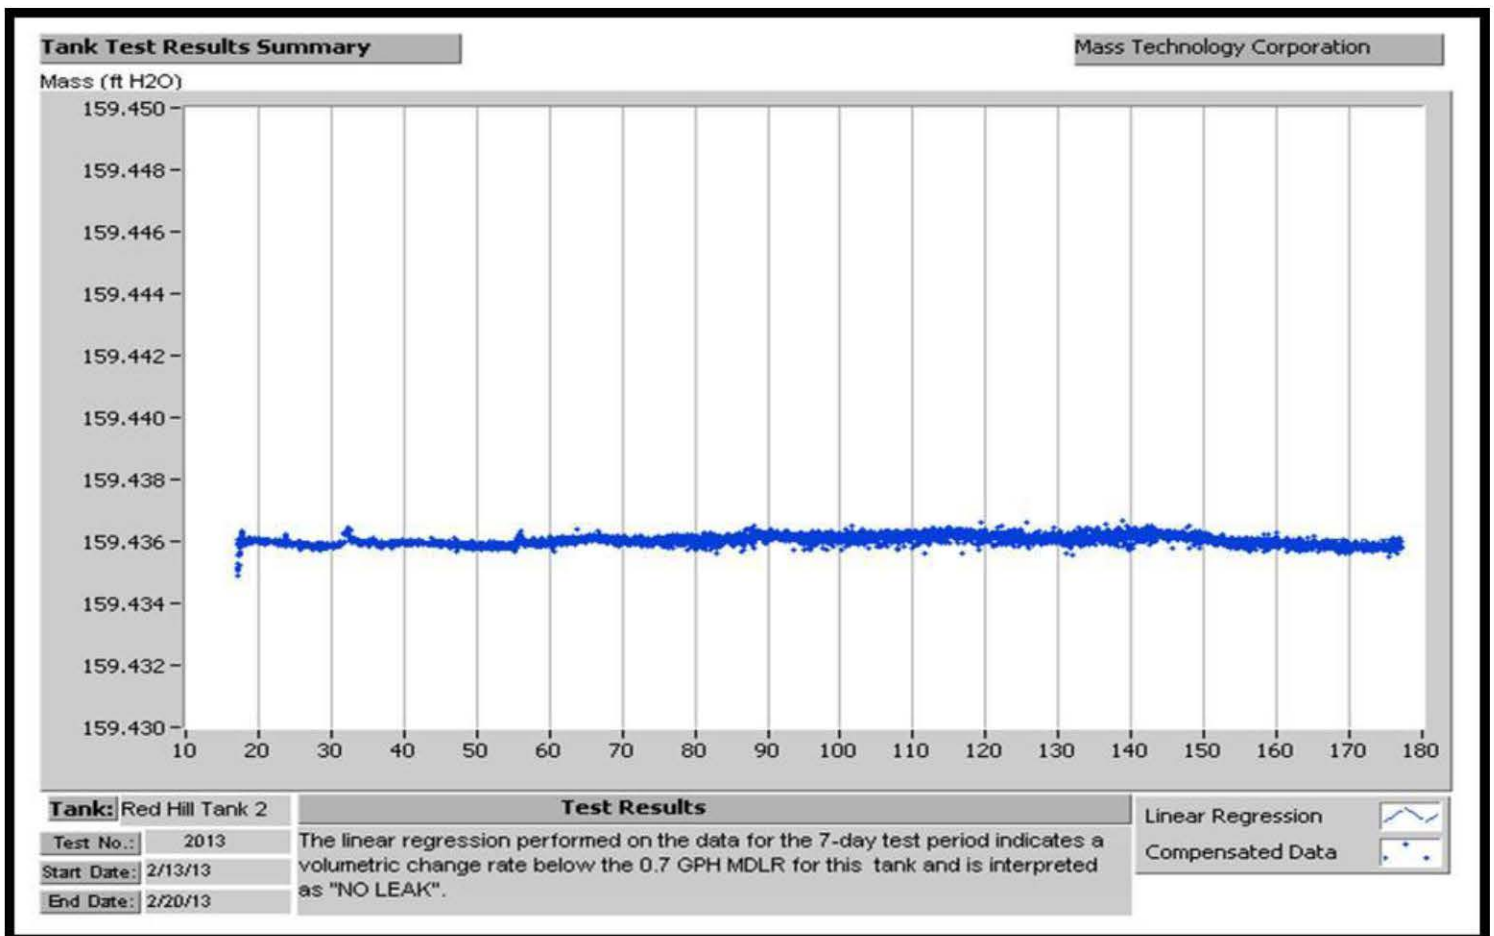
The fluid mass data was recorded over a 168-hour period. A linear regression of the recorded fluid mass data resulted in a leak rate detected below the minimum detection level of 0.7 gallons per hour. All tank valves were adequately secured such that any fluid loss was isolated to leakage. Therefore, the containment integrity of the tank was not compromised and the test is considered conclusive.

Tank # 2 is certified to be tight.
