FINAL 2013 BIENNIAL LEAK DETECTION TESTING REPORT OF BULK FIELD-CONSTRUCTED UNDERGROUND STORAGE TANK 3, RED HILL UNDERGROUND FUEL STORAGE FACILITY

JOINT BASE PEARL HARBOR- HICKAM, HAWAII

Submitted by:
Michael Baker Jr., Inc.
Virginia Beach, VA

Date:
17 APRIL 2013

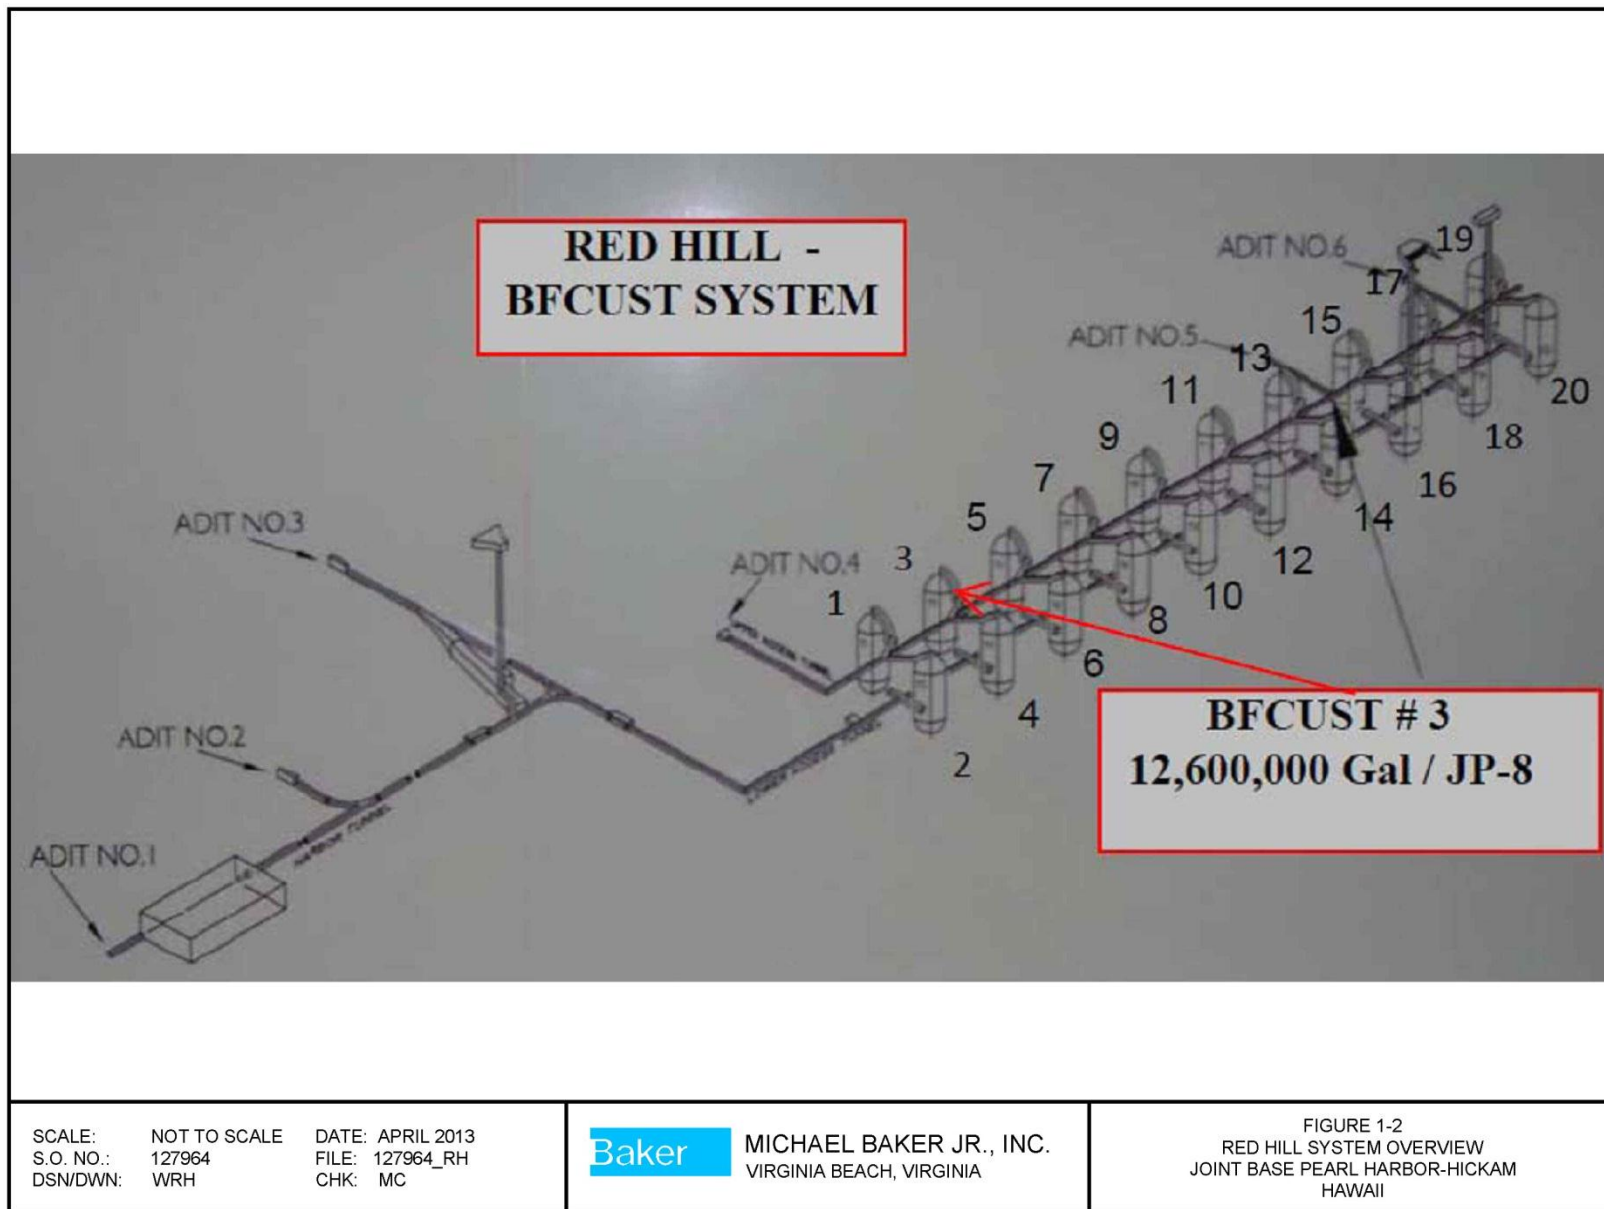
Figure 1-2: Red Hill System Layout

A MTC leak detection test on BFCUST 3 was performed from 28 February through 7 March 2013. Table 1-1 provides a description of the systems tested. Figure 1-1 provides a base overview map. Figure 1-2 provides a layout of the Red Hill system.

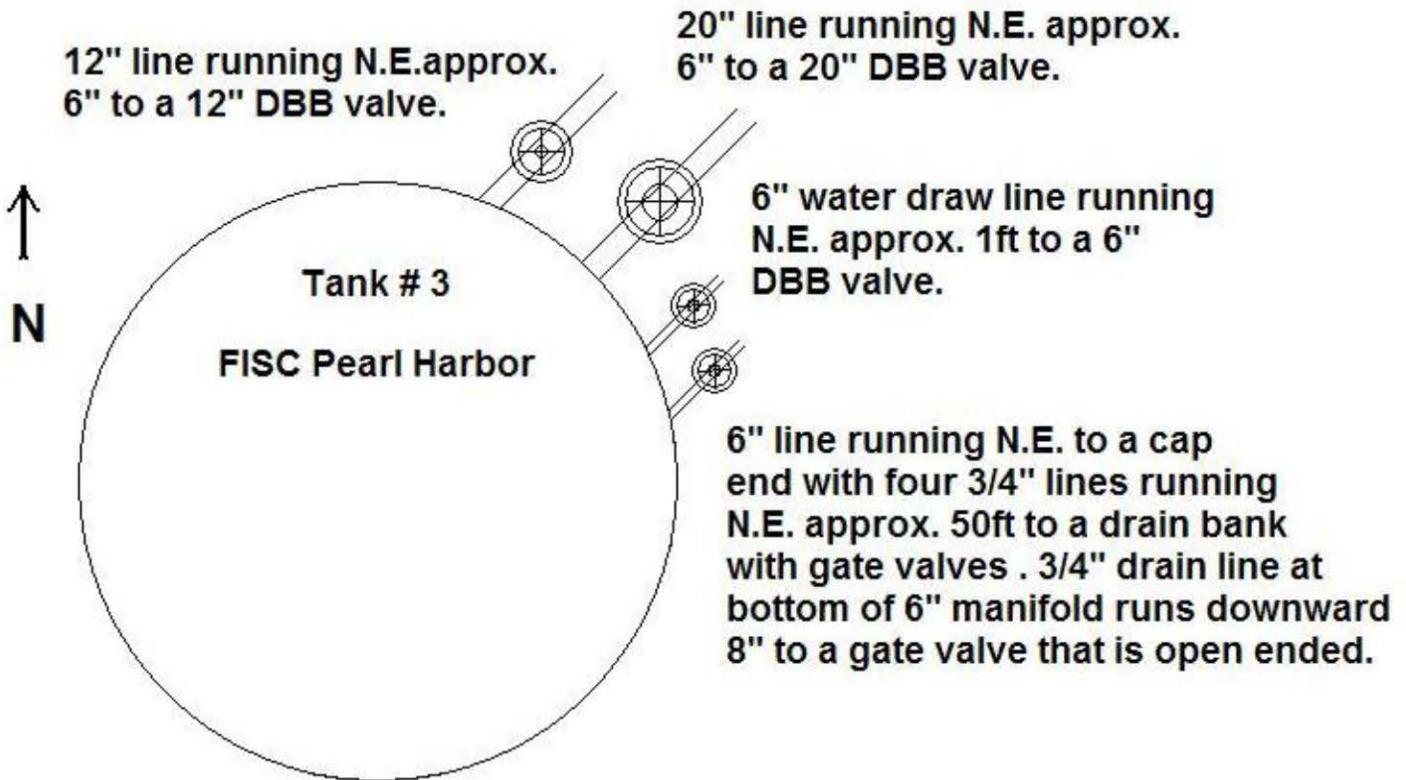
Tank Data Tank # 3

Diameter: 100 ft.
Tank Type: Vertical UST
Specific Gravity: 0.80

Height: 250 ft.
Contents: JP-8
Product Level: 211.09 ft.

All dimensions, line locations, sizes and valve descriptions have been furnished by the facility operator.

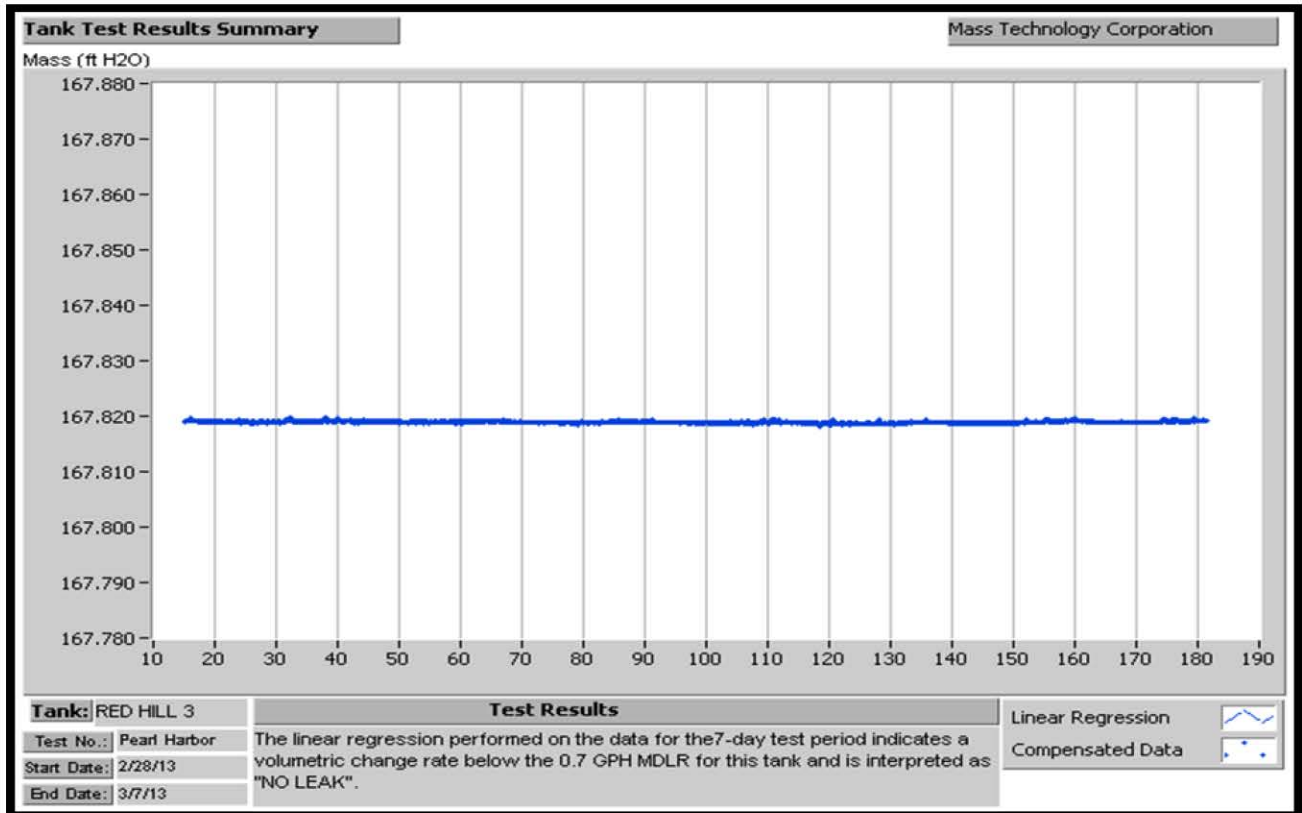
The fluid mass data was recorded over a 168-hour period. A linear regression of the recorded fluid mass data resulted in a leak rate detected below the minimum detection level of 0.7 gallons per hour. All tank valves were adequately secured such that any fluid loss was isolated to leakage. Therefore, the containment integrity of the tank was not compromised and the test is considered conclusive.

Tank # 3 is certified to be tight.
