FINAL- 2009 - BIENNIAL TANK INTEGRITY TESTING REPORT (CDRL A001) – BFCUST #8 *at* FISC RED HILL / PEARL HARBOR, HI

Date:
8 JUNE 2009

FINAL 2009 BIENNIAL INTEGRITY TESTING REPORT
(CDRL A001)
OF
BFCUST # 8

FISC RED HILL – PEARL HARBOR, HI

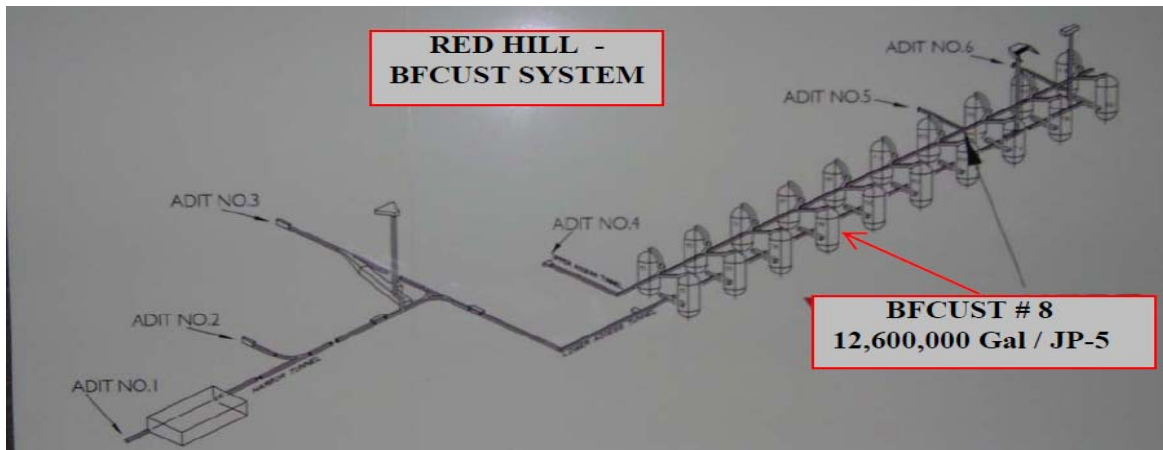
Figure 1: RED HILL – BFCUST SYSTEM – BFCUST #8

A Mass Technology Corporation (MTC) integrity test on BFCUST #8 was performed from 5 May to 12 May 2009. Table 1 provides a description of the systems tested. Figures 1-3 show details of the Red Hill system and typical tank access points.

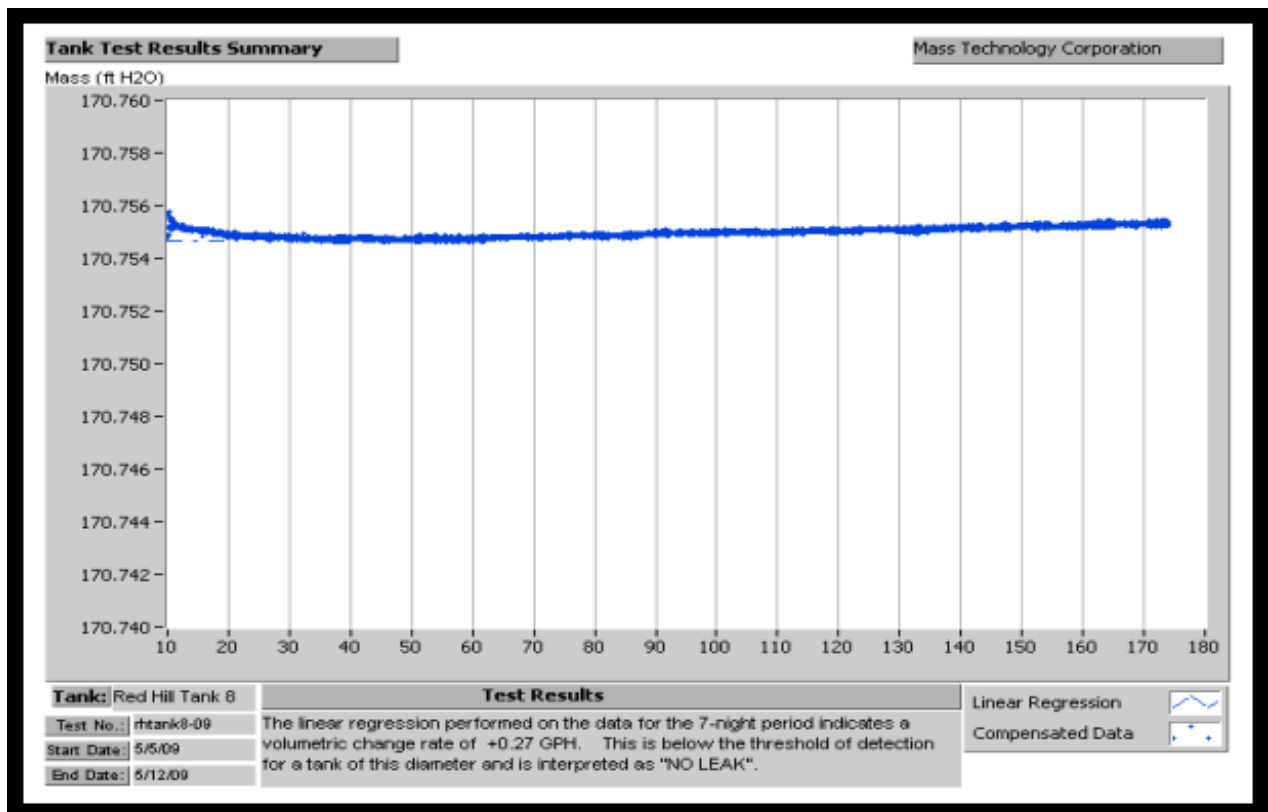
The fluid mass data was recorded over a 168-hour period. A linear regression of the recorded fluid mass data resulted in a leak rate detected below the minimum detection level of 0.7 gallons per hour. All tank valves were adequately secured such that any fluid loss was isolated to leakage. Therefore, the containment integrity of the tank was not compromised and the test is considered conclusive.

Tank # 8 is certified to be tight.
