# FINAL- 2009 - BIENNIAL TANK INTEGRITY TESTING REPORT (CDRL A001) – BFCUST #10 *at* FISC RED HILL / PEARL HARBOR, HI

**FINAL 2009 BIENNIAL INTEGRITY TESTING REPORT**  
**(CDRL A001)**  
**OF**  
**BFCUST # 10**

**FISC RED HILL – PEARL HARBOR, HI**

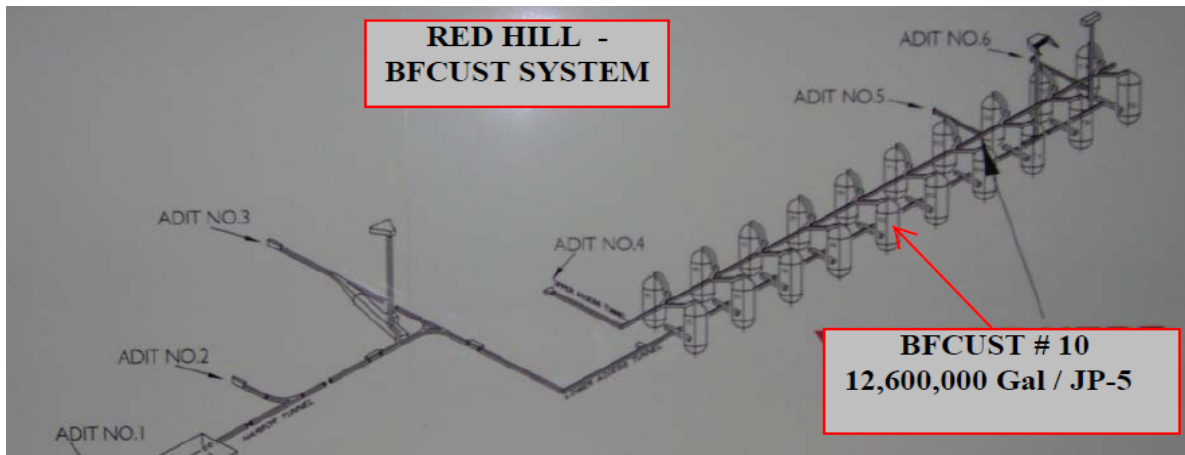
**Figure 1: RED HILL – BFCUST SYSTEM – BFCUST #10**

Figures 1-3 show details of the Red Hill system and typical tank access points.

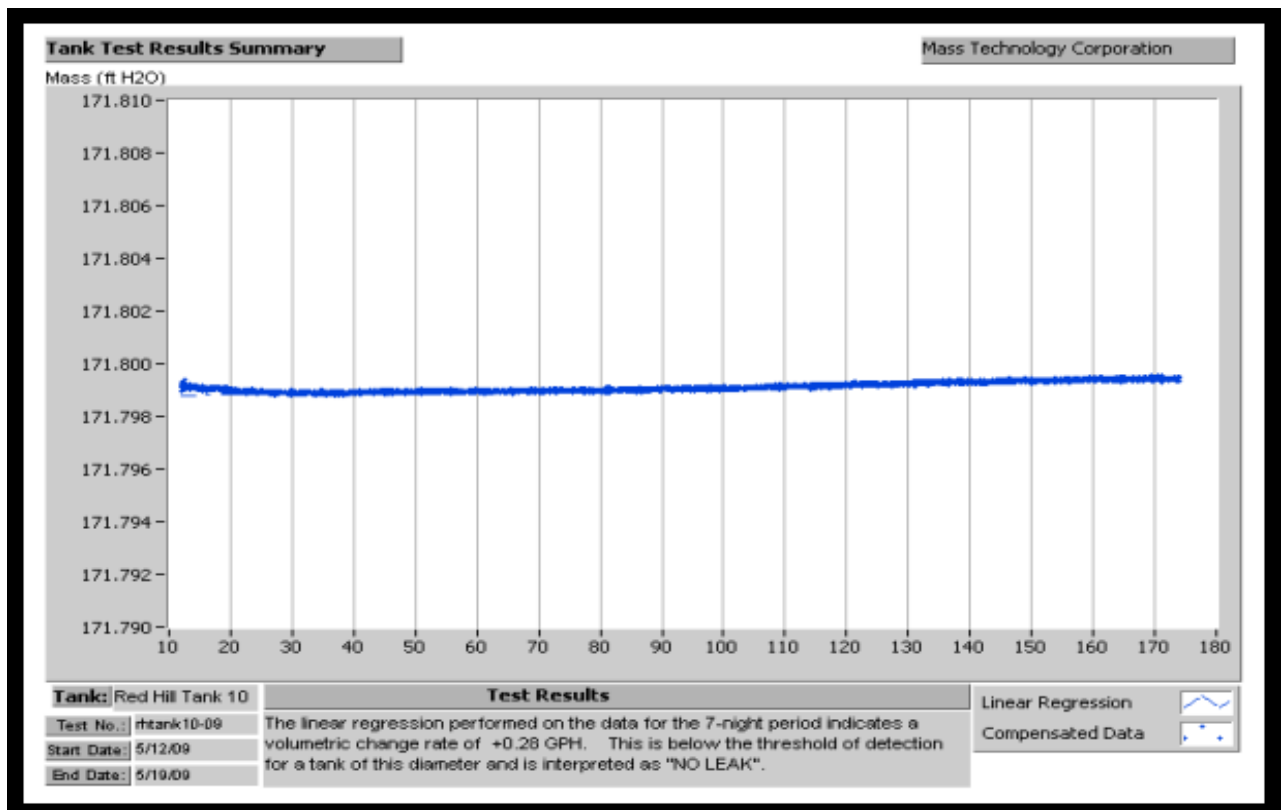
The fluid mass data was recorded over a 168-hour period. A linear regression of the recorded fluid mass data resulted in a leak rate detected below the minimum detection level of 0.7 gallons per hour. All tank valves were adequately secured such that any fluid loss was isolated to leakage. Therefore, the containment integrity of the tank was not compromised and the test is considered conclusive.
